Detector response from a defective wheel

Matthias Asplund^{a,b,*}, Pär Söderström^c

ABSTRACT

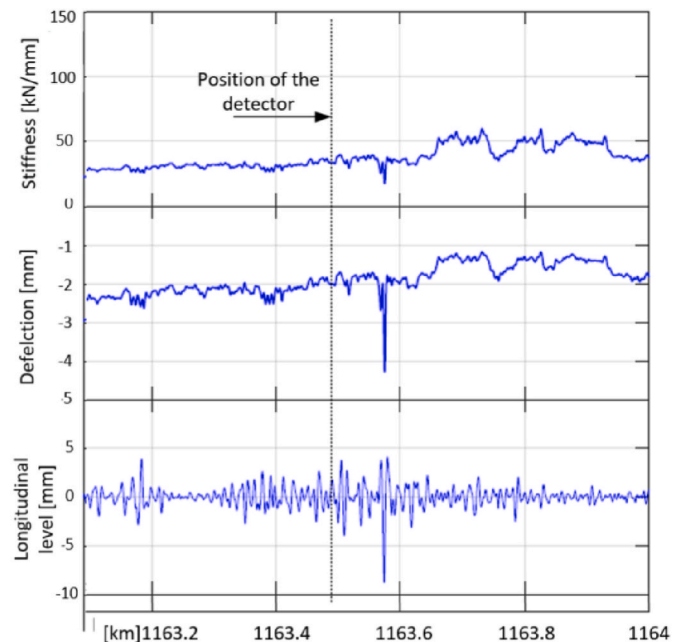
The wheel-defect detector is located in a section of straight track. The stiffness of the track was measured in 2022 with a track recording car equipped with a track stiffness measurement system [15]. The track recording car has a weight of 51 tons and an axle load of 12.75 tons. The track stiffness of this section where the detector is located is measured to about 40 kN/mm with a deflection of about 2 mm. This stiffness is what can be expected for this section after measurements totalling 16 km. The stiffness over the detector has no deviations from that of the track section in general. However, some minor deviation seems to be on the

levelling of the track on and around the detector. Anyway, it can be assumed that this will not significantly impact the performance of the measurements for the detector. Nevertheless, the track, along with the detector, incorporates various types of fastenings, leading to potential variations in their dynamic behaviours. The track employs elastic fastenings featuring rail-pads, whereas the detector utilizes load cells. These differences may affect the dynamic force transmission between the track and the detector. However, these nuances are not demonstrated in the current quasi-static measurement of track stiffness. The track stiffness, the deflection and the levelling are shown in Fig. 1, where the x-axis is the distance of 1 km. The position of the detector is defined as a dotted line in the figure about km 1163.5. The track stiffness measurements were done by a track recording car, which is in commercial use in Sweden.

Fig. 1. Measurements of the track section with the detector. The track stiffness for the section is about 40 kN/mm, the deflection is around 2 mm and the longitudinal level is less than ± 5 mm.

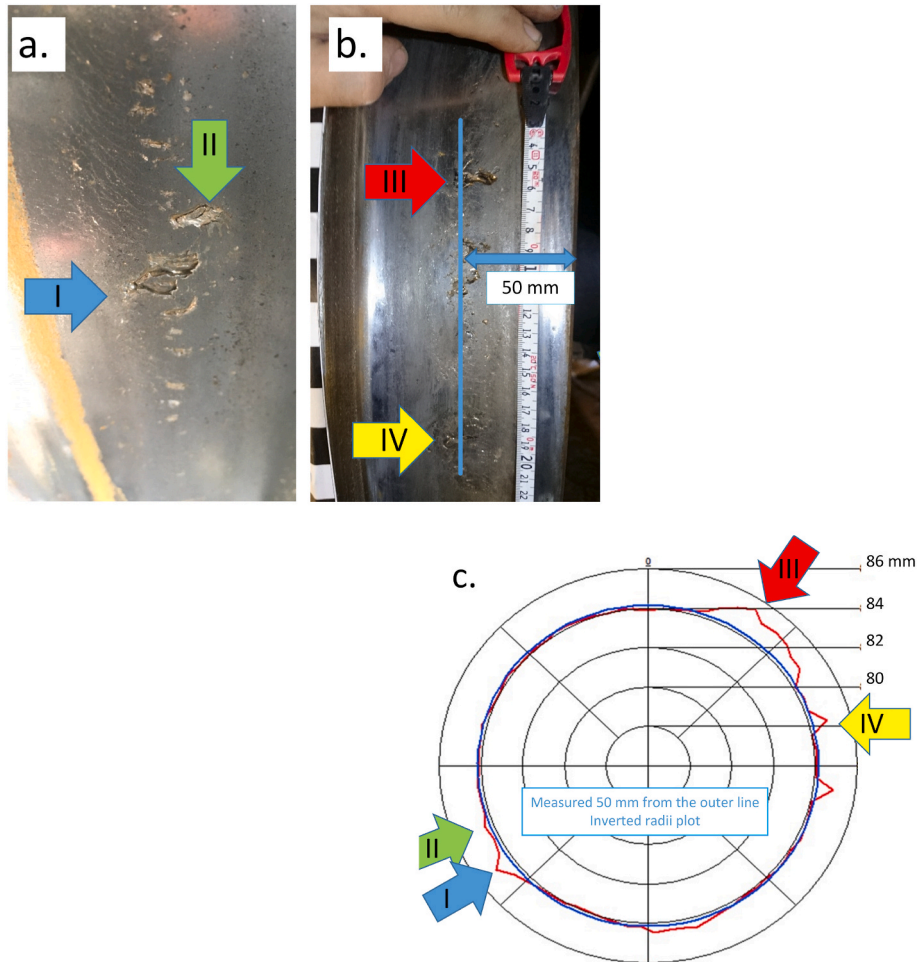
The damaged wheel investigated in this article is measured by laser; the defects can be seen in Fig. 4(a and b), with four different main damage areas: see arrows I, II, III, and IV. The largest damage found at the tread has a depth of 1.8 mm and has position III, as shown in Fig. 4 b). At the opposite side of the wheel are defects (Fig. 6 a) having a depth of 1.0 mm and represented at arrow I. In Fig. 4 b) is a line marked on the wheel that is 50 mm from the outside of the wheel (field side). Fig. 4 c) shows the inversed radii plot of the wheel at 50 mm from the field side of the wheel, where the four different defects are marked by I, II, III, and IV. The polygonalisation is measured for the wheel; this is presented in Table 1 for the four first orders: eccentricity, ovality, triangularity, and squarity. These can also be described as different orders of polygonalisation: first order of out-of-roundness, second order of out-of-roundness, third order of out-of-roundness, and fourth order of out-of-roundness; more on railway wheels and out-of-roundness is well described in Ref. [17].

The wagon was caught with force peak of 357 kN in a northerly direction at WILD in Norrmjöle, in the northern part of Sweden on March

17, 2018. When the force level exceeds 350 kN it is reported as a high-level alarm, and the vehicle needs to be immediately stopped, which was done with this wagon.

Fig. 4. Measurements of the damaged wheel, a) defect is at position I depth 1.0 mm, b) defect of position III with a depth of 1.8 mm, c) the inverted radii plot of the wheel at 50 mm from the outer side outer wheel.

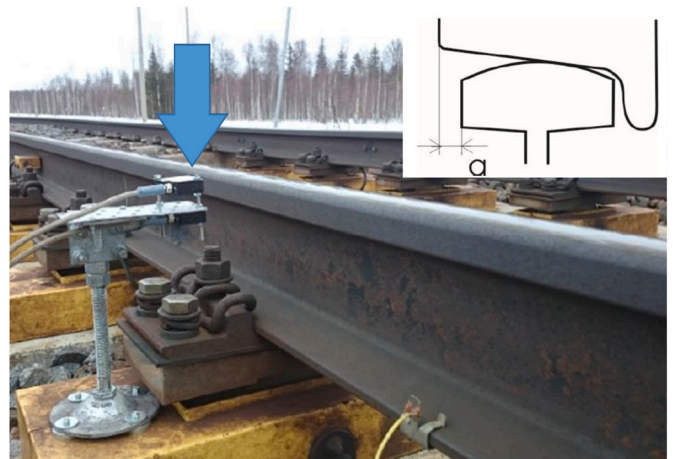
Fig. 8. Measurements of the lateral position of the wheel during the test of the response from defect wheel, photo by Dan Larsson DAMILL AB.

a speed of 100 km/h; this is due to the signaling system. The difference between the lateral positions over the detector differs between the traveling directions by an average of 3.0 mm.

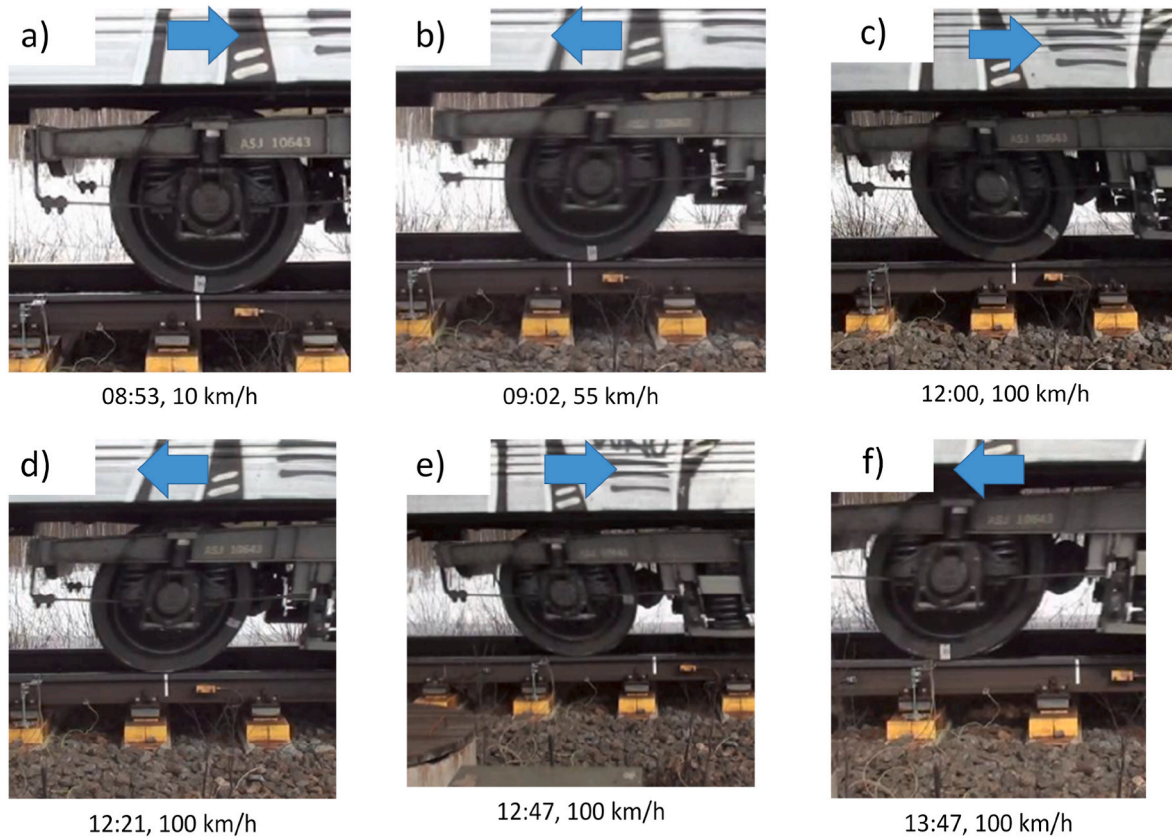
Fig. 9. The longitudinal positions of the wheel and rail for the different runs: a) the mark at the rail and wheel at the same position, b) all 13 runs with speeds up to 55 km/h the position are about 100 mm shifted from the start, c) the run 14th and the position between the rail has been moved with about 300 mm, d) the run 15th shows a larger difference between the marking, e) the 16th run aligns quite well with the marker at the rail and the wheel, f) the second last run and the position between the marker on the wheel and rail differs with about 600 mm. Photos by Dan Larsson DAMILL AB.

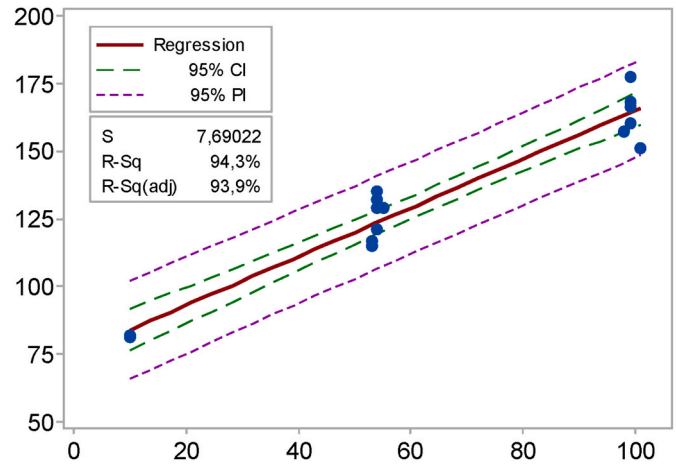
In other words, the most appropriate expression is the linear equation due to the good fit and simplicity. The formula for the force response expressed in Equation (1) was that each change in speed km/h changed the force response by about 0.9 kN. The constant in equation 74.98 is the quasi-static wheel load expressed in kN.

Fig. 10 presents the result where the x-axis represents the speed of the train and the y-axis represents the response measured force. The Figure includes 16 measurement points at 10 km/h, 55 km/h, and 100

Fig. 10. The fitted line plot with the measurement results from the runs over the detector.

Roughly, this means that the further response of this wheel can give a force level between about 100 and 140 kN at a speed of 55 km/h and 140 kN–180 kN at a speed of 100 km/h. The variations are about 40 % at the speed of 55 km/h and 30 % at the speed of 100 km/h.
