Mosul Dam Full Story: Safety Evaluations of Mosul Dam

Nasrat Adamo¹ and Nadhir Al-Ansari²

Abstract

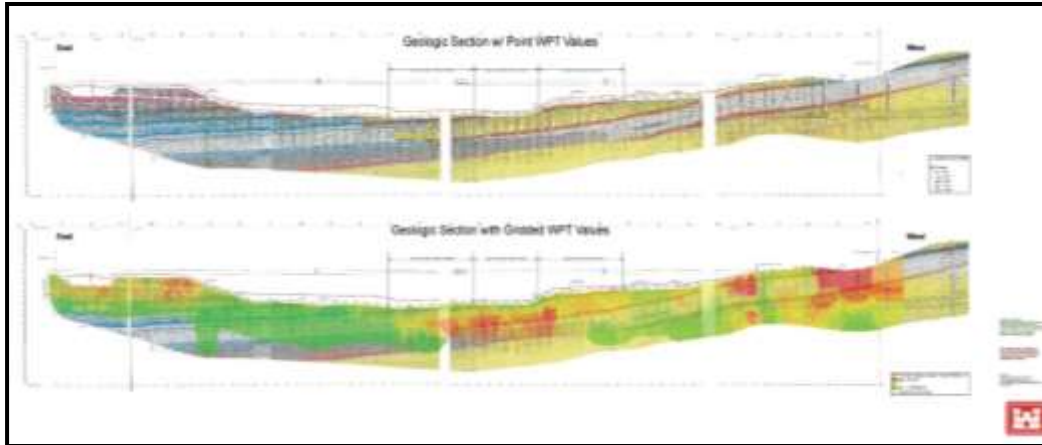
observed in Figure (5), the highest grout take (shown in red) were located within the historic river channel. Other areas of high grout take were within the highly permeable F-bed Limestone in the left bank. The sinkholes formation phenomenon in the left bank was also addressed and shown that it was a direct result of the movement of this dissolution front as already been mentioned in the Harza PoE report. Examining the quality of rock cores recovered from drill holes in the vicinity of the left bank sinkholes SD5 (2005) and SD6 (2006) and comparing them with cores from nearby drill holes which were performed during the 1980 investigation marked decrease of the RQD values. This indicated clear loss of volume of rock in these areas as a result of dissolution. The trend of grouting and re-grouting in the deep grout curtain during the previous year indicated that the dissolution front had moved eastward possibly as much as 10 grouting sections of the dam or approximately 350 meters in 20 years, averaging > 17 m per year. As a whole this study gave very dangerous indications for the future as the dissolution would continue in spite of grouting. It also supported the decision taken to limit the maximum operation water level to EL319 m.

Fig 5: Geologic sections with water-pressure test values (upper figure) and kriging statistical analysis (lower figure) indicating areas of dissolution at the time of construction. The sections are from boreholes of the grout gallery under the dam. In the kriging (lower) section, red areas indicate zones of prehistoric and historic dissolution.

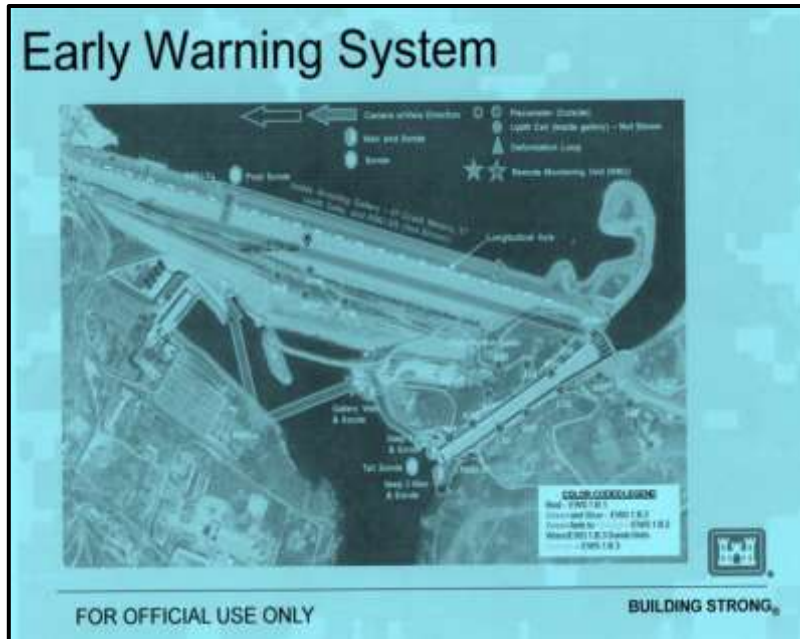
Fig 7: Early warning system showing locations of instruments and cameras

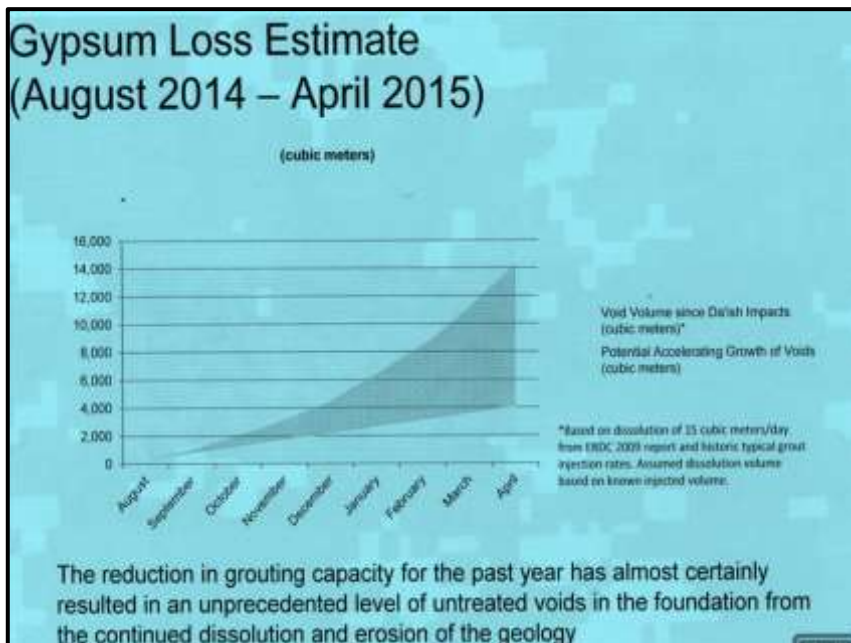
Figure 8: Dissolution of gypsum with grouting and without groutin

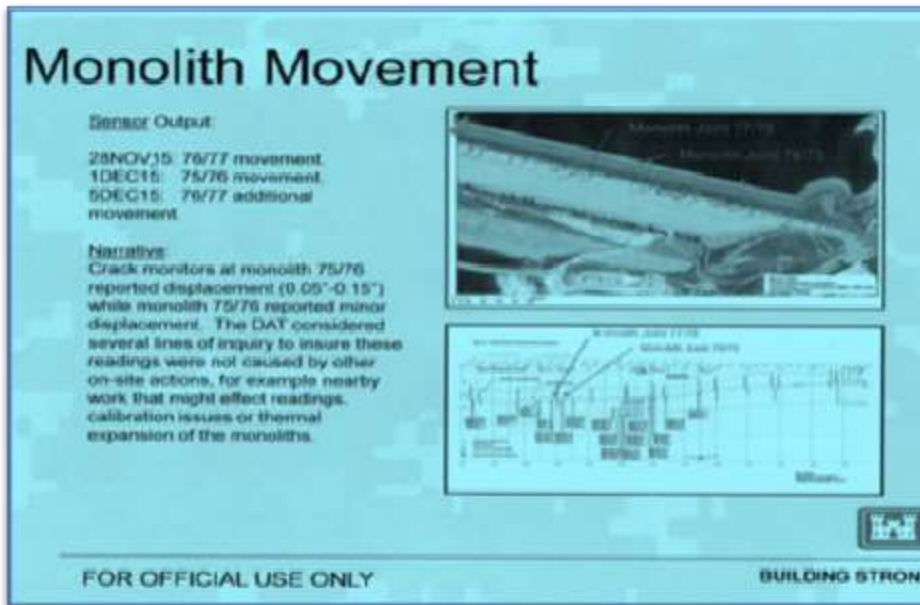
- ii) Increased concentration of sulfates in the seepage water indicating increased dissolution of gypsum.
- iii) Sign of increased monolith movement in the grouting gallery and cracks opening. One example is shown at the joint between sections 75 and 76 where recorded movement ranged between 0.05 inch and 0.15 inches as shown in Figure (9). Investigation of movement showed they were not caused by on site activity such as nearby works that might affect reading calibration issues or thermal expansion. The only reasonable conclusion is they are caused by settlement.

Figure 9 Displacement between sections 75 /76 in the grouting gallery

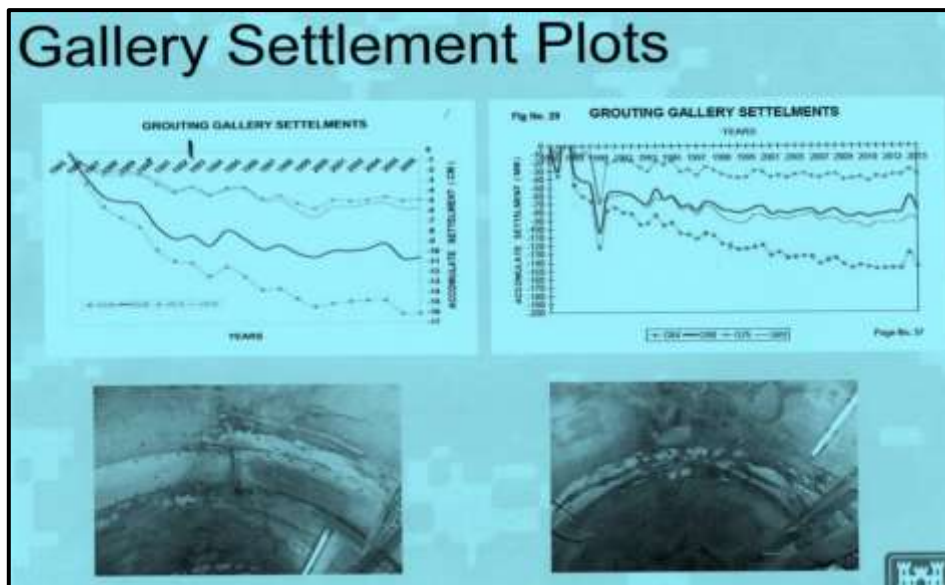
Continuous recording of cumulative settlement in the grouting gallery from 1986 to the end of 2015 showed also sharp increase in settlement in the last year which indicates a worsening situation in the dam foundations. Figure (10) shows the plots recorded in gallery sections 69, 75, 80, and 84 from 1986 till end of 2015. Photographs in the same figure show locations of distressed concrete in one joint.

Figure 10: Cumulative settlements in the grouting gallery

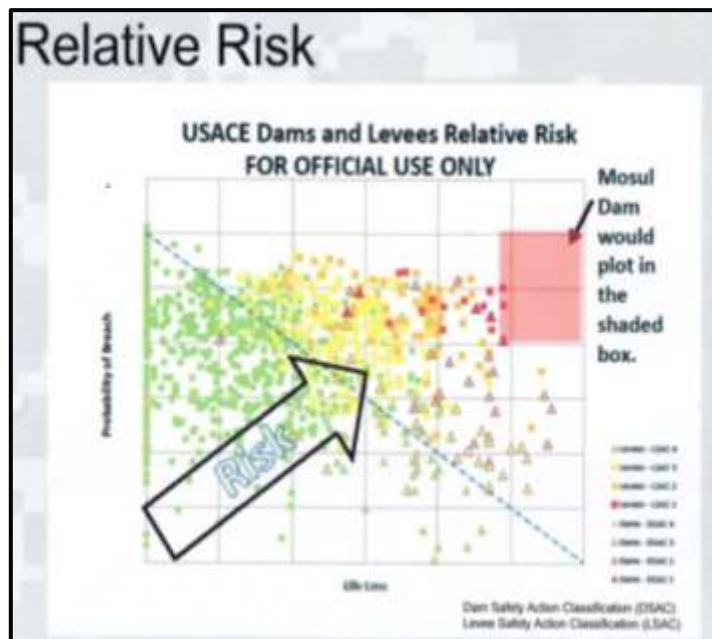
So it may be stated that the United State Interagency Team working on Mosul Dam could have used these procedures to evaluate the relative risks in Mosul Dam case based on all measurements and observations done in 2015 and arriving to a relative risk ranking for the dam. This ranking showed that Mosul Dam is in a state of extreme relative risk as shown in Figure (11). This diagram shows all the dams and levees of the USACE indicating their relative risks and also where Mosul Dam stands. In fact it shows that Mosul Dam is in a state of extreme and unprecedented high relative risk.

Figure 11: Plot showing the severe relative risk of Mosul Dam
