The impact of modernization of a 16th century timber-framed farmhouse, Suffolk, UK

Abstract – Well intentioned modifications to traditional buildings can potentially be detrimental if the full implications of the work are not fully understood. This paper presents the case of a 16th century Suffolk farmhouse. Extended in the 1700s, the timber-framed building was clad in cement render in the early 20th century. At a later date the timber sole plates were encased in concrete and painted with an impervious resin. Finally in 2005 the panel infills were replaced with rigid polyisocyanurate (PIR) thermal insulation. In-situ environmental monitoring and digital simulation are used to assess the impact of these measures on the performance of the building. The outcomes of this research are now being used to enhance the informed conservation of this building.

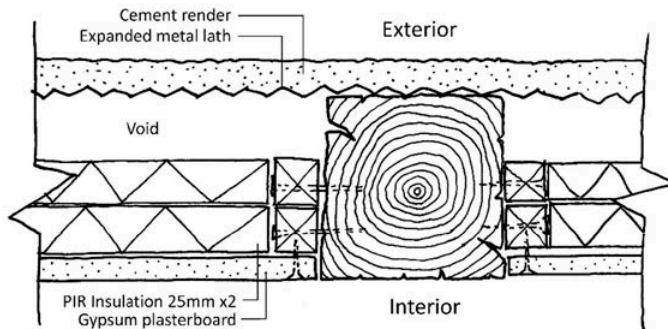
The timber-frame was overclad in cement render in the early to mid-20th century. The timber sole plates were then encased in concrete and their interior faces painted with an impervious resin. In around 2005 most of the lath and plaster infill panels were replaced with rigid polyisocyanurate (PIR) thermal insulation (Figure 4). In this detail, the cold-bridging of the historic timber-frame is exacerbated by the introduction of additional timber battening to take the plasterboard. The PIR insulation is not mechanically fixed or bonded and is left free-standing within the opening with large gaps around the sides in many instances.

Figure 4. Sketch plan detail of replacement panel infill at case study. Source: Author's own, 2017.

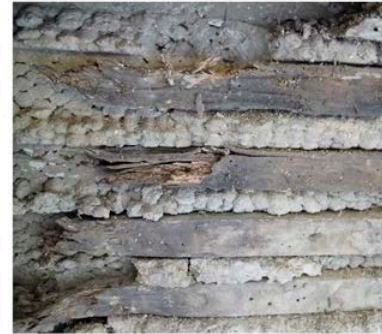
Figure 5. Internal face of cement render. Source: Author's own, 2017.

On opening up the walls, it can be seen that the expanded metal lath used to carry the cement render has in many places completely corroded away and the original oak laths are also in a state of advanced decay (Figure 5). There are also areas where the external cement render is cracked allowing rain penetration into the wall and building interior.

It is likely that the cement render was applied to reduce the need for maintenance of the previous lime render and the PIR insulation installed to improve internal comfort conditions and reduce energy consumption. Both actions were presumably undertaken believing that they were improvements; however, neither have been undertaken with a full understanding of the performance of the historic built fabric, and have now resulted in the poor current condition of the building. Today many of the timbers are rotten and will require replacing and the cement render is in danger of collapse.

The current owner proposes to remove all external cement render, PIR thermal insulation and gypsum plasterboard infill. The timber-frame will then be fully assessed and any necessary repairs will be undertaken. The house will be re-rendered in lime render on split oak lath, however some uncertainty over the preferred insulation material remains.

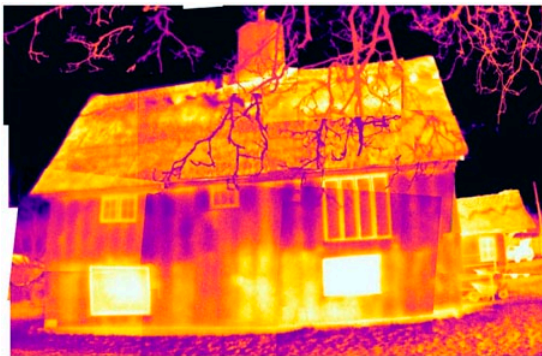
Figure 6 shows the higher internal temperatures of the ground floor, especially the study (bottom-right) where a $10 \text{ }^\circ\text{C}$ temperature differential was achieved. The single glazed windows of the study and master bedroom are the weakest thermal element of this façade. The concrete encased brick plinth is shown to be a thermal bridge, as is the close studded timber frame which is clearly visible through the cement render.

Figure 6. External thermography of east façade. Source: Author's own, 2017.

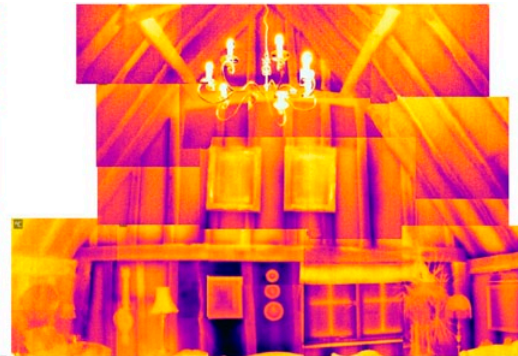
The internal thermography (Figure 7) confirms the previously noted weakness of the junction between the modern PIR thermal insulation and the timber-frame. This detail has no sealant or taping and as such, thermal transfer through air movement is occurring. The low radiant surface temperature of the infill panel to

Figure 7. Interior thermography of north wall of drawing room. Source: Author's own, 2017.

the bottom centre left of the image is however unexplained and requires further exploration.

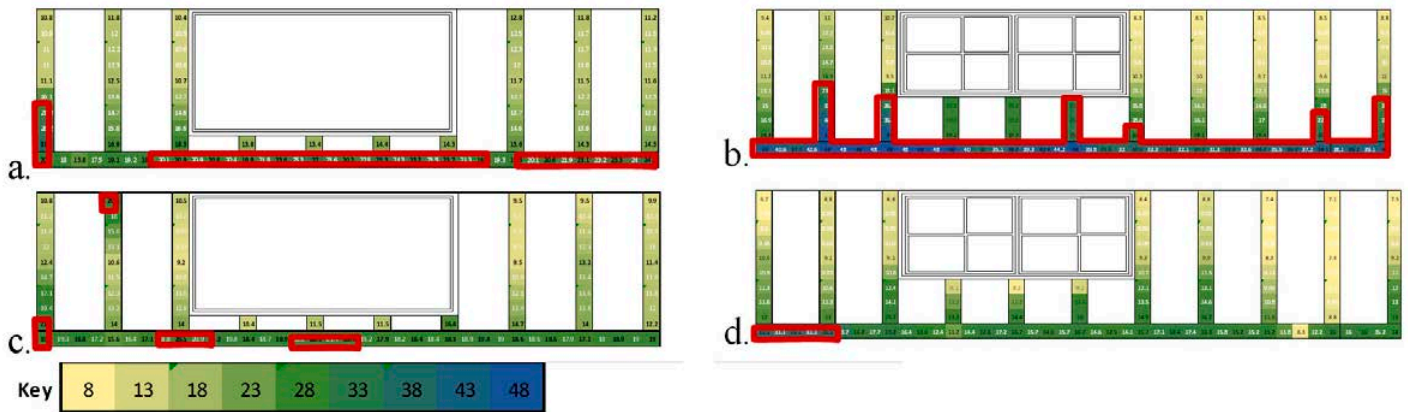
Figure 8 shows high moisture content in the sill beam of both walls due to their encasement in cement rendered brick externally and resin coated internally. Evidence of drying can be seen between the summer (upper) and winter (lower) measurements.

Figure 8. Surface moisture content (%) of timber-frame. Ground floor. Bedroom east wall (a. 02/08/2016 and c. 11/03/2017) Study north wall, (b. 02/08/2016 and d. 11/03/2017). Source: Author's own, 2017.

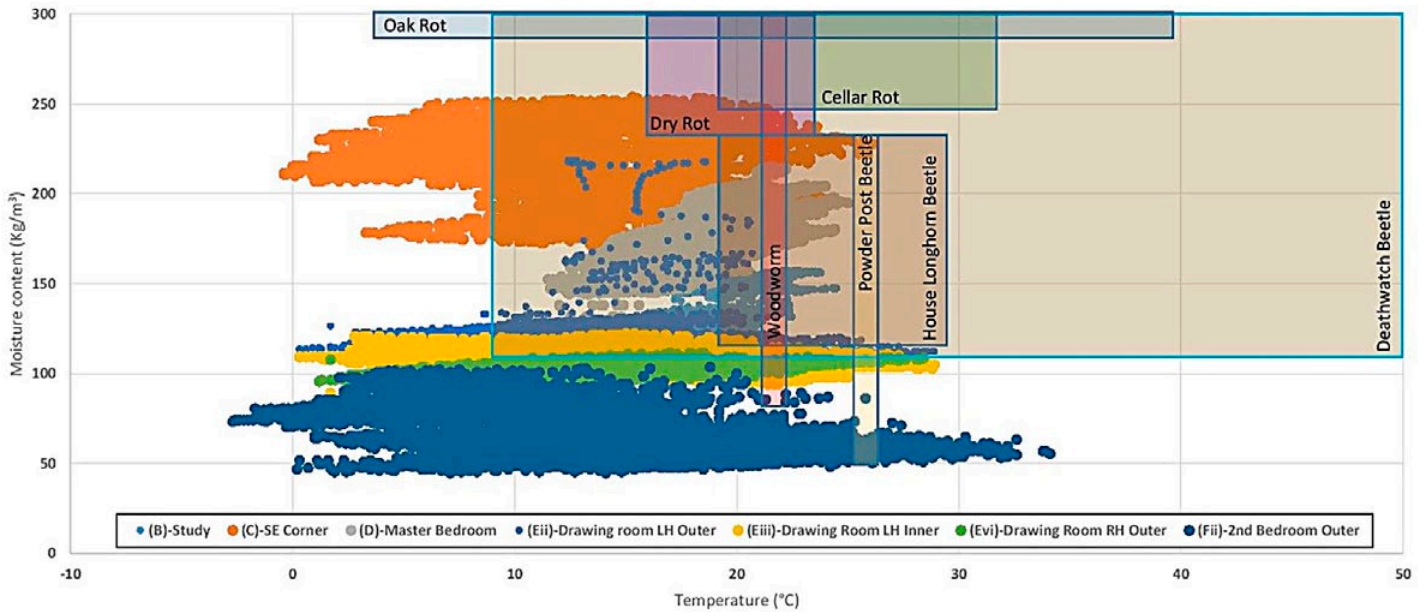
The results indicate that many of the monitoring locations are experiencing hygrothermal conditions favourable to biological attack (Figure 9). The most frequent risk is from deathwatch beetle, with the sill beam in the SE corner of the

Figure 9. Hygrothermal conditions at monitoring positions with conditions favourable to biological attack overlaid. Source: Author's own 2017, with conditions favourable to biological attack based on [15].

master bedroom being open to this threat 99 % of the time. This location is also at threat from house longhorn beetle more than 1,000 hours per year. Within the same wall there also exists 249 hours when conditions are favourable for dry rot and 35 hours favourable to cellar rot. This further increases the risk of insect attack as both deathwatch and house longhorn will only inhabit wood previously damaged by decay. An instance of penetrating damp due to wind driven rain was recorded, with the affected area taking 9 months to return to its previous moisture levels.
