# **Rock Mass Response to Coupled Mechanical Thermal Loading**

## **Äspö Pillar Stability Experiment, Sweden**

Doctoral Thesis

Division of Soil and Rock Mechanics  
Department of Civil and Architectural Engineering  
Royal Institute of Technology

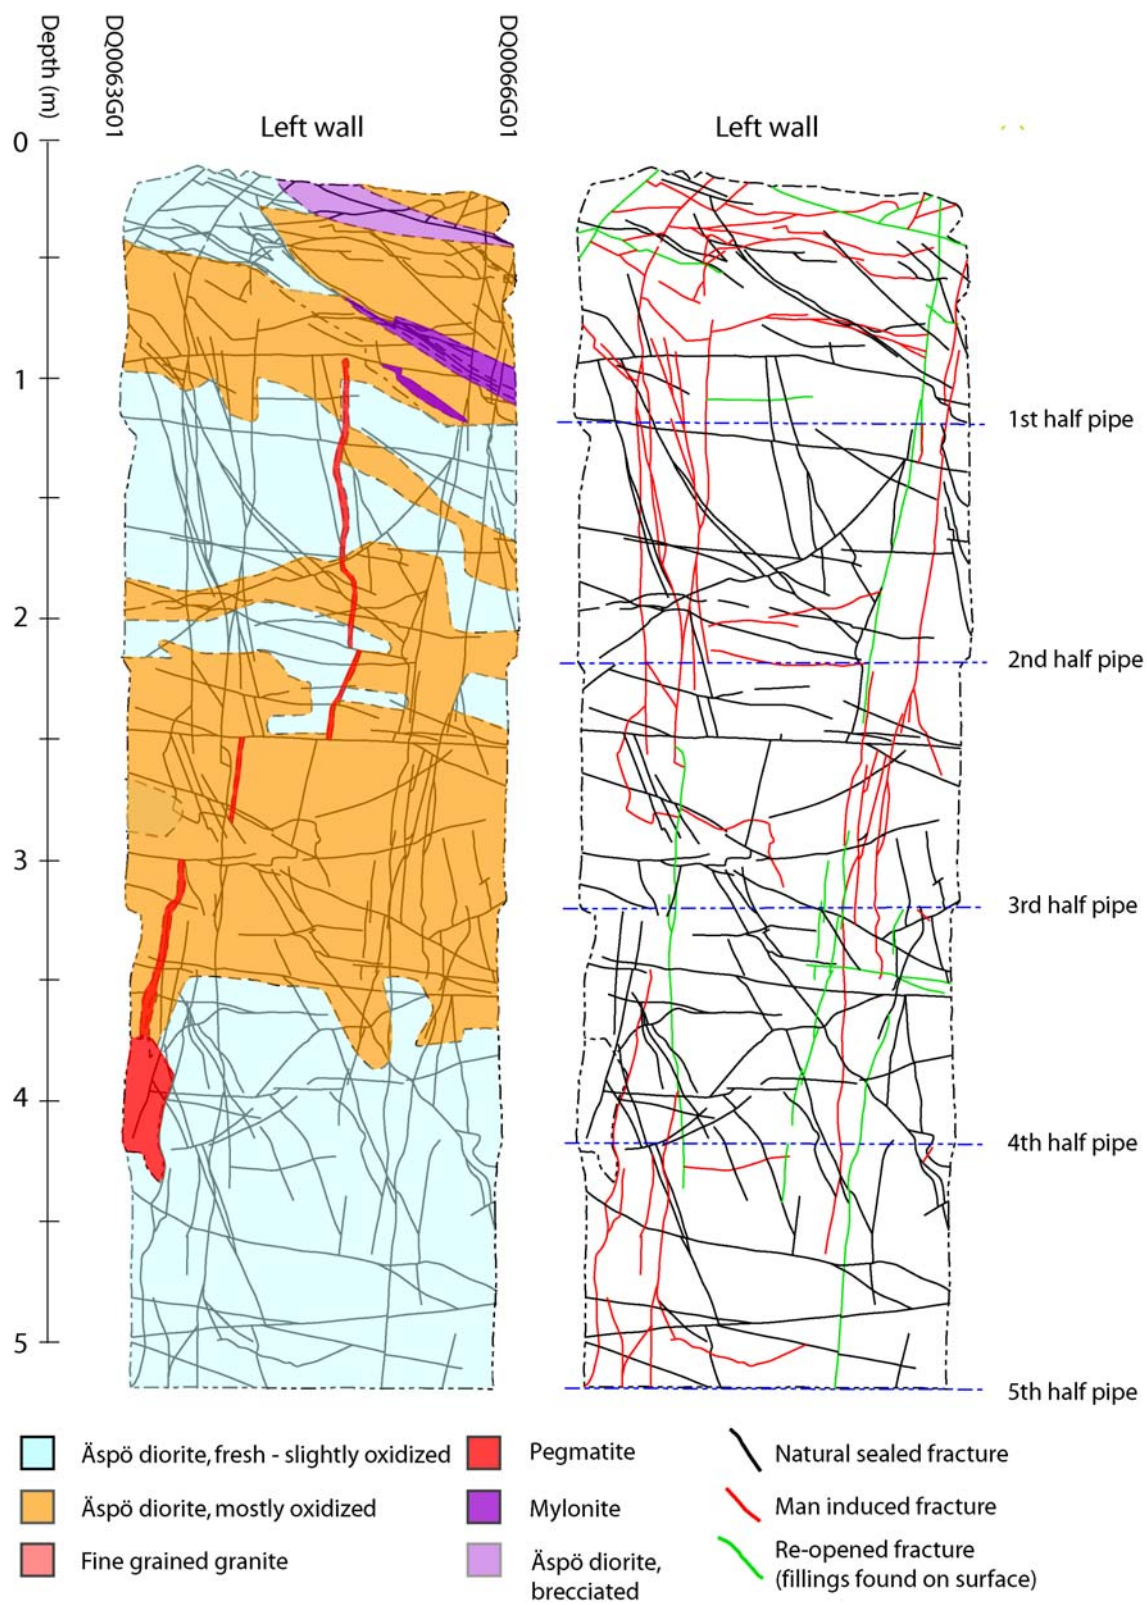
**Figure 2-6. Geological mapping of the left pillar wall (A-wall). The half pipes originate from the boreholes used for the wire sawing (chapter 10).**

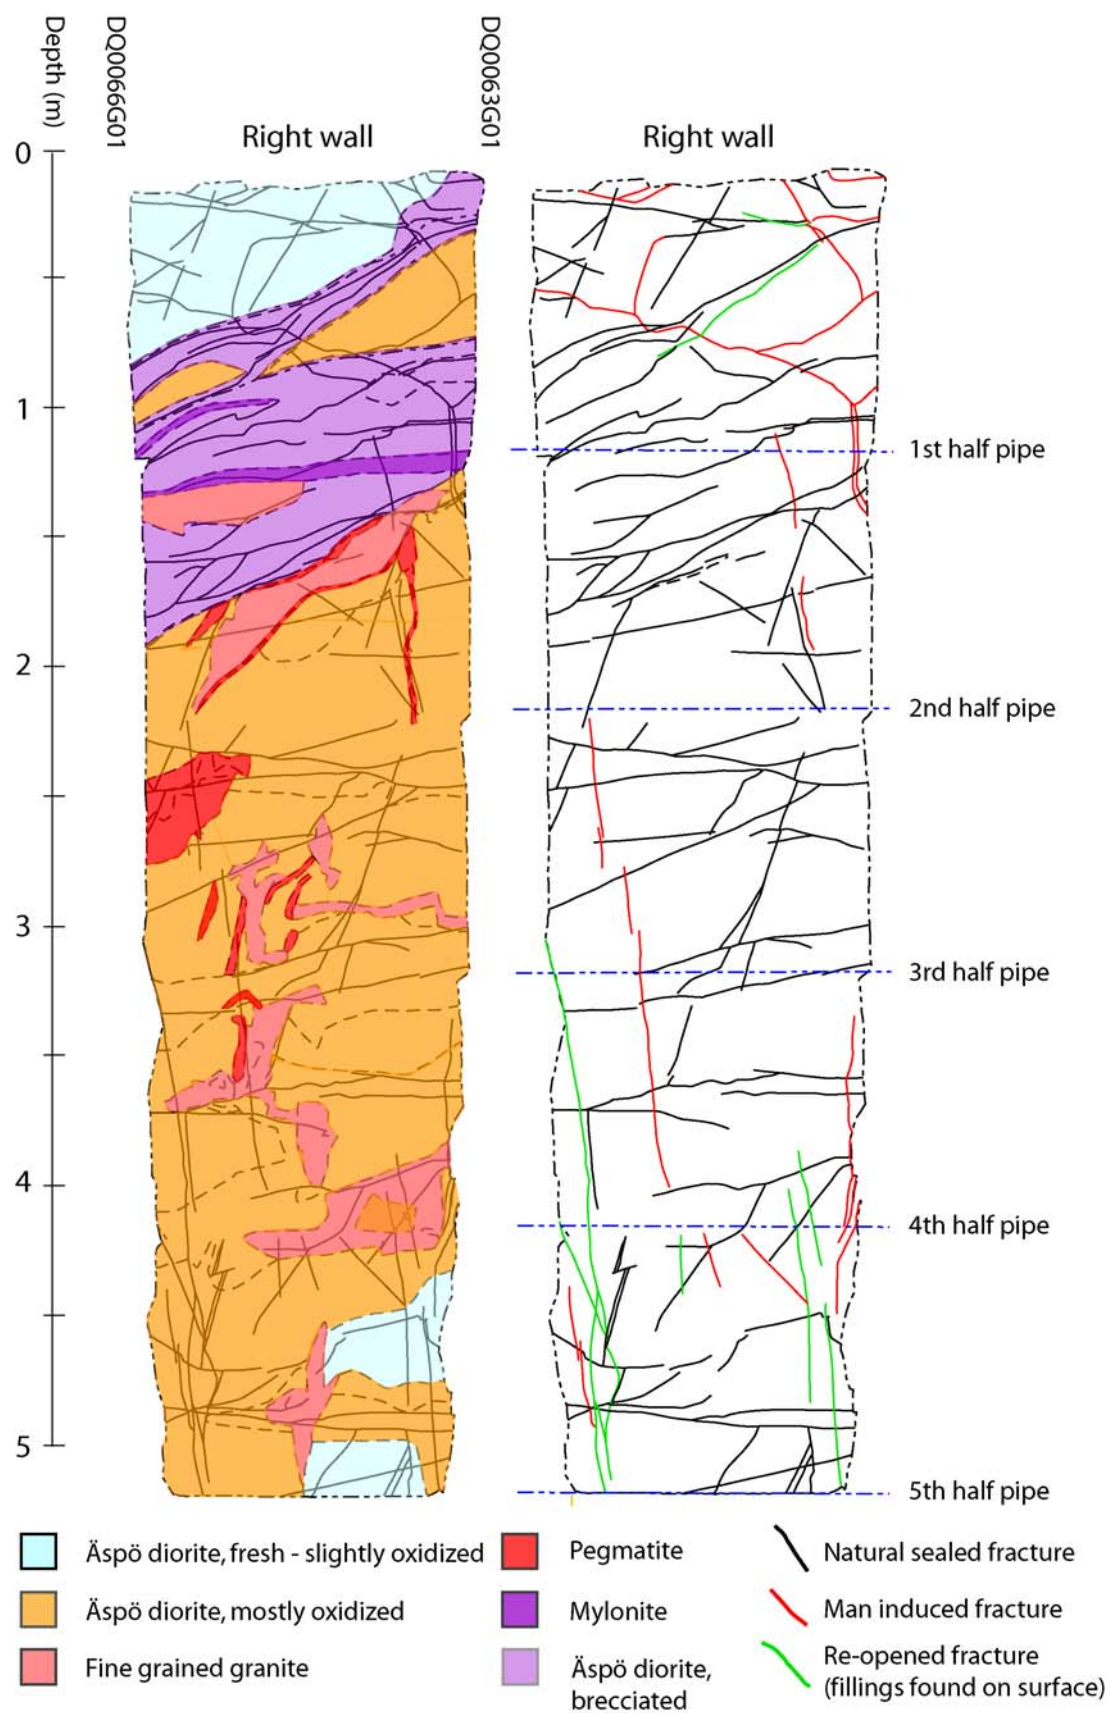
**Figure 2-7. Geological mapping of the right pillar wall (B-wall).**

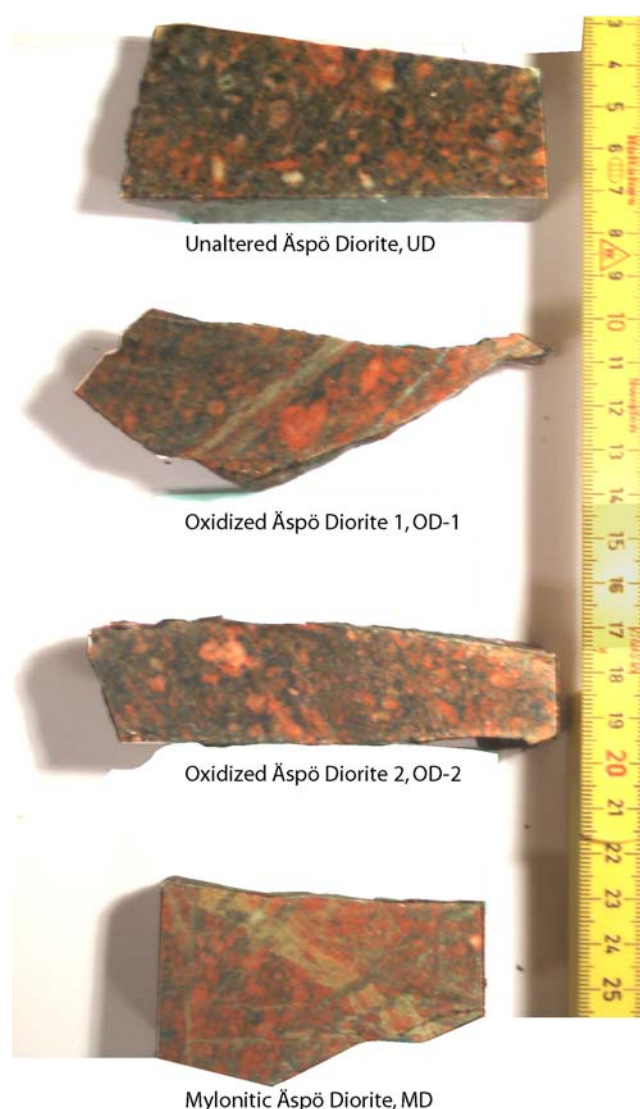
**Figure 2-8. Photographs of the rock samples used to make the thin samples.**

The thin sections were made from samples taken from the slabs formed during yielding and removed before the blocks were sawn. The removal of the slabs is described in chapter 6. The samples were selected so that Äspö diorite in different alteration stages was studied for mineral composition, grain size and induced microfractures. The descriptions presented here are modified from Lampinen (2005). Photographs of the samples used for the thin sections are presented in Figure 2-8

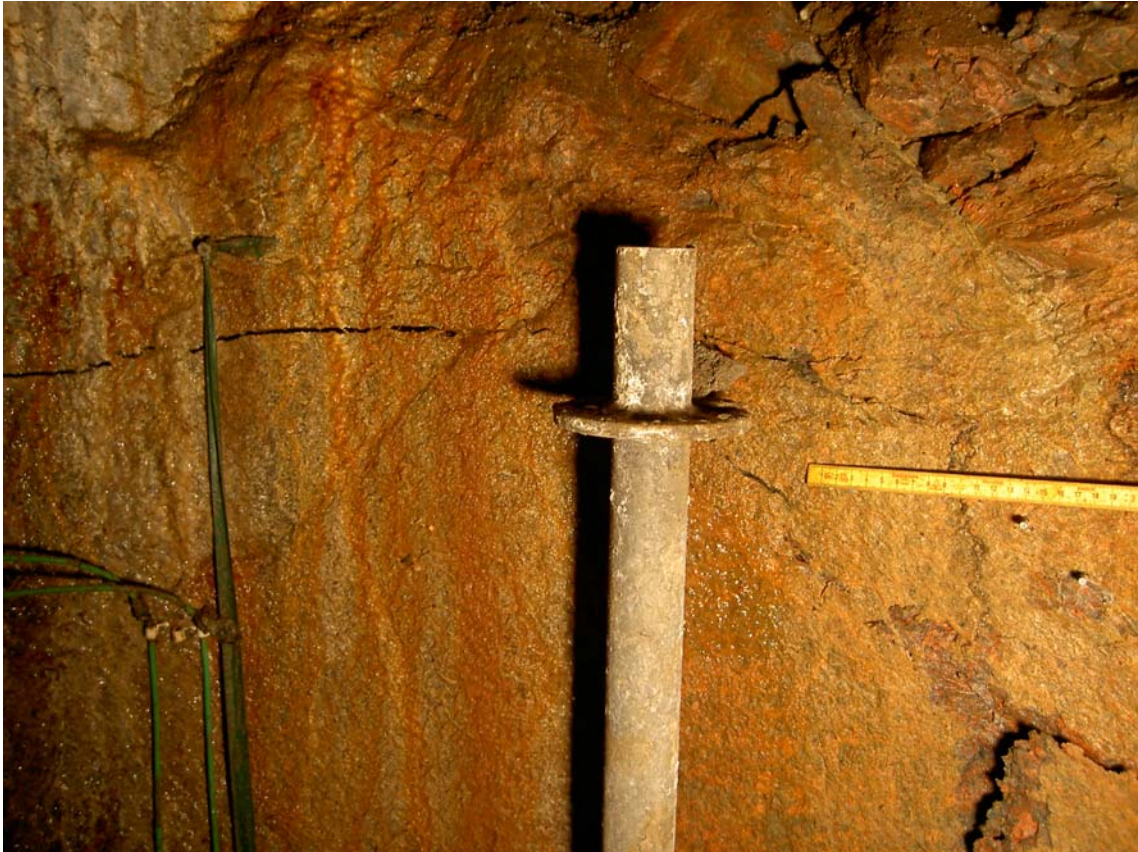
*Figure 10-7. Photograph of the horizontal fracture that dilated during de-stress drilling. Note how it ends/begins close to the shear zone.*

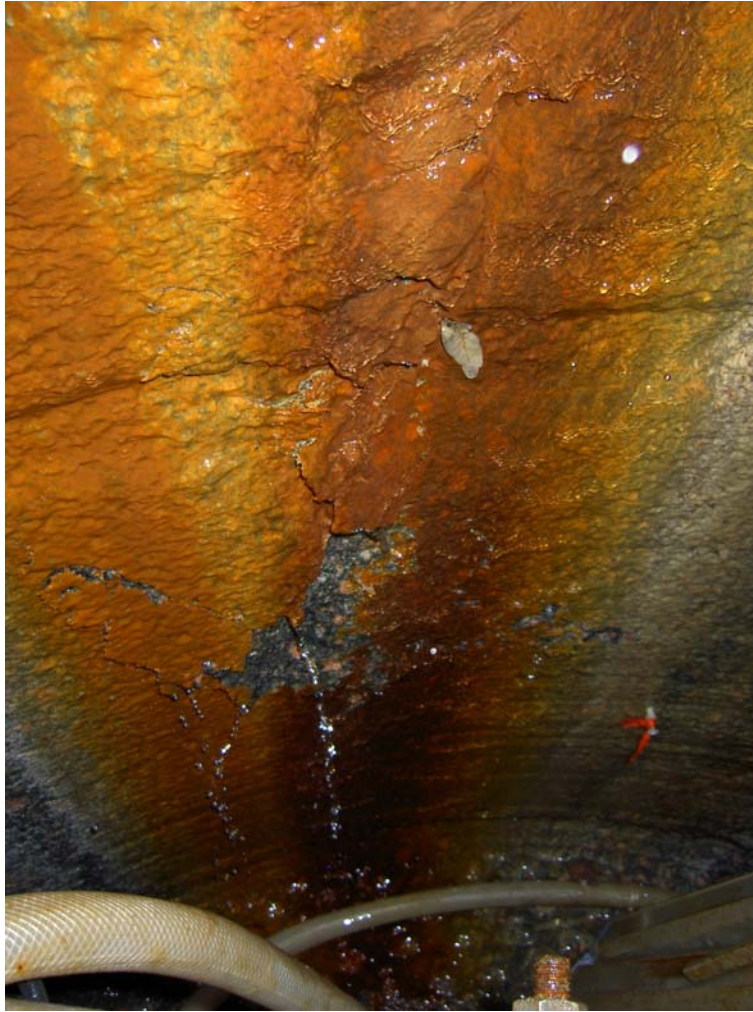
*Figure 10-8. Yielding at the back side of DQ0063G01. Dilation of rock slabs and the previous location of the ejected rock piece are visible.*

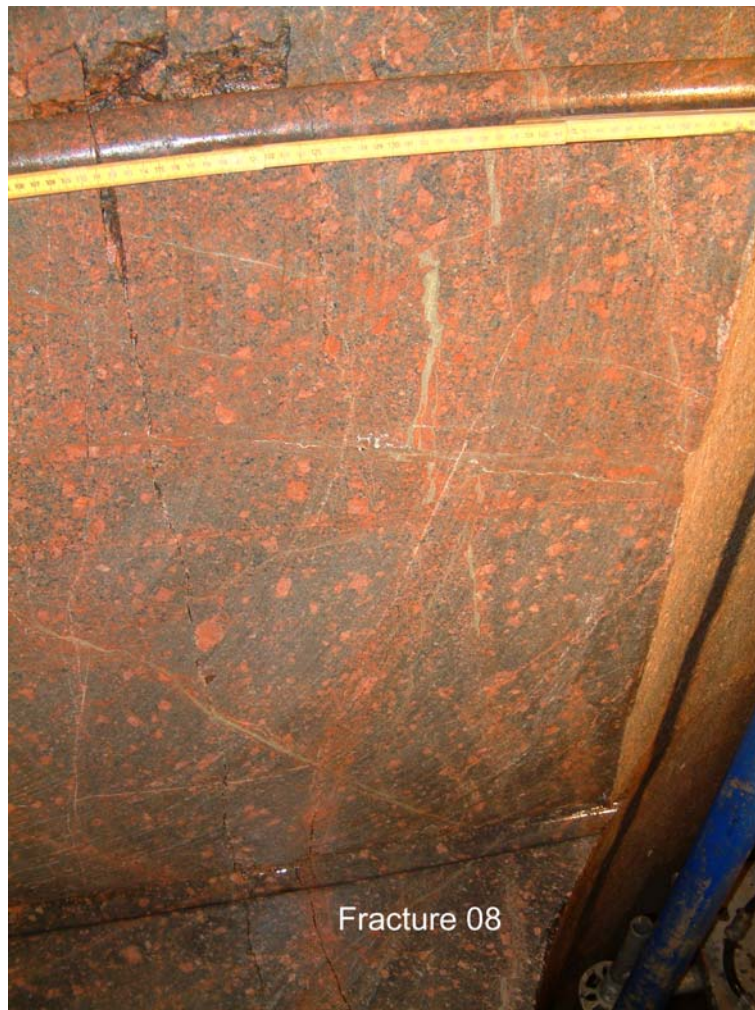
***Figure 10-11. Photograph taken of fracture 08 in the remaining left wall. The drill pipe is at a depth of 4 m. The intersection between the failed zone and the pre-existing fracture indicated by the oxidized band is clearly visible.***

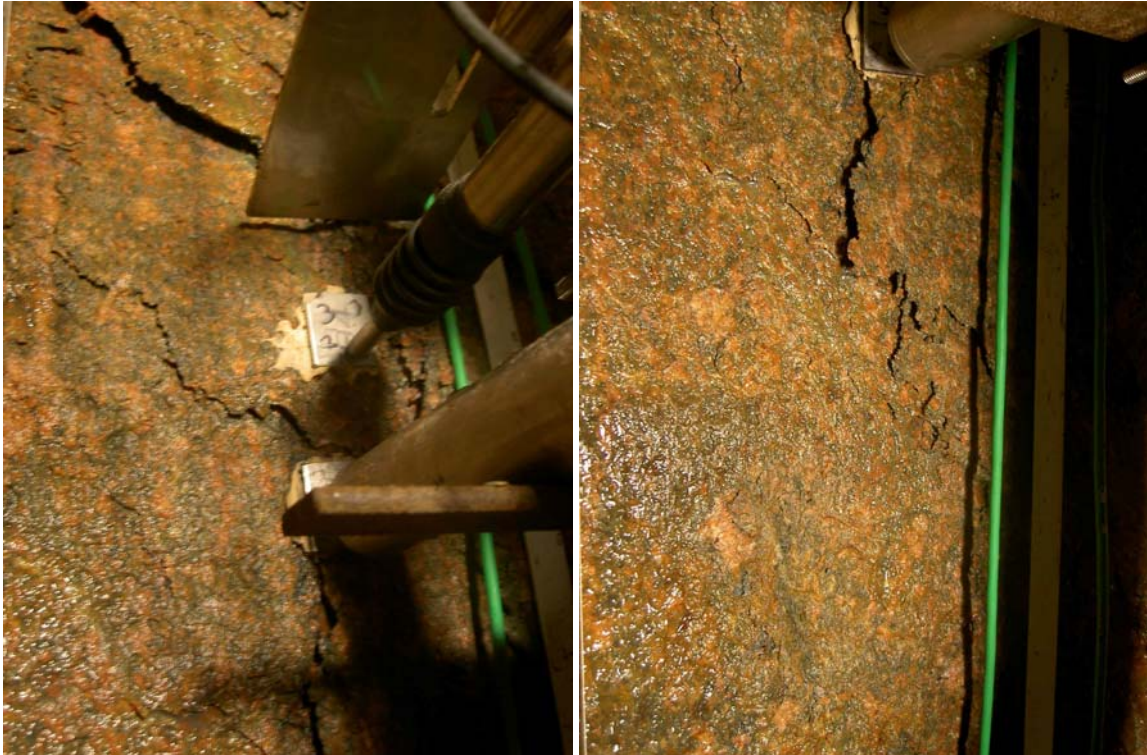
*Figure 20-8. May 27. Photograph of position 3, left both sensors and right below the short range sensor.*

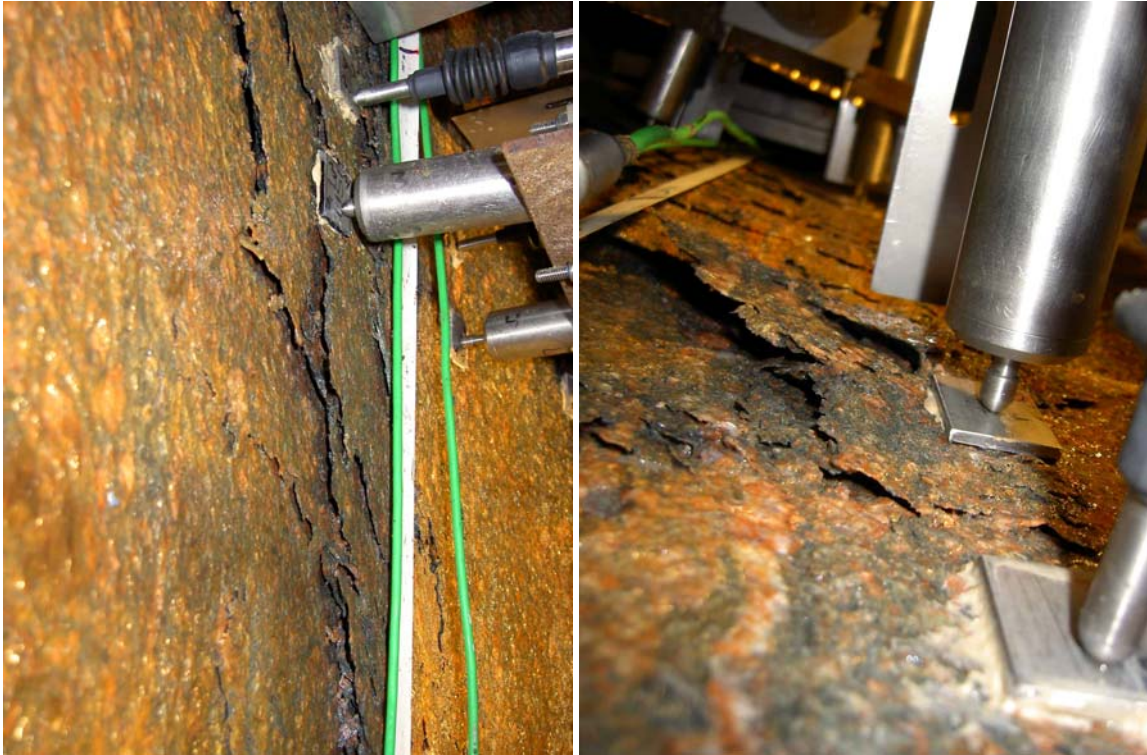
*Figure 20-10. June 2. Photograph of spalling/fracturing at positions 3 (left) and 10 (right).*

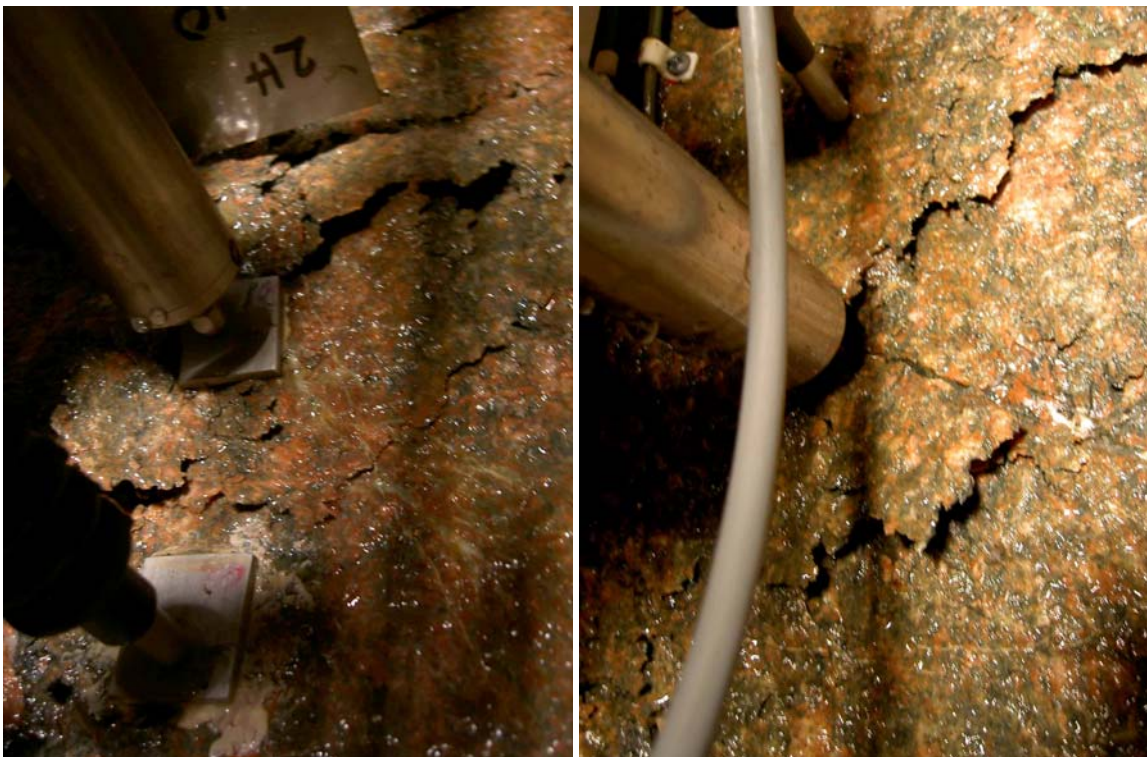
*Figure 20-23. July 6. Photographs of position 10 (left) and position 16 (right).*

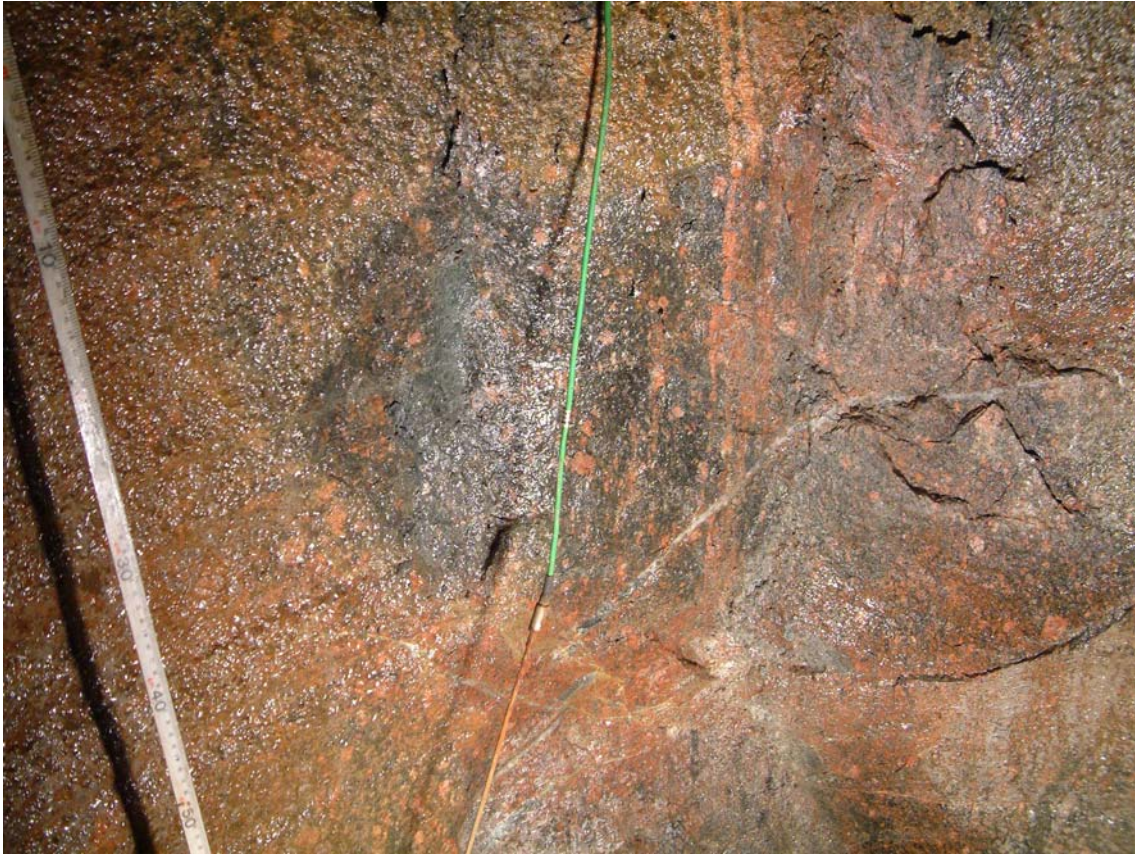
***Figure 20-25. The greenstone body that created a small pit in the rock wall.***

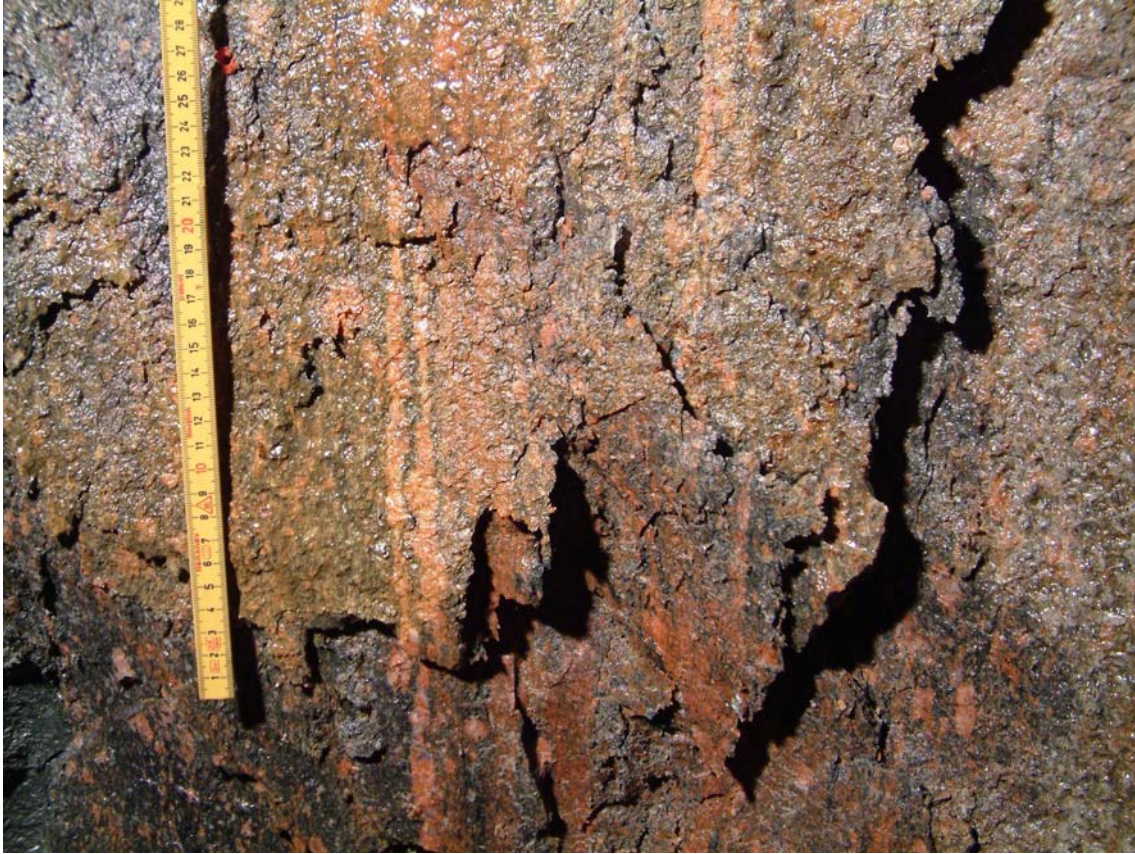
*Figure 20-27. Photograph of rock wall at depth of approximately 4 m. The small cm-scale chips on top of the larger chips are clearly visible.*

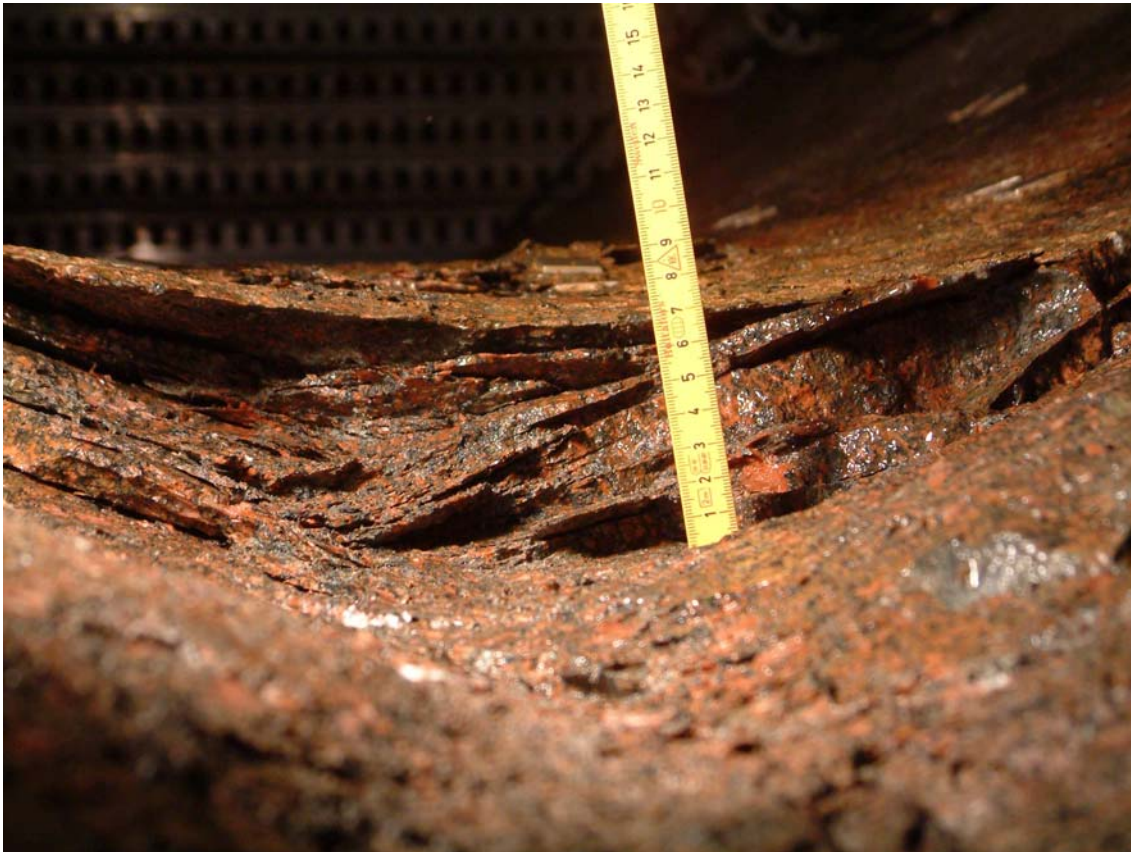
*Figure 20-29. Photograph of the smooth arched notch at a depth of 3.7 m.*

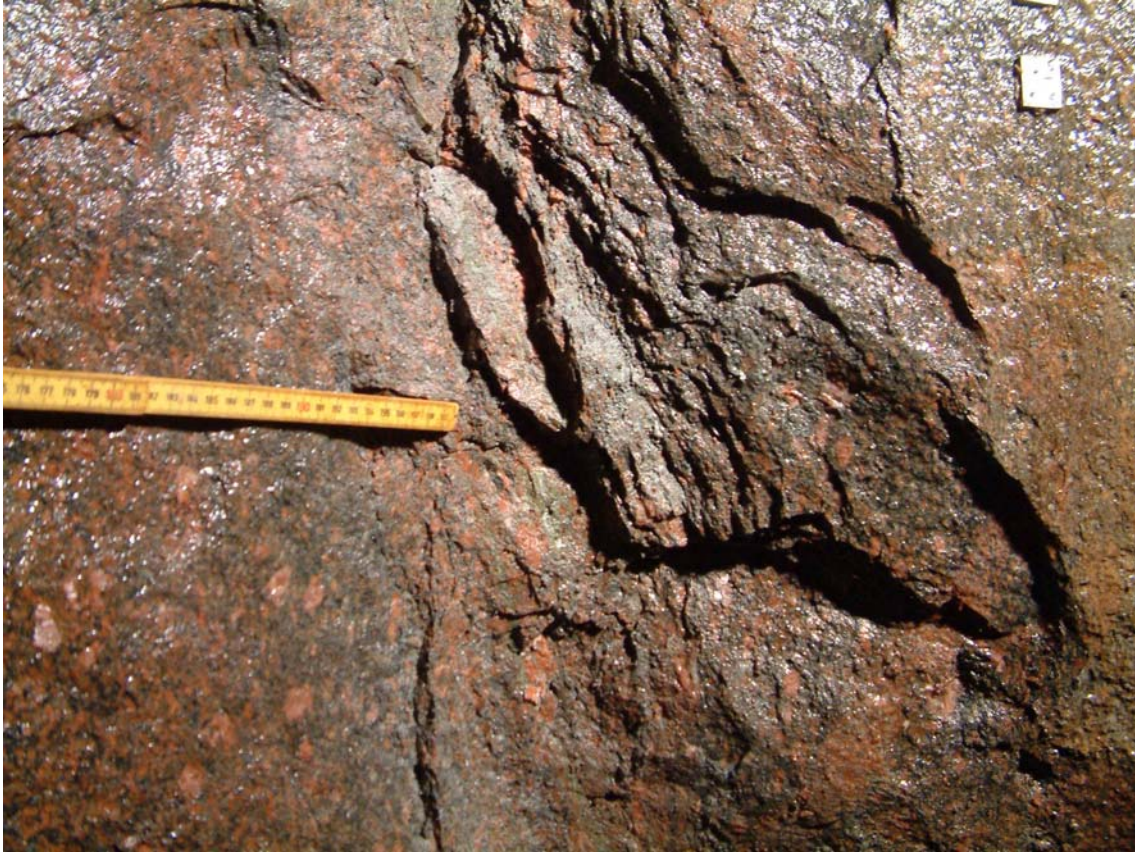
*Figure 20-33. Photograph at depth of approximately 2.5 m showing the right side of the pillar, where almost no slabs could be removed.*

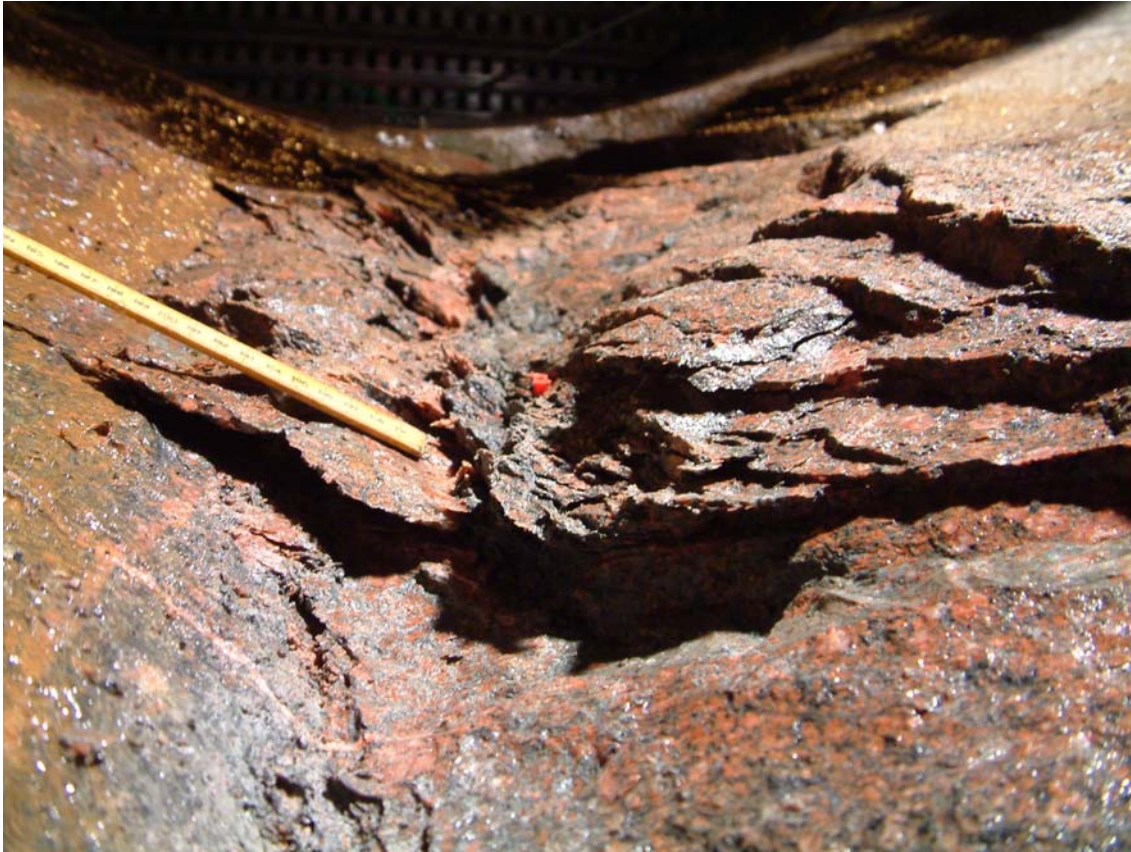
*Figure 20-36. Photograph of the fractures and slabs between 1.6 and 1.1 m.*
