Full Scale Test of a PC Bridge to Calibrate Assessment Methods

2 Testing the Kiruna Bridge

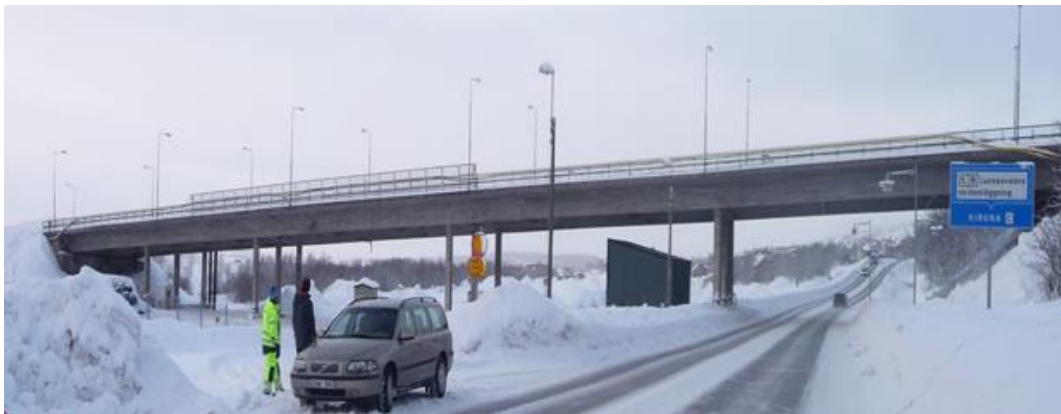
The prestressed concrete bridge in Kiruna (northern Sweden) shown in Figure 1 was taken out of service due to uneven ground settlements caused by the extension of an iron mine under the bridge. It was built in 1959 and had five continuous spans with a total length of 121,5 m and a width of 15,6 m (see Figures 2-3).

Figure 1. Kiruna Bridge constructed in 1959, Nilimaa et al. [3]

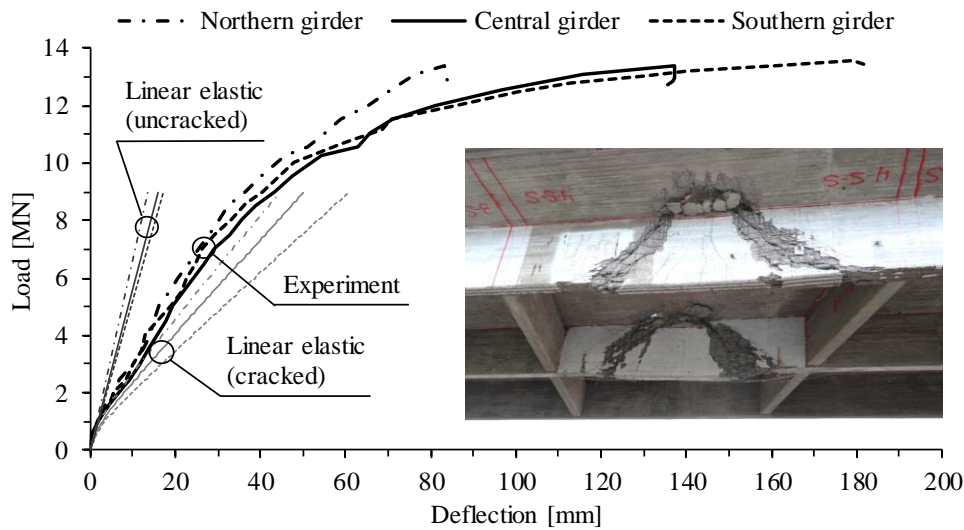
In Figure 4, the load-deflection curves at mid-span of the three girders are shown. The experimental curves are also compared to those obtained through a standard structural analysis using a FE model with linear uncracked and cracked concrete response, respectively [2]. As it is clearly shown in Figure 4, there is an important variation in the true stiffness of the bridge, which illustrates the need of using a better calibrated non-linear analysis for a more correct modelling of the behaviour.

The final bending-shear failures of the south and central girders are also illustrated in Figure 4. As indicated, the loading of the bridge resulted in extensive concrete cracking at the midspan region of the girders, in addition to yielding of longitudinal reinforcement and stirrups and, consequently, large deformations. First, the southern girder was tested to failure and a peak load of 13,4 MN was achieved. Failure initiation was indicated in the slab and in the upper part of the girder where diagonal cracking was formed. Rupture of the stirrups

crossing the cracks took place, first on the west side and then the east side. Thus, the failure mechanism incorporated, beside bending, both out-of-plane shear in the slab, where the loading plate punched through, and in-plane shear in the girder.

Figure 4. Load-deflection relationship for the test of the bridge's girders and photo of south and central girders after shear-bending failure.

Before demolition, the bridge was loaded to failure in the summer of 2014 by applying concentrated loads in the middle of the second span. The witnessed failure mechanism consisted in a combined shear-bending failure in the girders and the slab as shown in Figure 4 [2, 6-9].

Subsequently, loading of the central girder was carried out. A similar failure mechanism was observed with a total external load of 12,7 MN. Here, the test showed a remarkable robustness of the bridge structure as it was able to keep carrying loads after the failure of the southern girder.

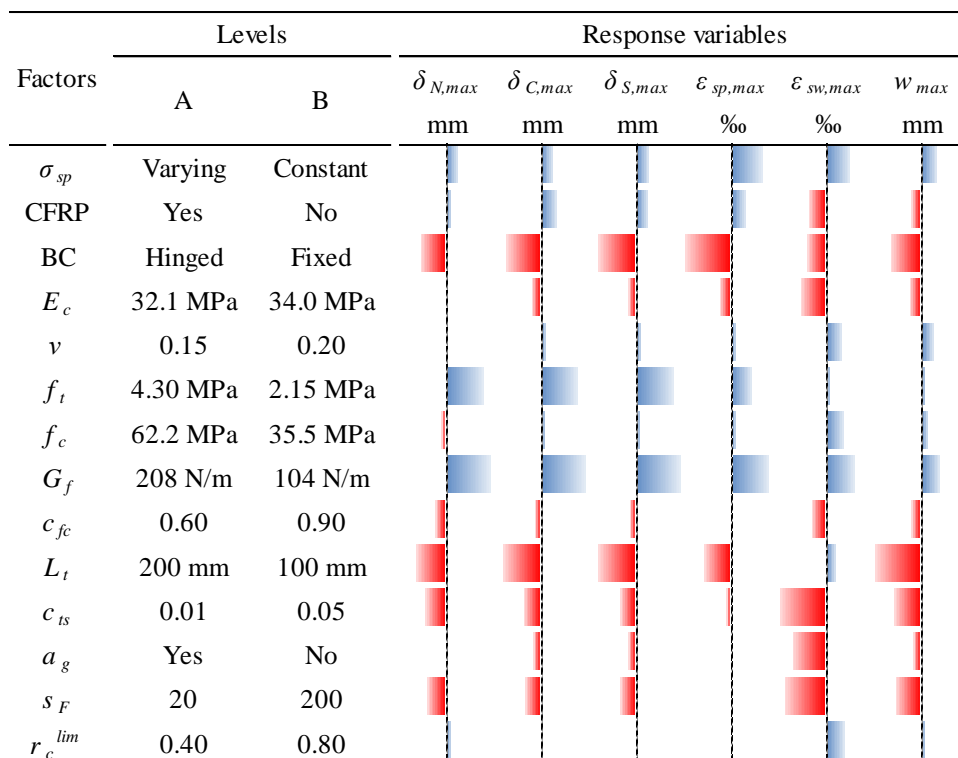
Figure 5 shows how the bridge structural response is influenced by changes in the investigated modelling parameters. The change in response is scaled so that the increase (blue) or decrease (red) due to the studied parameters changes can be compared. Note that the influences of the different parameters shown in Figure 5 can only be compared for a certain response parameter, while the influence of a given modelling parameter on different response parameters cannot be directly compared.

Generally, the study showed that the assumed boundary condition at the bottom of the columns, the tensile strength, the fracture energy, and the crack spacing are parameters of high importance, particularly for the deflections and strains in the prestressed reinforcement. The strains in the stirrups were mainly affected by the tension stiffening, aggregate interlock, and the shear stiffness reduction factors, leading to reduced values when changing from level A to B, while the variation on fracture energy resulted in the opposite effect.

Figure 5. Sensitivity study of the Kiruna Bridge externally loaded to 12 MN with the response variables being maximal deflections ($\delta_{i,max}$), maximal tendon and stirrup strains ($\epsilon_{sp,max}$ and $\epsilon_{sw,max}$) and maximal crack width (w_{max}). The levels correspond to modelling parameters assumed in the initial FE analysis (Level A) and in the sensitivity study (Level B). A red colour indicates a decrease in response when a factor goes from (A) to (B), while a blue colour indicates an increase. Bagge [2].

The concept of fractional factorial design at two levels (see Figure 5) with resolution IV was used in the sensitivity study [16]. Level A corresponds to the assumptions in the initial FE model, while level B gives the other extreme to be examined. In total, 32 simulations were carried out and 14 modelling parameters were investigated [2].

The sensitivity study indicated that the tested material properties (compressive strength and elastic modulus) were of minor importance for the bridge response. In contrast, the tensile properties (tensile strength and fracture energy) were shown to be important and, thus, preferably determined accurately through in-situ testing. Failure to do this might result in unnecessary uncertainties being built into the FE model if the relationships between

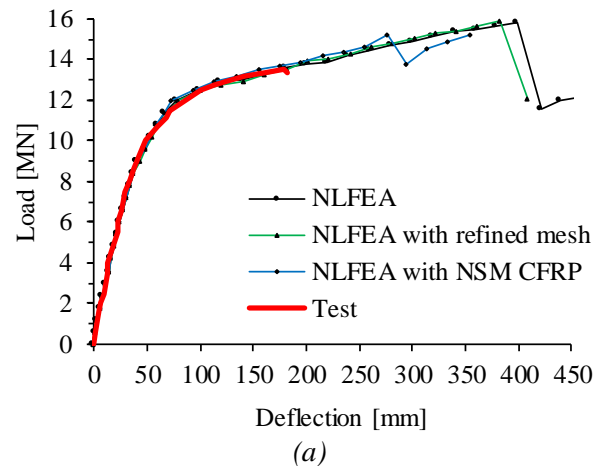
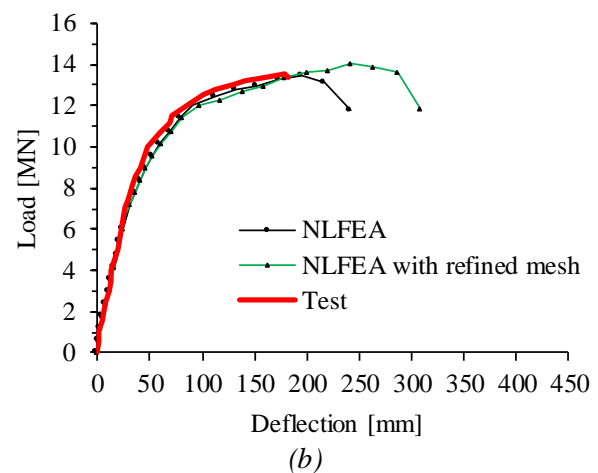
The initial model (level A) did not predict the correct failure mode and overestimated the load-carrying capacity, as shown in Figure 6a for the response of the south girder.

Figure 6. Load-deflection curves for the south girder: (a) Initial NLFEA model; (b) updated NLFEA model.

Consequently, in order to better reflect the behaviour and failure mode observed in the full-scale test of the bridge, the updated model was developed [2, 12]. In addition to the experience from the experiment, the knowledge from the sensitivity study was further utilised with a particular focus on the parameters shown to be of highest importance within the value ranges investigated. Figure 6b shows that the updated model predicts a closer value of load-carrying capacity and final deflection when compared to those attained in the original model.

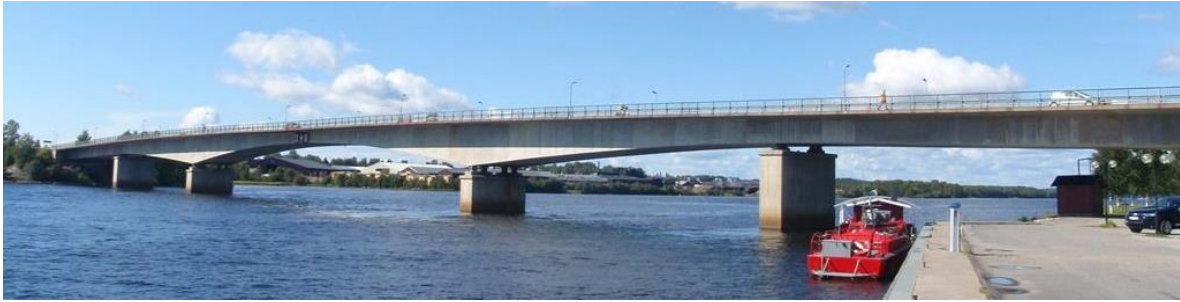
The bridge was built in 1957 and has five spans of 43,85 m, 47,0 m, 84,0 m, 47,0 m, and 43,85 m for a total length of 275,7 m (see Figure 7). The bridge will be replaced by a new composite bridge as it has been assessed not to be fit to carry traffic with heavy trucks. Load testing, aimed to check its condition and function, is planned to take place during 2021/22.

Figure 7. Bridge over Kalix River in Kalix, view towards south.

The bridge was modelled using the available information (drawings, original design calculations, etc). Figure 8 shows the moment diagram along the bridge length for a moving convoy defined by the Swedish assessment code [20]. This preliminary analysis showed that a potential critical section in the superstructure is the one above pier 2 (second from right to left in Figure 7).

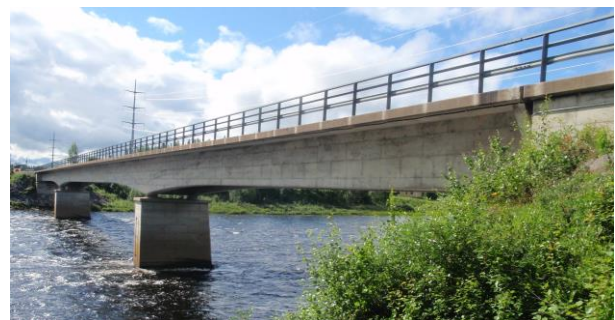
This bridge was built in 1963 and has three spans of 36,4 m, 62,0 m, and 36,4 m for a total length of 134,8 m (see Figure 9). The width is 7,48 m. The prestressing was applied with BBRV cables of 32 threads with 6 mm in diameter.

Figure 9. Bridge over Torne River at Autio (Sweden).

A new mine has started in the neighborhood and heavy trucks are passing over the bridge. Many concrete cracks have been observed parallel to the tendons, and the bridge is continuously monitored to check its function. A new assessment is planned to estimate the remaining life length of the bridge and to provide basis for decisions for further actions. As experienced for the Kiruna Bridge, use of enhanced structural assessment methods is a possible measure to produce a reliable and precise assessment.
