Cracking and Fatigue of Heavy Loaded Prestressed Concrete Bridge in Sweden

Angelica Agredo Chavez, Jaime Gonzalez-Libreros, Kasper Andersson, Jon Leidzen, Erik Andersson, Mats Petersson, Gabriel Sas, Lennart Elfgren

Luleå University of Technology, Sweden

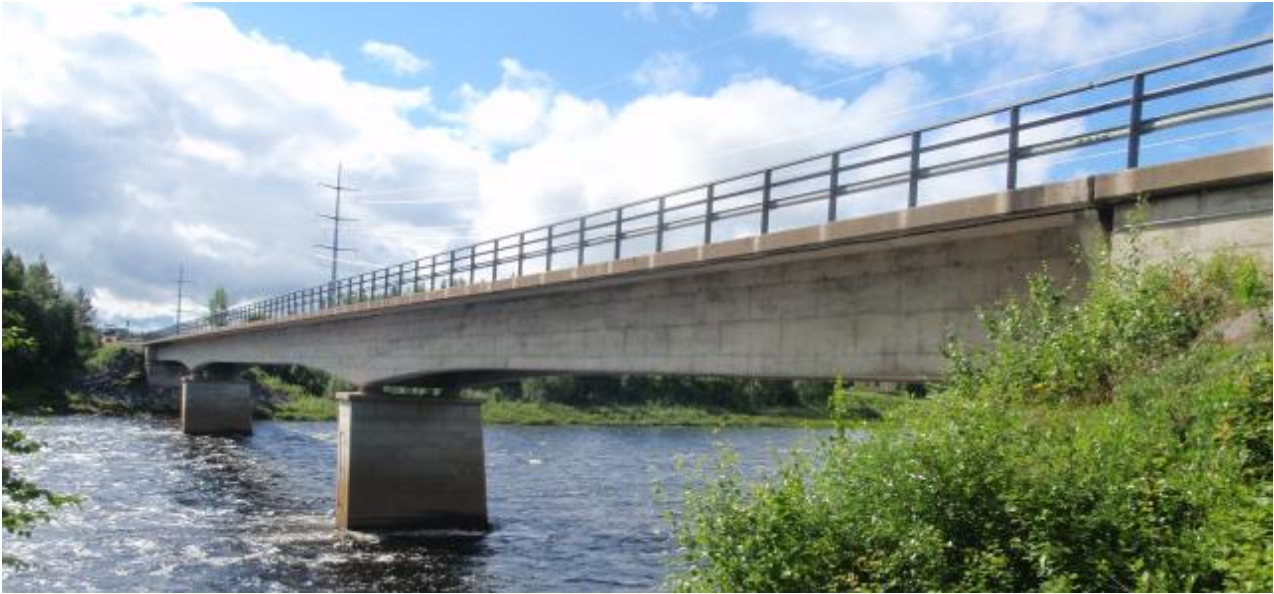
Figure 1. Prestressed Concrete Bridge over Torne River at Autio built in 1963 with three spans and a total length of 134.8 m. View towards SE.

Many prestressed concrete bridges in the world have an age of more than 50 years and questions are being raised about their condition and load-carrying capacity [1]-[3]. In this paper a case study is presented of a bridge built in 1963 over Torne River at Autio in northern Sweden, not far from the border to Finland, see Figure 1, [4].

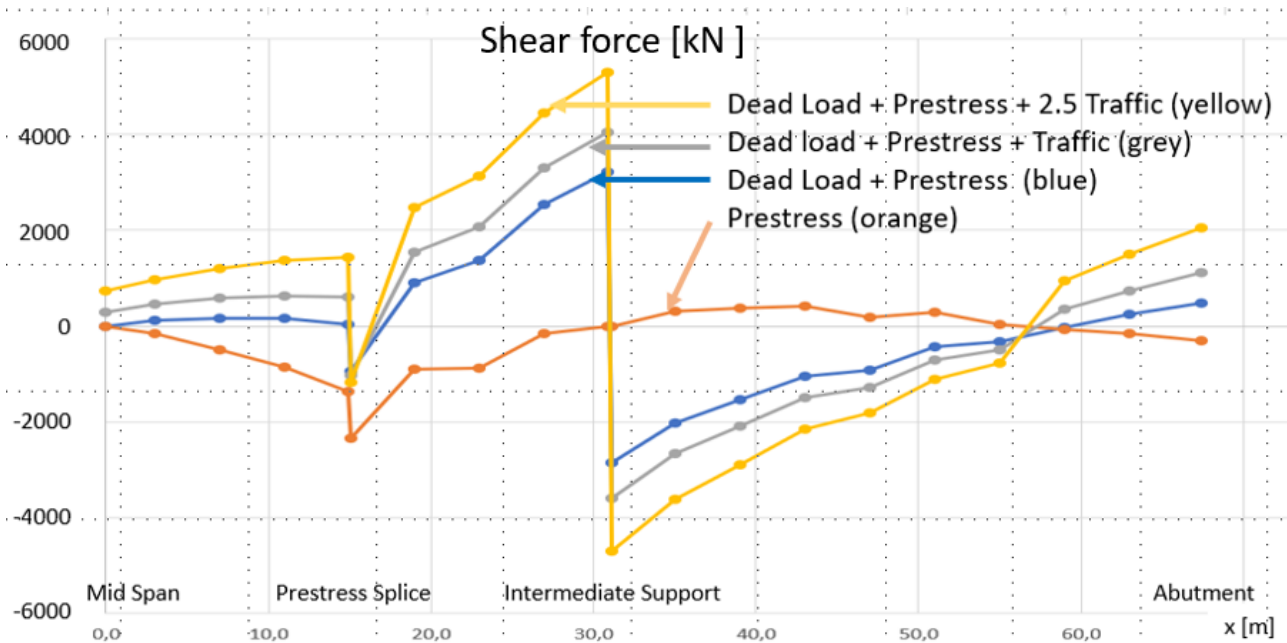
Figure 5.. Shear forces according to the original design. From Andersson & Leidzén [5].

The shear capacity is more problematic. The original design is illustrated in Figure 5. If the traffic load is multiplied with 2.5, a maximum shear force of ca 5.5 MN is obtained. If we consider the positive influence of the intermediate support, the needed capacity for the beams can be reduced to ca 5 MN. These loads give a shear stress $\tau = 1.2$ MPa close to the midspan and a maximum principal stress $\sigma_1 = 0.36$ MPa. Due to so small principle concrete stresses, only a minimum shear reinforcement of $\phi 10$ c 250 was needed.

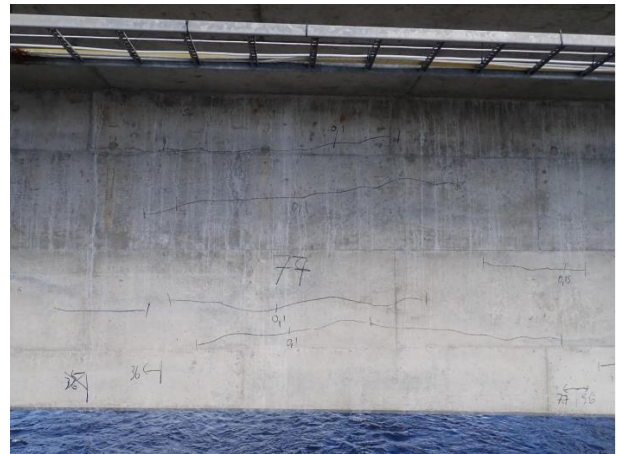
Figure 7. Crack pattern at section 77 in Figure 6 (the 1/4-point) where joints of the prestressing reinforcement are situated. There are five cracks of width 0.1 mm, but they are hard to see for the naked eye.
