## Vibration properties of a timber floor assessed in laboratory and during building construction

**Jarnerö K.; Brandt A.; Olsson A.**

Technical Research Institute of Sweden, SP Trätek, Växjö, Sweden

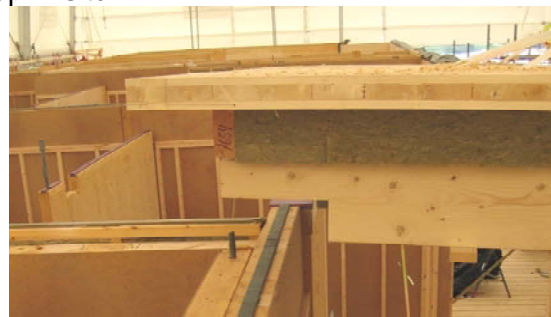
Figure 1 - Basic layout sketch of floor element and a photo of the end part of a floor element when installed. A Sylodyn® strip may be seen on top of the wall.

The prefabricated floor elements in the Limnologen project are generally 2400 mm wide and consist of a three-layer cross-laminated timber (CLT) board and glulam beams with center distance 460 mm in the load carrying part of the floor. The CLT board at the top of the element is 73 mm thick and the beams underneath consist of C40 glulam webs and flanges, with dimensions 42×220 mm<sup>2</sup> and 56×180 mm<sup>2</sup> respectively, see Figure 1. The beams are both glued and screwed to the CLT. The space between the beams is filled with mineral wool. The ceiling is separated from the load carrying part and is self-supporting on the walls in the underlying room. Half of the secondary spaced boarding in the ceiling is pre-assembled at the factory and the rest is nailed up in situ.

The ends of the floor elements are placed on the walls or beams below resting only on the CLT board, meaning that the glulam beams are cut off at the ends of an element and not laid up on the supports. The floor elements also rest on walls parallel with the load bearing direction only on the CLT board, which implies that the floors to some extent are load bearing in two directions. In cases where the floor has an intermediate support the glulam beams are continuous over the support. To reduce the flanking transmission strips of Sylodyn® are placed between the supporting walls and the CLT board at all supports as shown in Figure 1. The stiffness of the Sylodyn® strips is adjusted to the expected final loading.

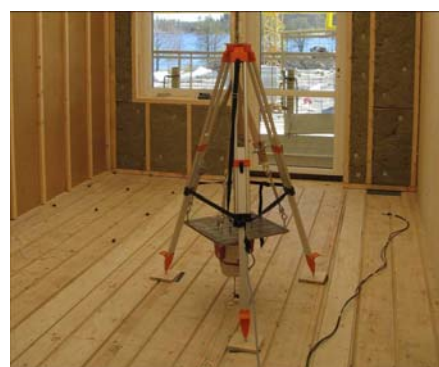
Figure 2 - Bedroom plan and suspension of shaker from tripod in situ. The location of the shaker on bedroom floor is marked with yellow dots. The red area marks the floor element that also was tested in laboratory. The dashed lines correspond to the beams beneath the floor.

To investigate how the damping in a floor changes as it is integrated in the building a simply supported floor in a 3.1 m wide and 5.2 m long bedroom on storey three in one of the buildings was tested, see Figure 2. The same floor on the same storey was subjected to testing at different stages of building construction as follows:

In laboratory two tests were performed on a copy of the the floor element in the bedroom floor marked red in Figure 2. The test specimen was tested both with ungrounded and simply

The floor both in situ and in laboratory was excited with an electromagnetic shaker. In the laboratory the excitation was carried out with the shaker suspended from an overhead crane and in situ the shaker was suspended from a tripod standing on the tested floor, as shown in Figure 2. The floor response was measured at 9 points along each of the glulam beams of the floor. To excite both the first and second bending modes two different locations of the shaker were used; a symmetrical and an asymmetrical location as shown in Figure 2. The location of the excitation on the simply supported floor element in laboratory coincides with the excitation locations of the floor element in situ. The simply supported support condition was accomplished with a steel beam that was underpinned with concrete on the floor and a wooden beam placed on top of the steel beam to support the CLT board as shown in Figure 3. The ungrounded condition in the laboratory test was accomplished by placing the floor on spring mattresses as shown in Figure 3. The shaker was during this test located in two diagonal corners of the floor element (corner 1 and 4).

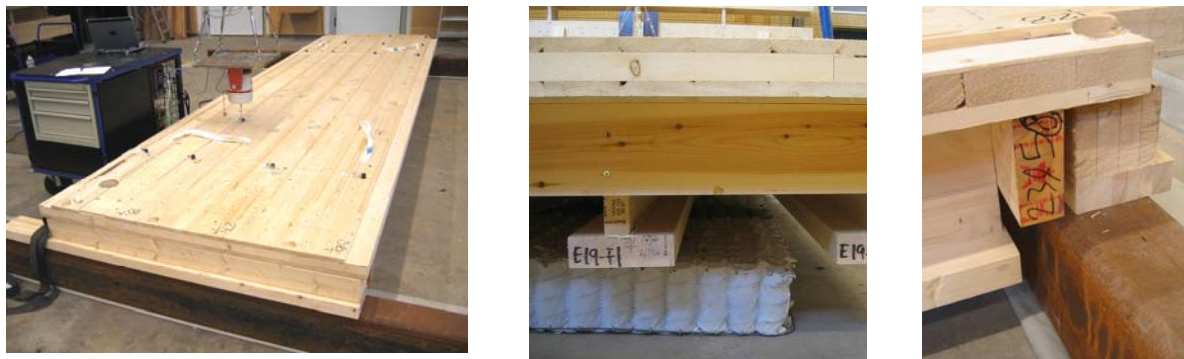
Figure 3 - Laboratory setup, ungrounded and simply supported support conditions

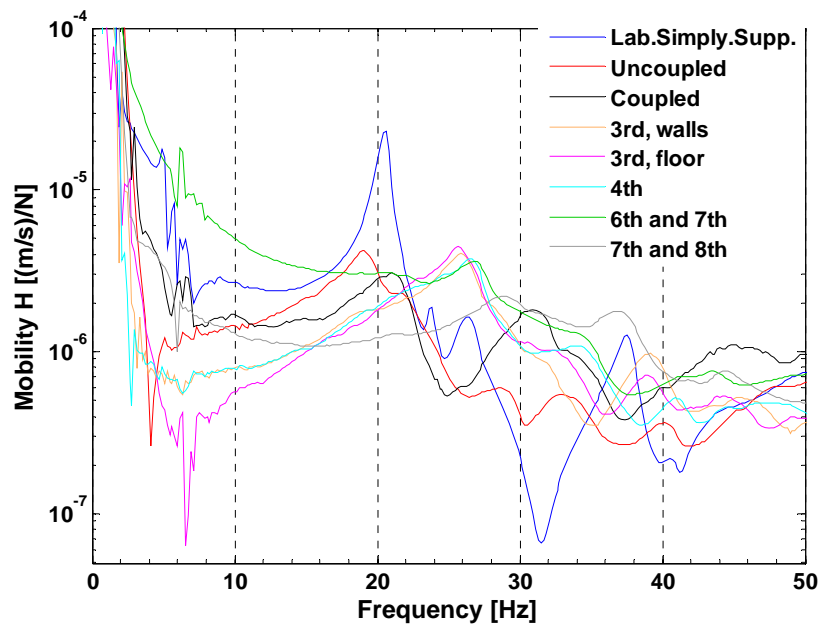
Figure 4 - Driving point mobility with symmetrical excitation of the in situ tests and the simply supported floor test in laboratory.

In Figure 4 the driving point mobility with symmetrical excitation of all the *in situ* tests and the simply supported laboratory test are plotted. It is clear that the in situ conditions have a large influence on the vibration performance. The resonances of the in situ floor element are flattened and not as obvious as in the laboratory test. This is not surprising since the floor is integrated into the building construction and interacts with it. The change may also depend on the support conditions as the floor in situ rests on the Sylodyn® strips that are put there to reduce the flanking transmission and will inevitably influence the vibration performance by reducing the vibration levels and introducing more damping to the structure.
