HÖGSKOLAN
DALARNA

Thesis work

Examination of defects and long term crack growth in rolled bars during long term storage

Author: Jon Scheutz
Mentor: Erik Hedlund
Examiner: Anders Eliasson
Subject/Main area: Material science
Points: 30hp

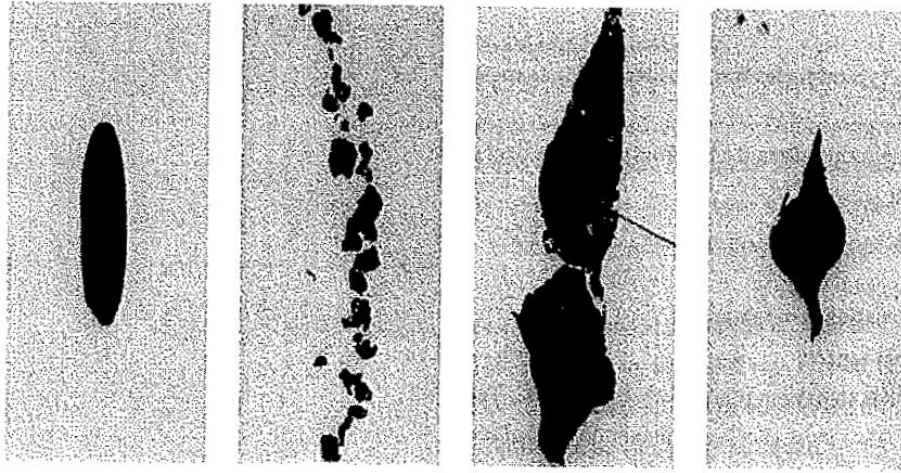
A picture of the appearance of the four kinds of inclusion is shown in Figure 1.

Figure 1: Picture of the appearance of inclusion types a-d.

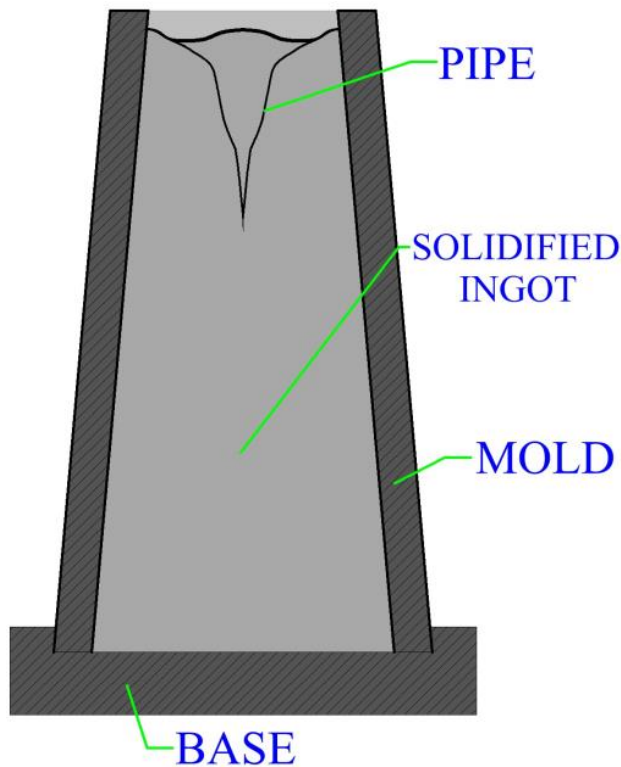
Steel have different densities depending on temperature. This is especially true when going from molten to solid forms. Because of this there is shrinkage during solidification. On the microscopic scale this means molten steel have to be sucked in between the forming dendrites. If the material transport is too slow pores might be formed. These pores are often easily sealed during hot working of the steel. On the macroscopic scale a pipe might form, which is a big cavity, see Figure 2. This is foremost a problem with ingot casting. [2]

Figure 2: An ingot with a pipe defect [2].

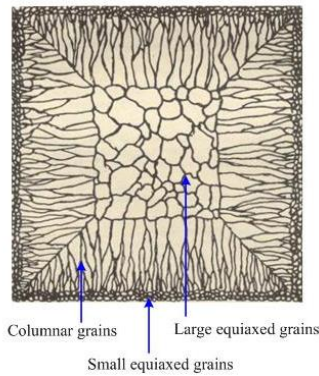
For the steel to solidify there is some supercooling required. Depending on if the supercooling is high or low the steel forms different structures. In a mold the supercooling is highest along the walls of the container and lowers towards the center. Normally three zones are formed. The first one is a thin layer of equiaxed crystals followed by the second one which consists of column shaped crystals. The column shape arises when the heat travels through the first zone to reach the mold wall. The new crystals therefore form at the old ones and grow into the unaffected melt. In the center the temperature lowers below the melting temperature but above the final solidification temperature which means new crystals can form easier. This gives the third zone in the center consisting of larger equiaxed crystals. A picture of how this could look is shown in Figure 3. [2]

Figure 3: Picture of the crystal structure in a steel ingot [2].

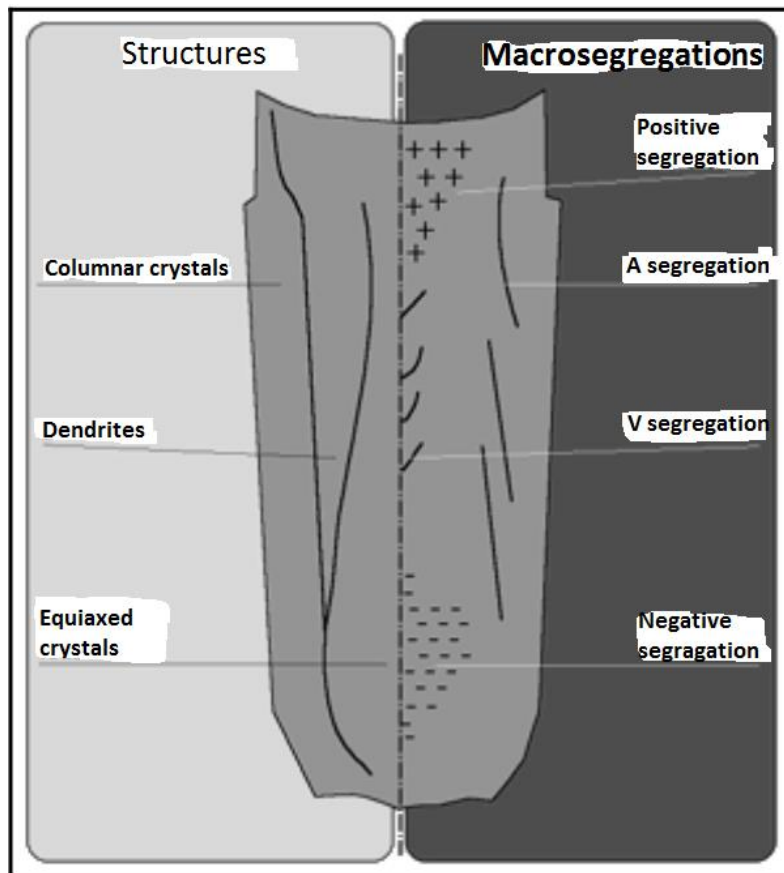
Figure 4: Structures in a solidified ingot [2]

This figure shows how the structure of the ingot goes from columnar dendrites to equiaxed crystals from the wall to the center. It also shows the different kinds of segregations found. To decrease the amount of air dragged down into the steel bottom casting is used. The steel then rise into the mold rather than being poured in from the top. [2]

The ingot is solidified in a form most often made of cast iron. When it has finished solidifying the mold is turned upside down to remove the ingot. The ingot is then either allowed to cool or transported to an oven to be kept warm before rolling. The cross section of a typical ingot can be seen in Figure 4. [2]

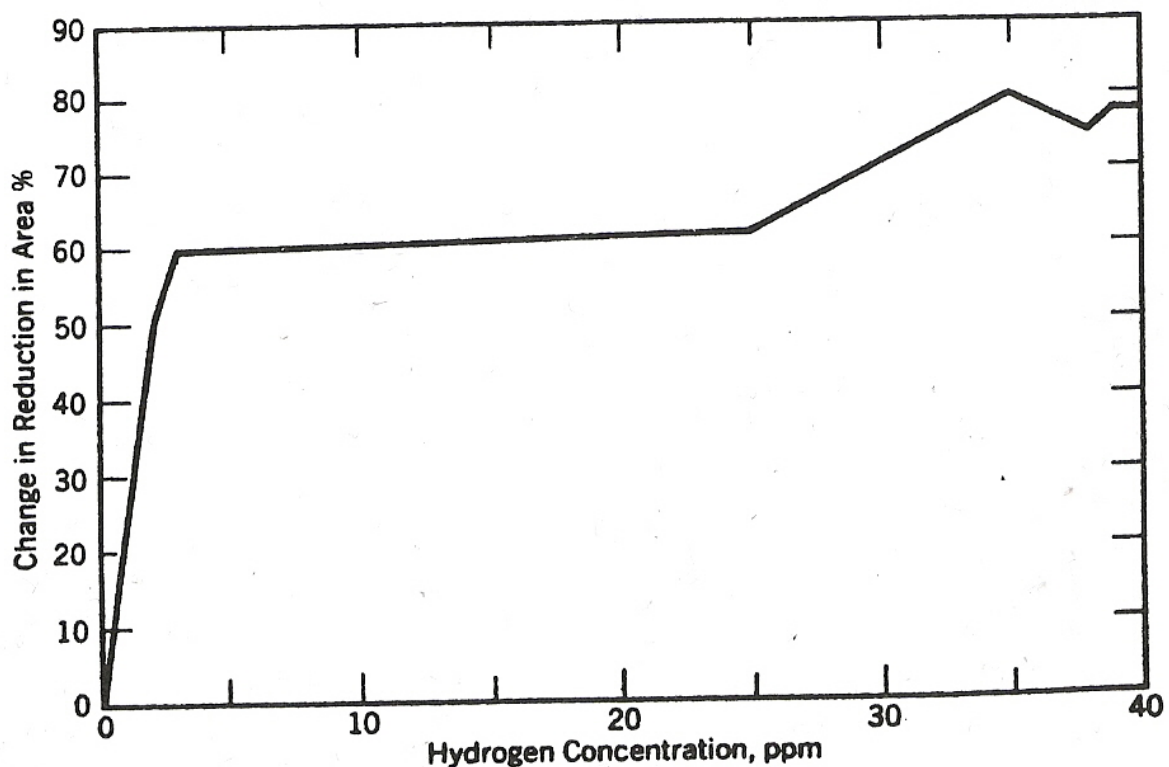
Figure 5: The change in reduction in area in percent as a function of hydrogen content in ppm [7]

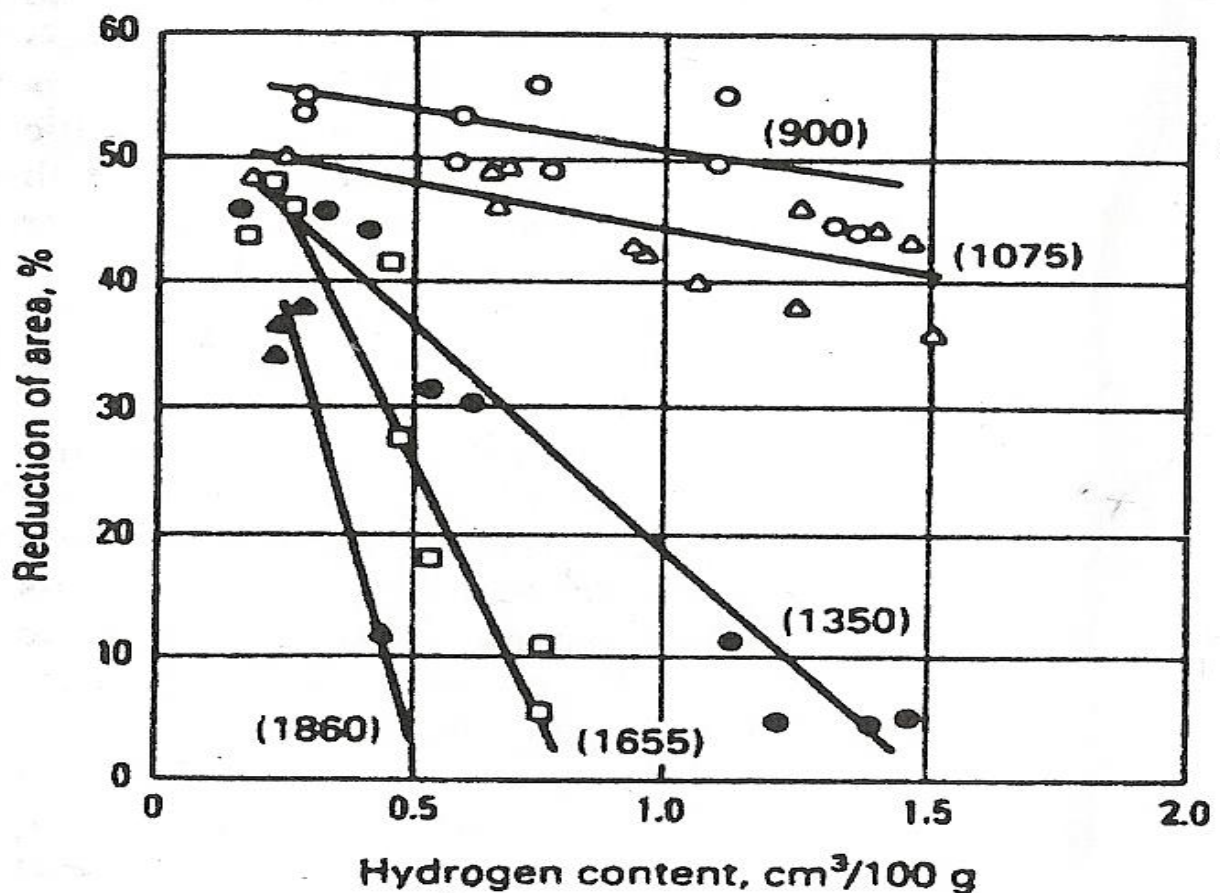
Figure 6: Ductility versus hydrogen content for various steels at various strength levels. The numbers in parentheses indicate the ultimate tensile strength in MPa [7].

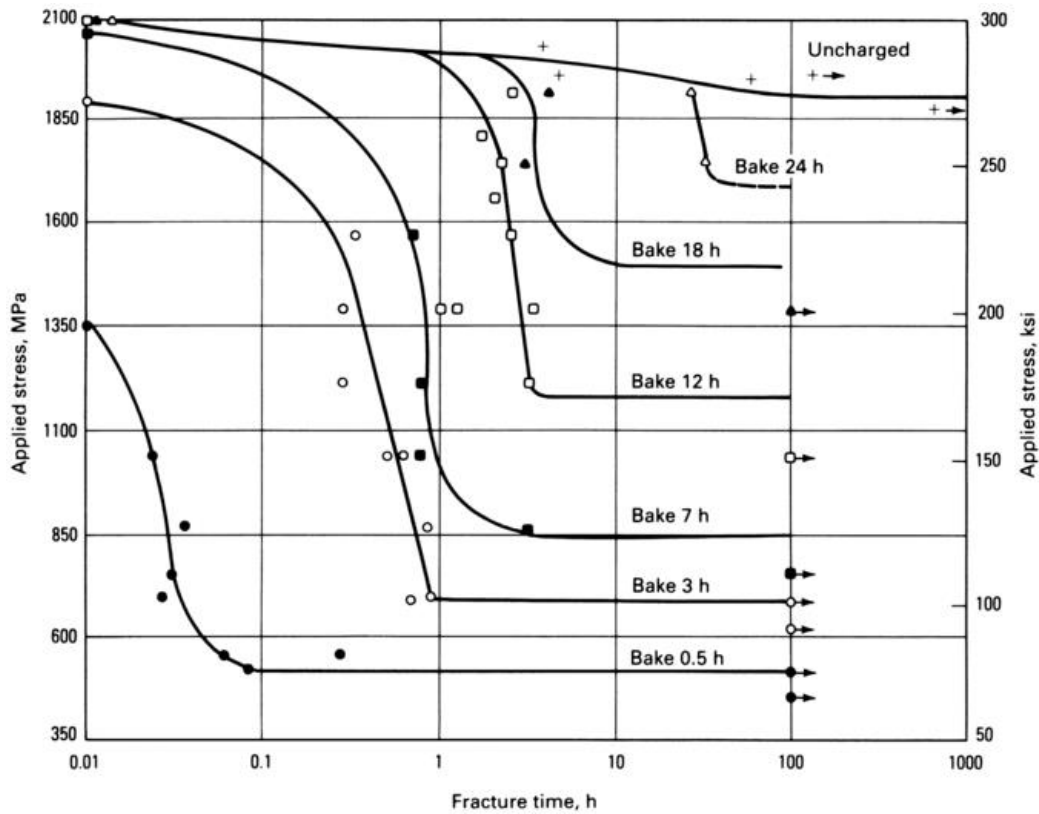
As can be seen in Figure 7 the HSC effect is reversible. If the hydrogen is removed by baking the steel at 150° C higher applied stress is needed for fracture after a certain time. Longer baking time increases the applied stress necessary. This work as long as the hydrogen has not formed any chemical bonding in the steel or if damage has already occurred before baking. [7, 8]

Figure 7: Static fatigue curves for various hydrogen concentrations obtained by different baking times at 150° C. Sharp notch strength steel specimens 1590 MPa; Normal notch strength: 2070 MPa [8]

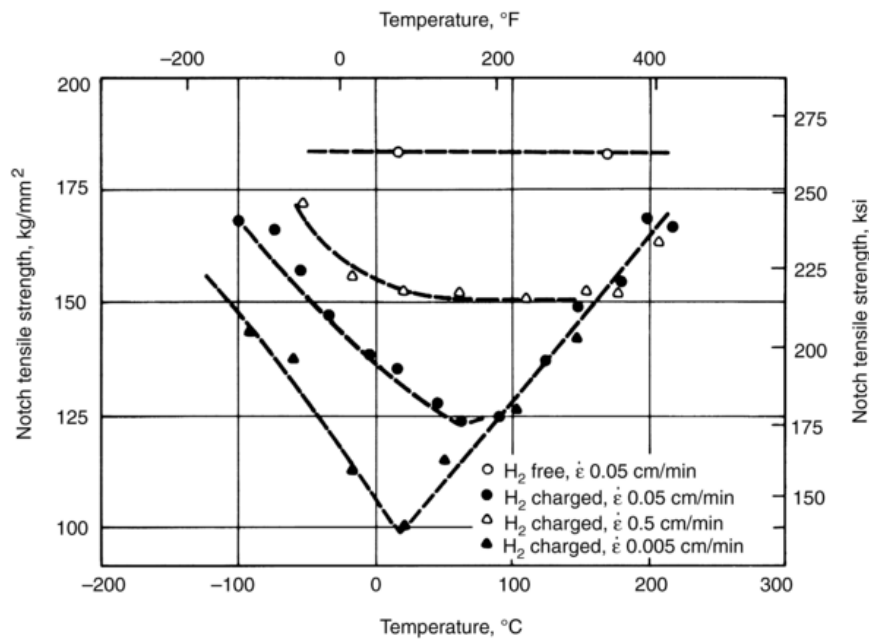
Hydrogen can also induce cracking at slower strain rates. This hydrogen induced cracking has been observed during mechanical testing in hydrogen environments. As for delayed failure there is a minimum level of applied stress. This phenomenon is for the most part observed in higher strength steels and there is similar temperature dependence. This embrittlement of steel increases with decreasing strain rate because at higher strain rates the hydrogen does not diffuse fast enough for embrittlement to occur. This phenomenon can be seen in Figure 8. [7, 8]

Figure 8: Notch tensile strength of high strength steel plotted against testing temperature for three strain rates [7, 8]

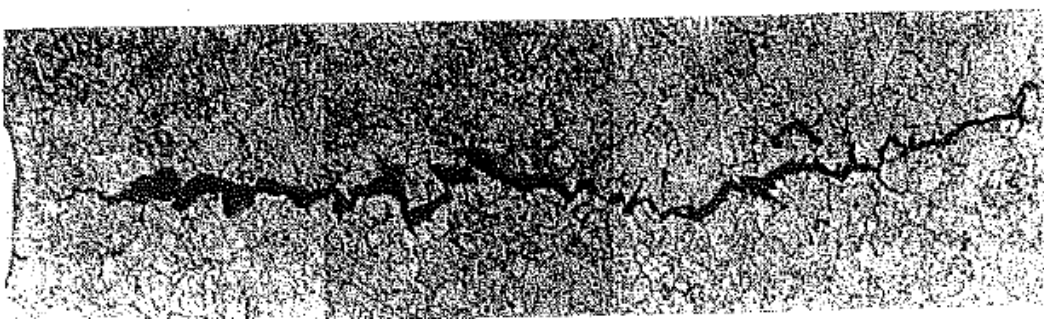
Intergranular cracks are generally observed in steels affected by hydrogen embrittlement. An example of an Intergranular crack can be observed in Figure 9. HSC usually produces sharp singular cracks like that one. The mode of fracture might be changed from the one normally observed into another. At higher stress intensities there have been reports of transgranular cracks in steel. The addition of silicon to an iron-carbon alloy also produced transgranular cracks. [7, 8]

Figure 9: Intergranular crack resulting from hydrogen embrittlement during chromium plating [7]

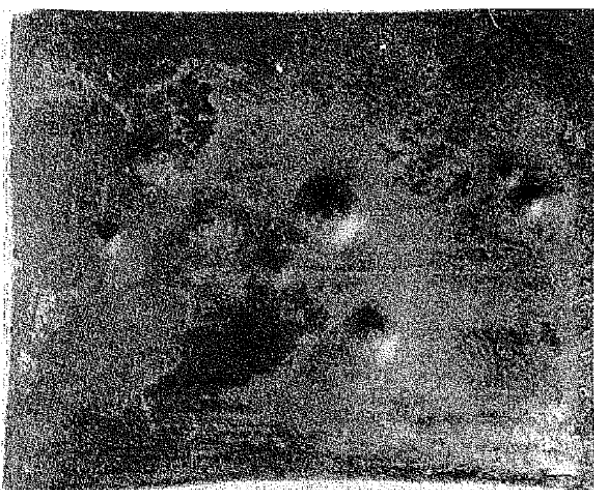
Figure 10: Blisters in a carbon steel plate formed by hydrogen [7]

The phenomenon of hydrogen blistering is caused by the pressure created when atomic hydrogen combines into molecular hydrogen. This can happen when a high enough concentration of atomic hydrogen accumulates at internal defects such as voids or inclusions in low strength unhardened steels. This could show as the formation of surface bulging, known as blisters, as can be seen in Figure 10 or delamination caused by internal blistering at grain boundaries as can be seen in Figure 11. It occurs predominantly in low strength alloys. [7, 8]

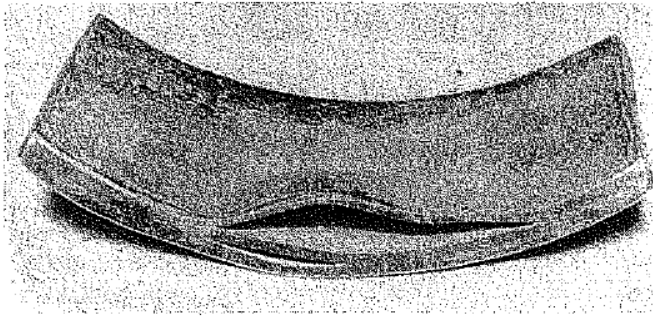
Figure 11: Delamination of a steel plate as a result of hydrogen blistering [7]

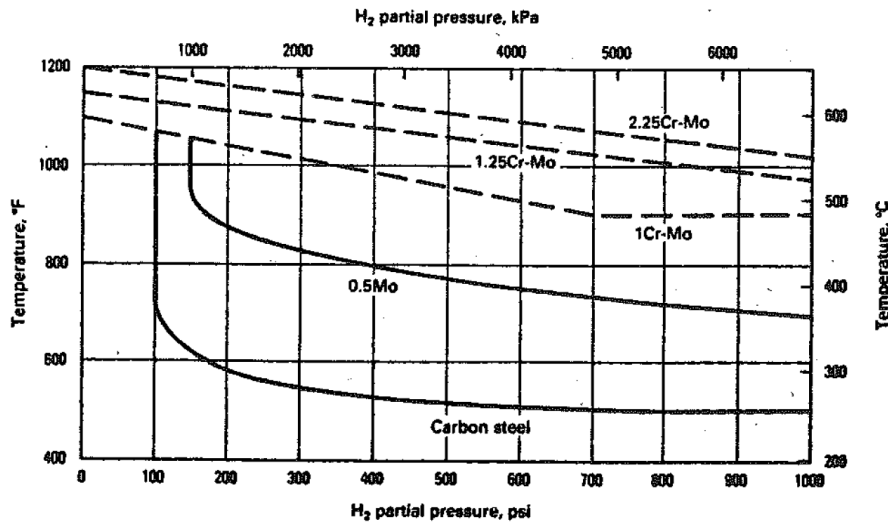
The initial point of attack is often found at areas of high stress concentration since hydrogen diffuses to those areas. To prevent hydrogen attack from occurring it is a good idea to add carbide stabilizing elements such as vanadium, titanium, chromium or molybdenum. It does not occur in austenitic stainless steels which make them good choices for this kind of environments if they are suitable from other considerations. Operation limits of carbon steel and some alloy steels are shown in the Nelson curve in Figure 12. [7]

Figure 12: Nelson curves showing the operation limits of carbon and alloy steels in contact with hydrogen at high temperature and pressure [4]

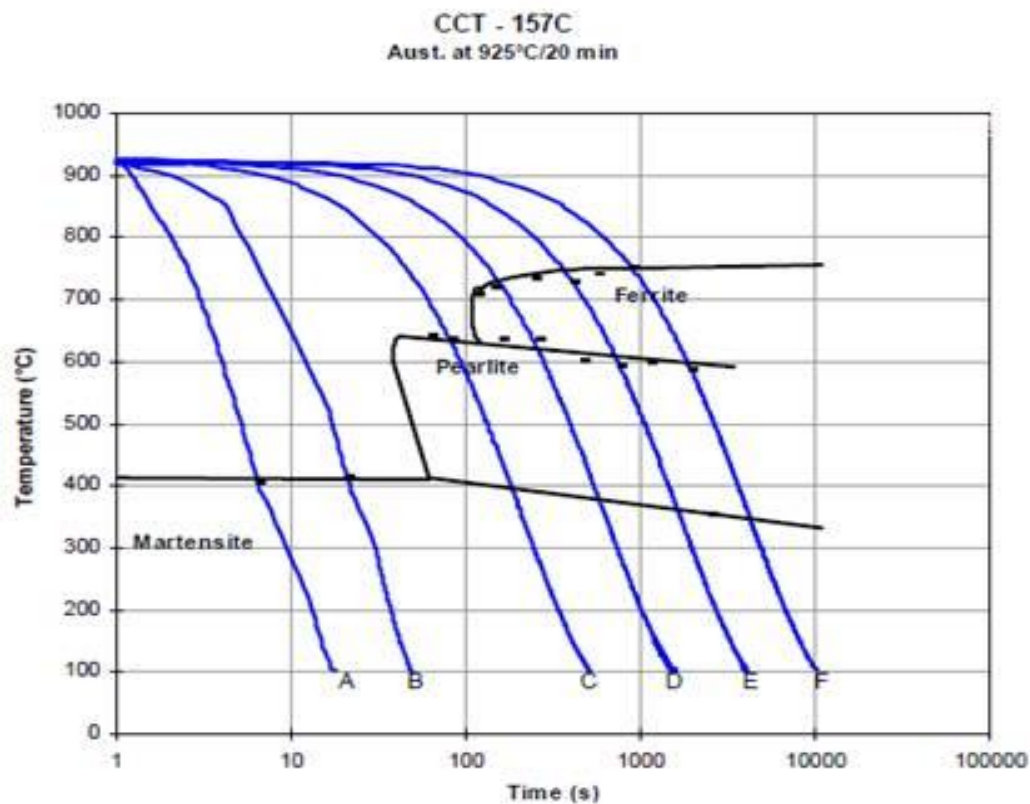
Figure 13: CCT diagram for Ovako steel type 157C [12]

Figure 13, Figure 14 and Figure 15 shows CCT diagrams for the different steel types. Since Ovako in Hofors do not produce a finished product they are cooled in air and the exact cooling speed is not known and therefore neither is the exact structure they end up with. [12]

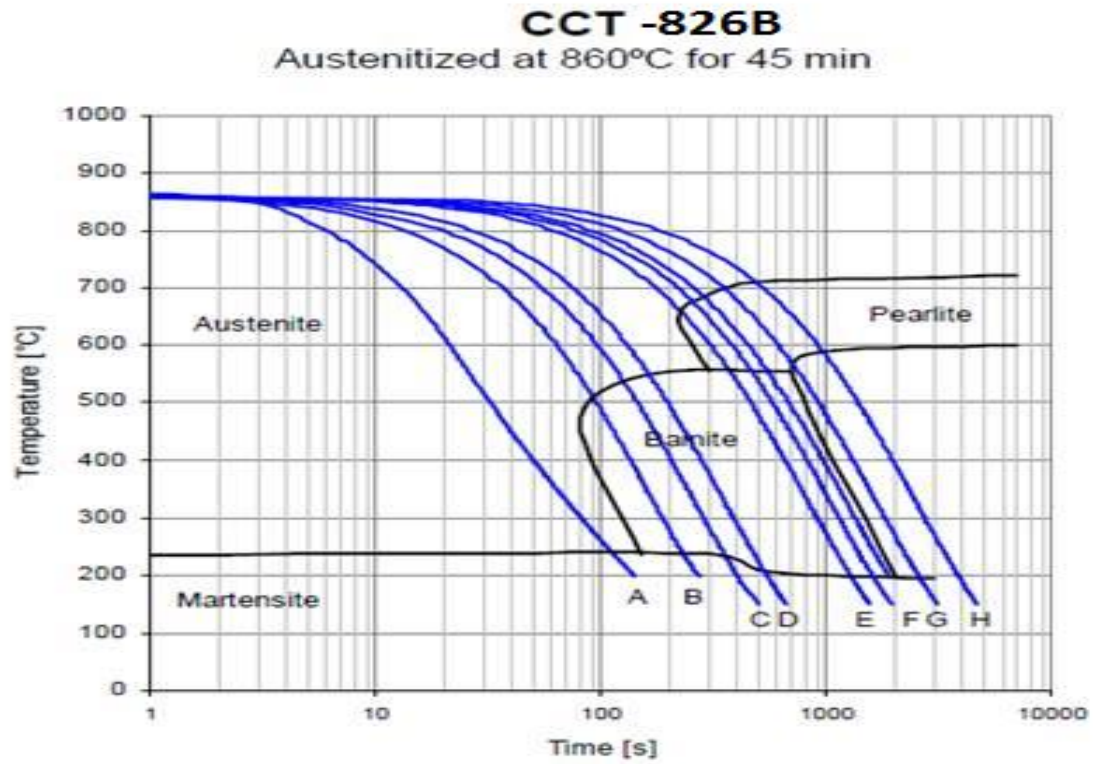
Figure 14: CCT diagram for Ovako steel type 826B [12]

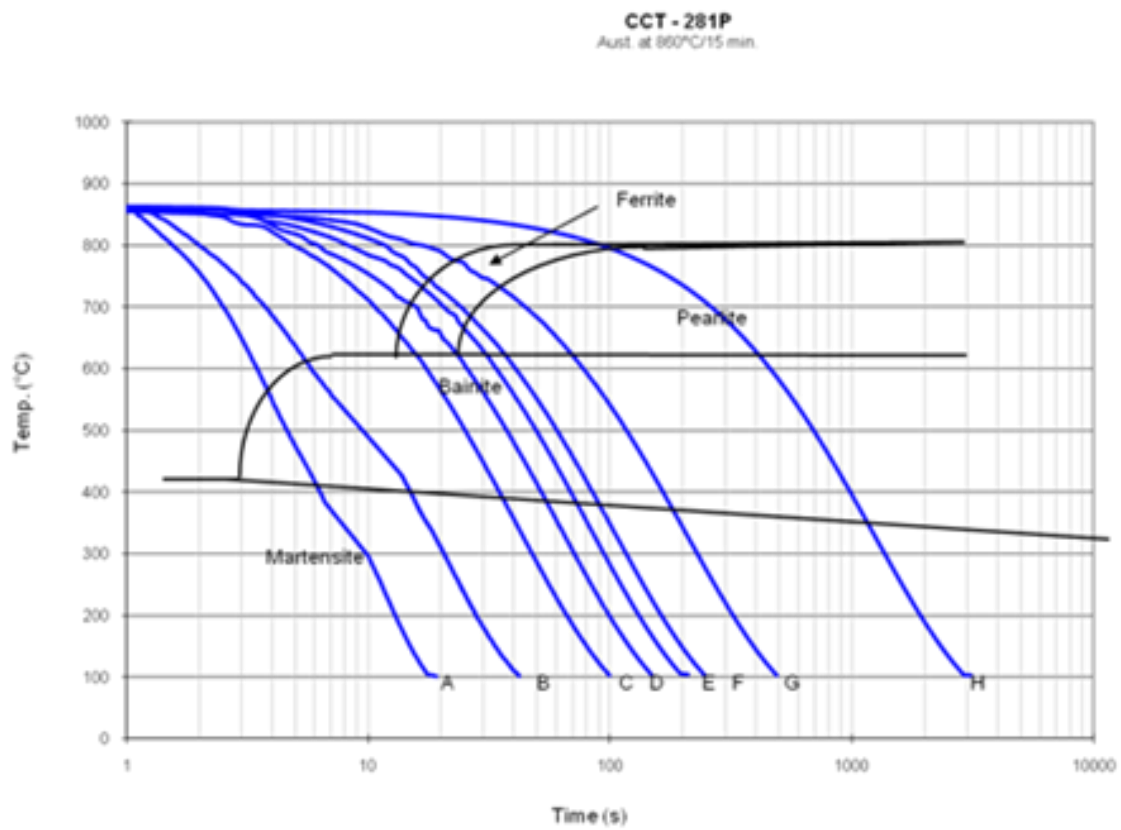
Figure 15: CCT diagram for Ovako steel type 281P [12]

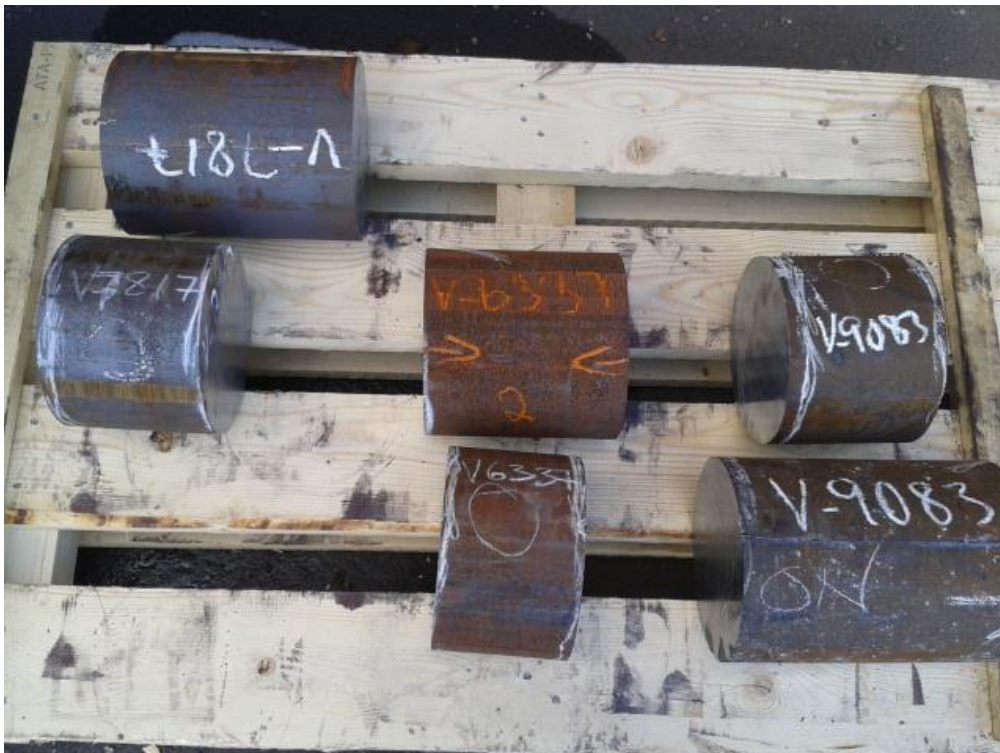
The selected bars were examined with portable ultrasonic testing to find a part with an available defect to study. Two pieces were cut out from each bar, se Figure 16. One of the two was between 2 and 3 dm long and the other was between 1 and 2 dm long. The smaller one was cut out to include defects if any were found. The longer were cut out next to it.

Figure 16: Picture of the cut out pieces from three bars of steel type 157B and 157C.

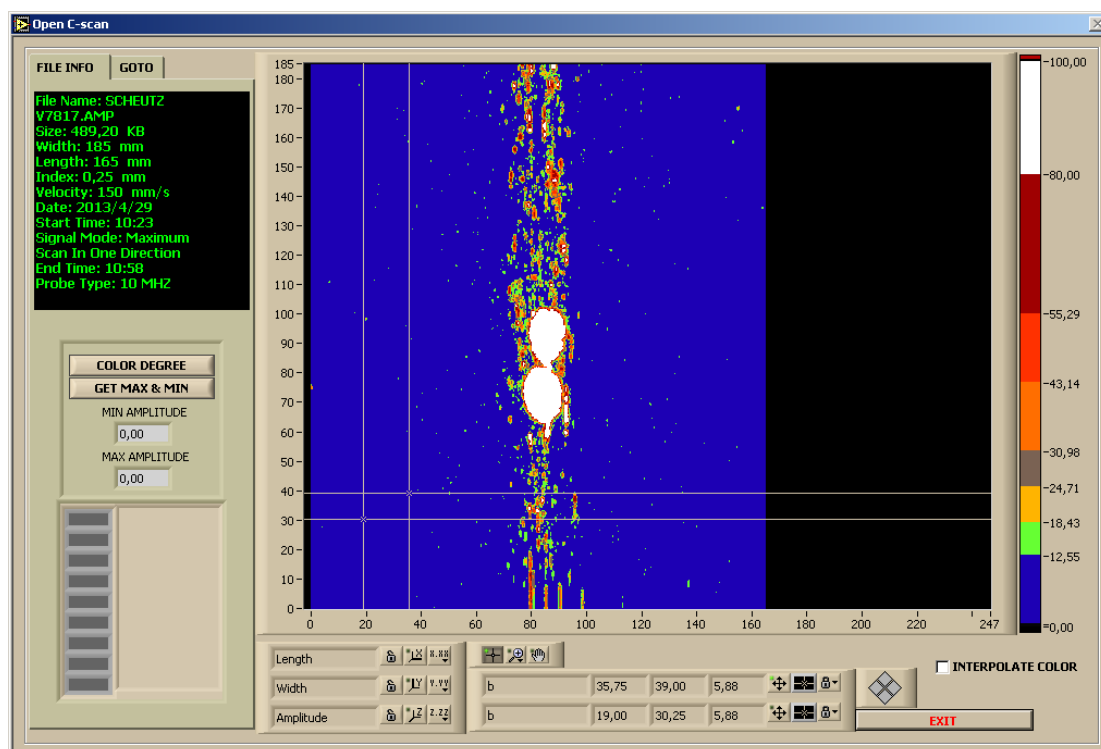
Figure 18: Ultrasonic testing in the lab at Ovako for steel specimen with charge number v7817, steel type 157B and rolling date 2012-06-03

In Figure 17-Figure 23 the results from the ultrasonic testing in the lab at Ovako are shown. The test is calibrated so that 100% = 0.2 mm flat bottom hole.

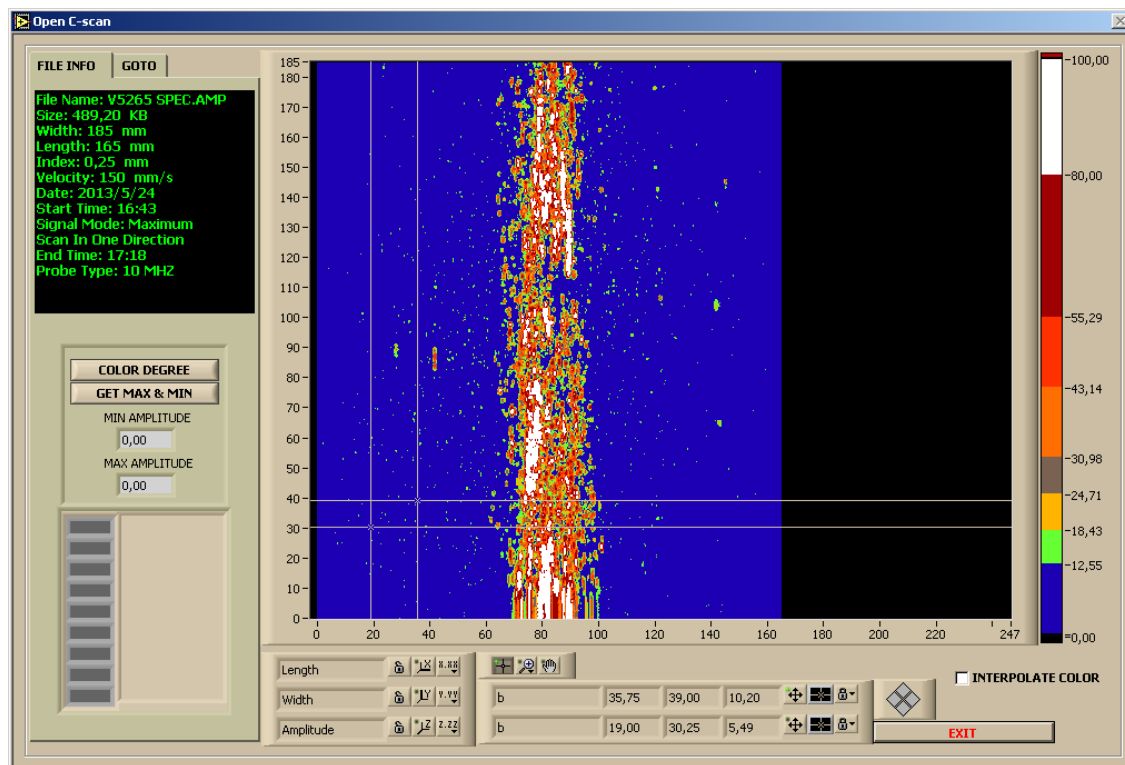
Figure 21: Ultrasonic testing in the lab at Ovako for steel specimen with charge number v5265, steel type 826B and rolling date 2011-10-23

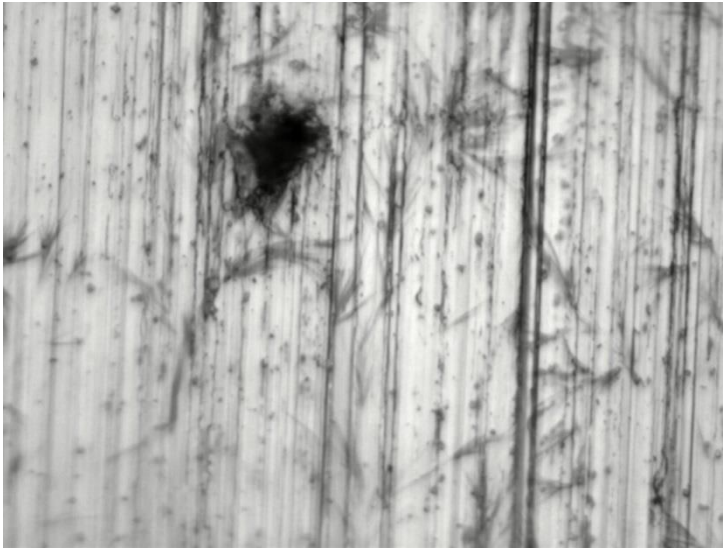
Figure 24: Picture from optical microscope showing a defect in the steel with charge number v9083. The picture width is 210 μm

Pictures taken in optical microscope of the defects surfaces examined further are shown in Figure 24- Figure 27.

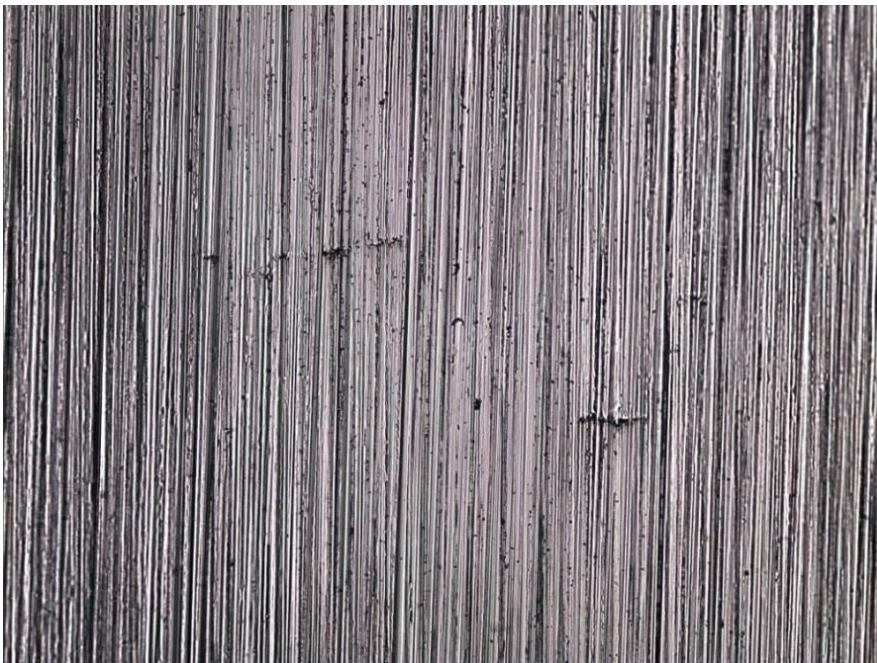
Figure 25: Picture from optical microscope showing defects in the steel with charge number v7817. The picture width is 520 μm

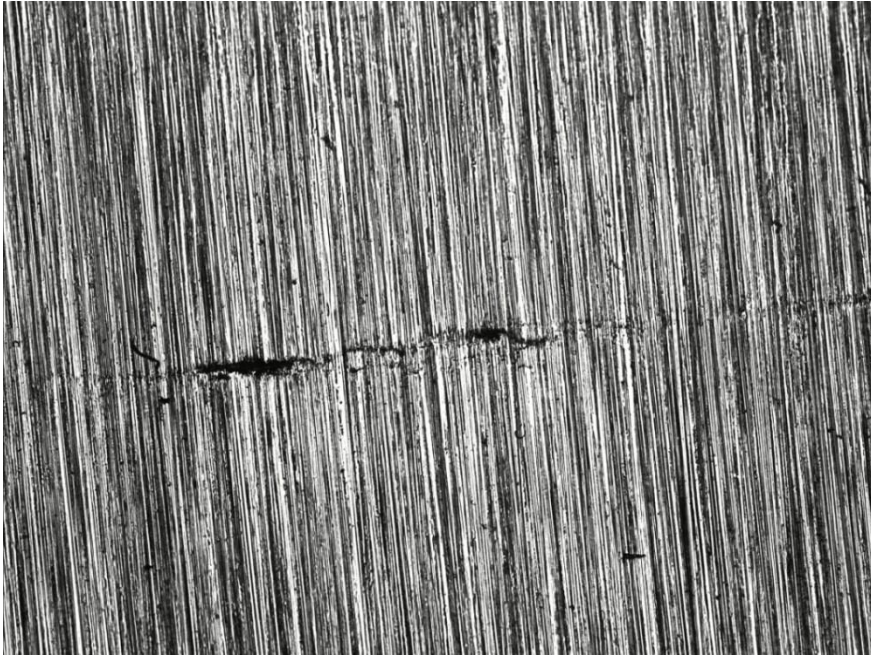
Figure 26: Picture from optical microscope showing defects in the steel with charge number v6337. The picture width is 1030 μm

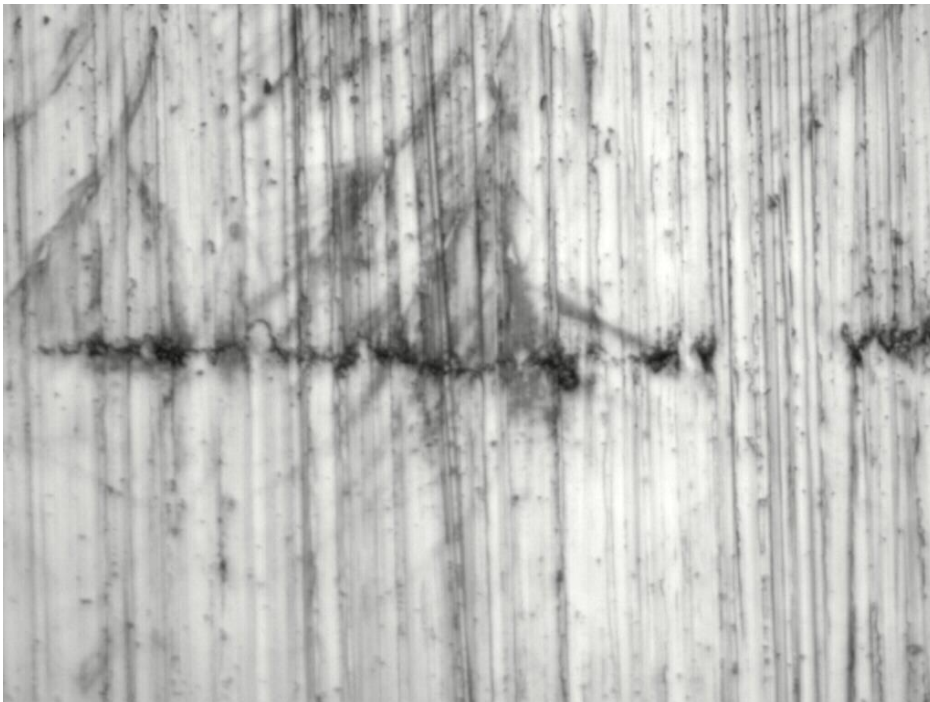
Figure 27: Picture from optical microscope showing defects in the steel with charge number d1051. The picture width is 210 μm

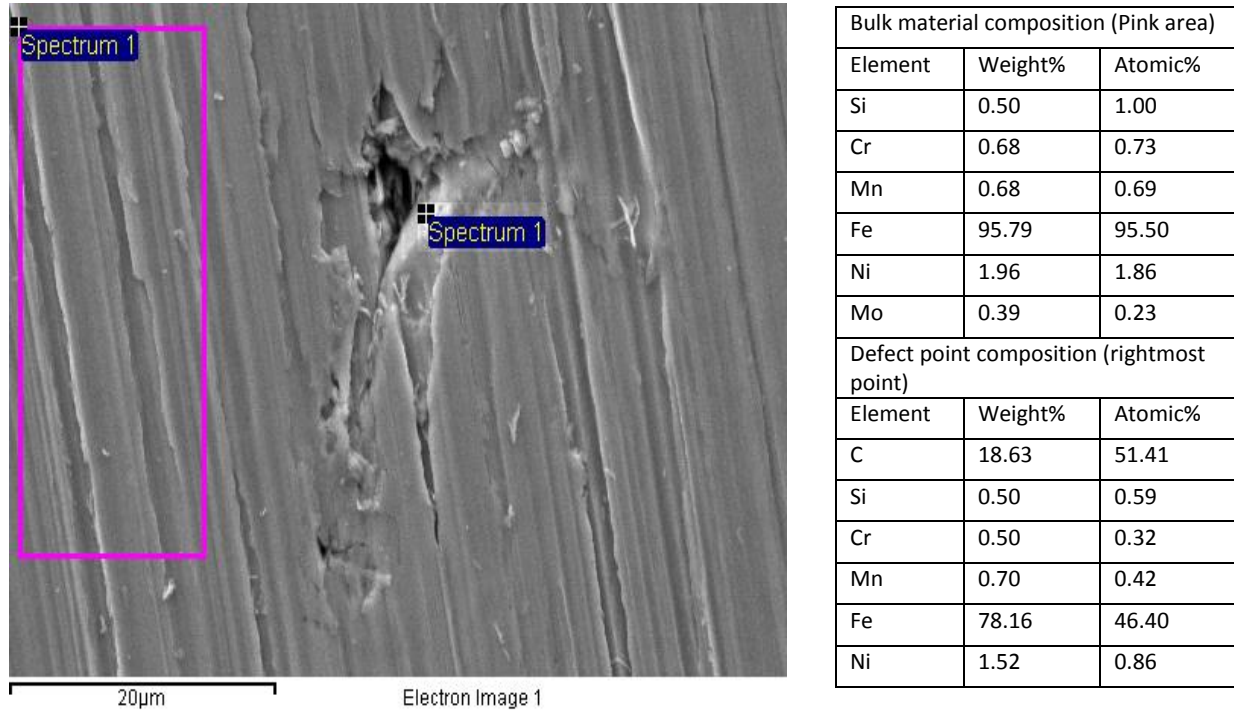
Figure 28: Bulk Material and defect EDX analysis and compositions

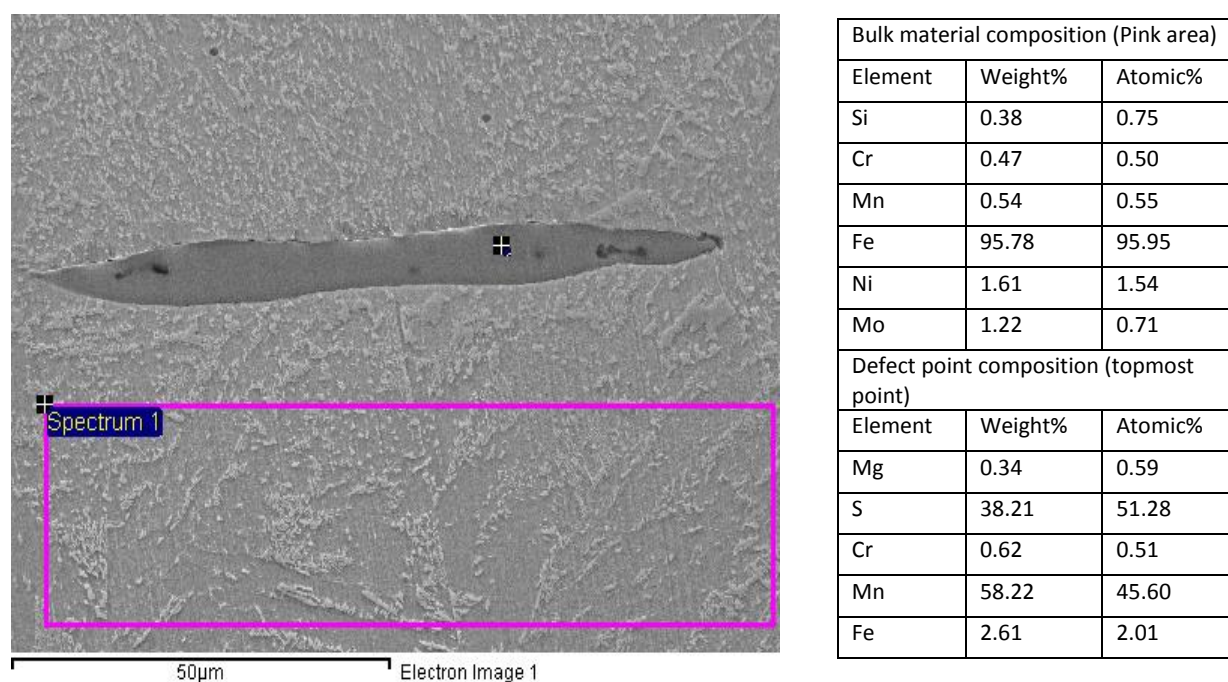
Figure 29: Bulk Material and defect EDX analysis and compositions for steel specimen with charge number v7817

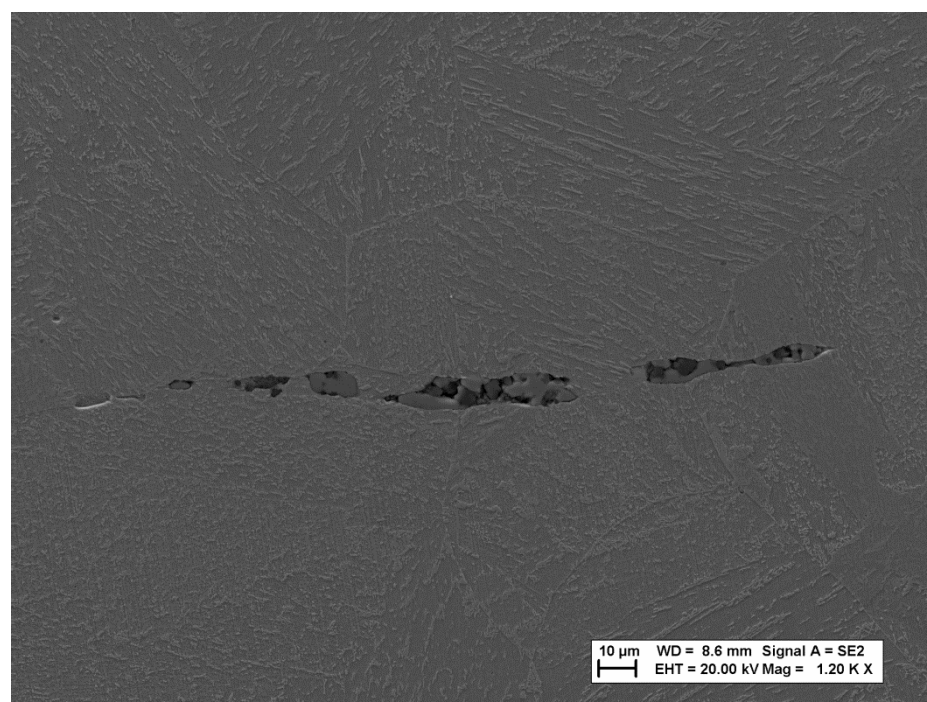
Figure 30: SEM picture of a chain of defects in steel specimen with charge number v7817. Picture width is 250 µm.

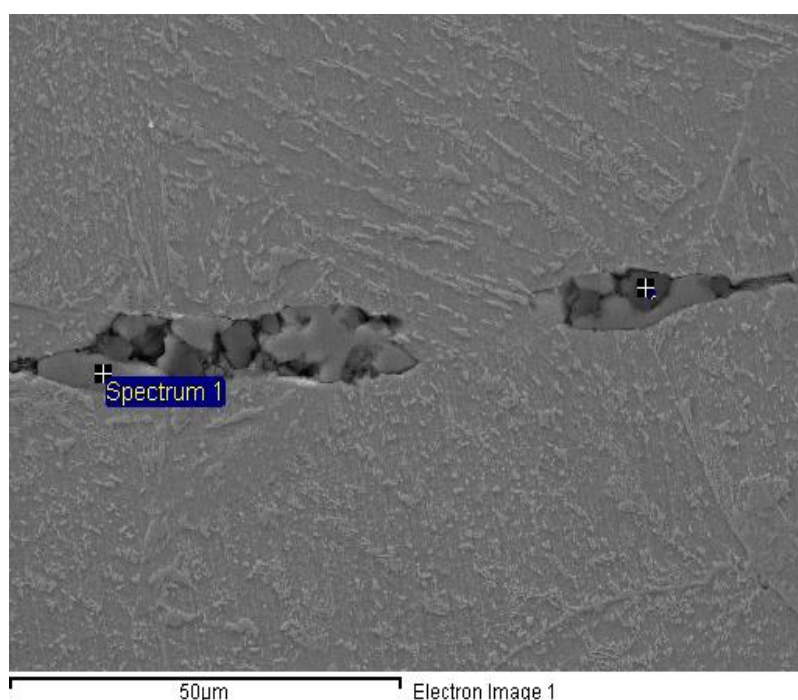
Composition at the left point		
Element	Weight%	Atomic%
Mg	2.22	3.83
Al	0.65	1.00
Si	0.19	0.28
S	38.25	49.93
Ca	0.95	0.99
Cr	0.34	0.27
Mn	54.97	41.88
Fe	2.43	1.82
Composition at the right point		
Element	Weight%	Atomic%
O	46.07	59.93
Mg	9.13	7.82
Al	37.62	29.02
S	1.94	1.26
Mn	3.44	1.30
Fe	1.80	0.67

Figure 31: EDX analysis of two points in the defect in Figure 30

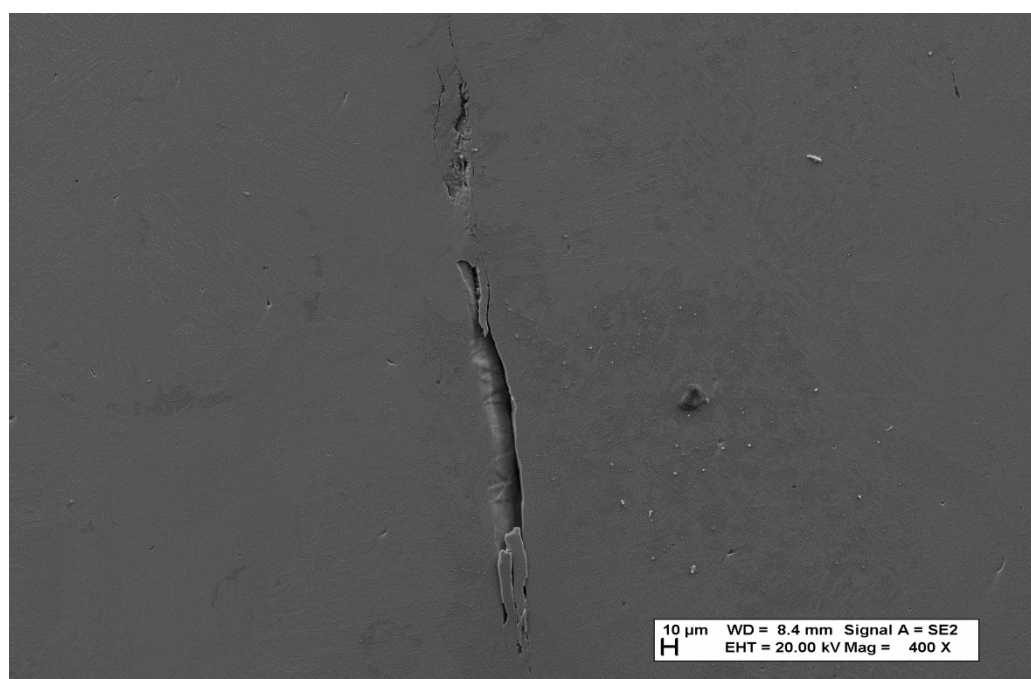
In this specimen several chains of defects were found. Three pictures of three of them can be found in Figure 32-Figure 34. The defect length is in the rolling direction. EDX analysis of the bulk material as well as on two representative parts of the defects was made. The results of the analysis of the bulk material and the defects are shown in Figure 35, Figure 36, Table 14 and Table 15. There were also small darker defects in this sample that is not captured in the pictures.

Figure 32: SEM picture of a chain of defects in steel specimen with charge number v6337. Picture width is 730 µm.

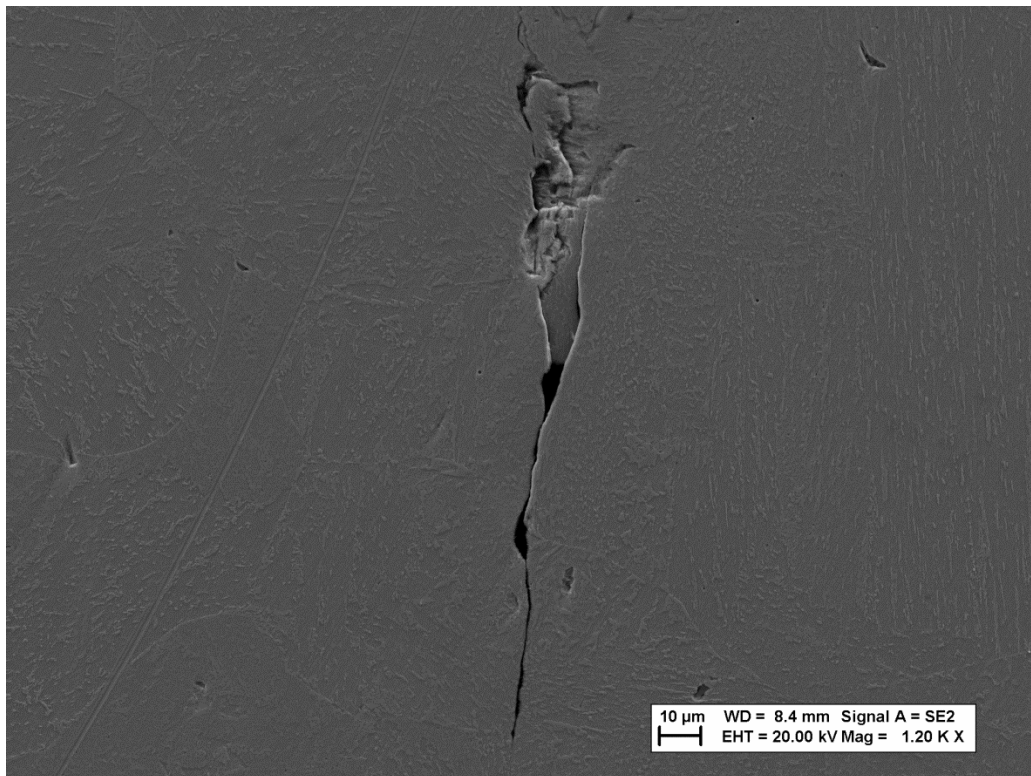
Figure 33: SEM picture of a chain of defects in steel specimen with charge number v6337. Picture width is 250 μm .

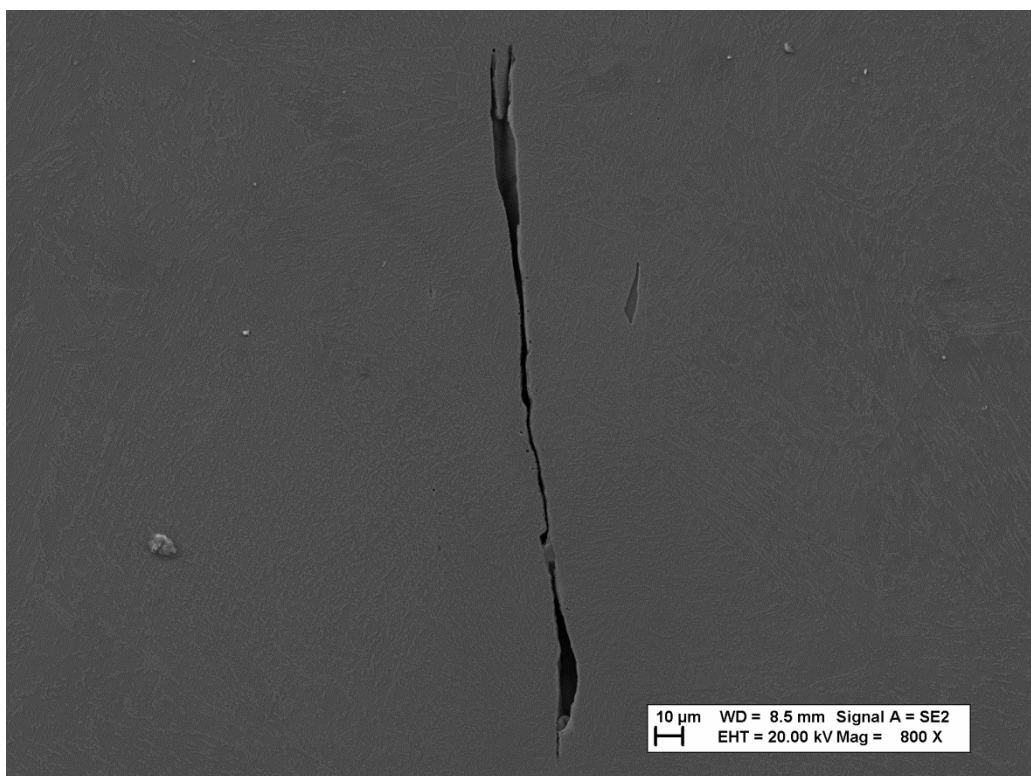
Figure 34: SEM picture of a chain of defects in steel specimen with charge number v6337. Picture width is 370 μm .

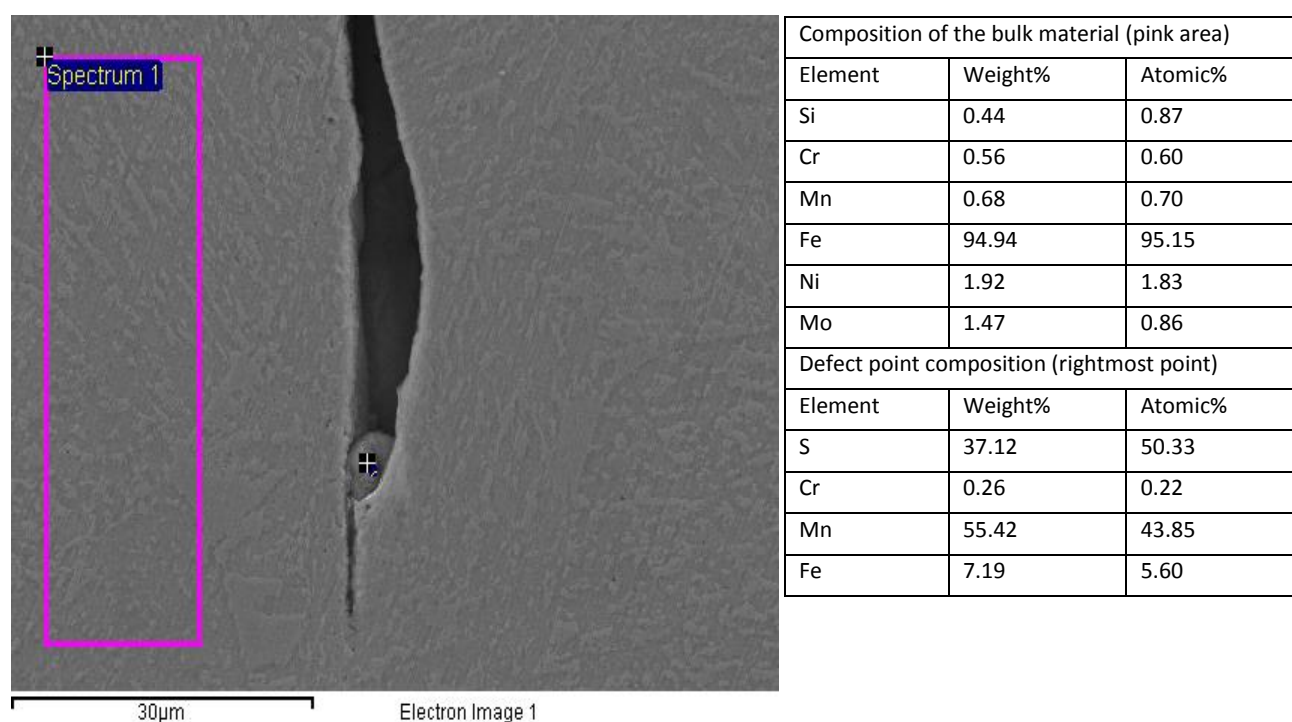
Figure 35: Bulk Material and defect EDX analysis and compositions for steel specimen with charge number v6337
