HÖGSKOLAN
DALARNA

Thesis work

Examination of defects and long term crack growth in rolled bars during long term storage

Author: Jon Scheutz
Mentor: Erik Hedlund
Examiner: Anders Eliasson
Subject/Main area: Material science
Points: 30hp

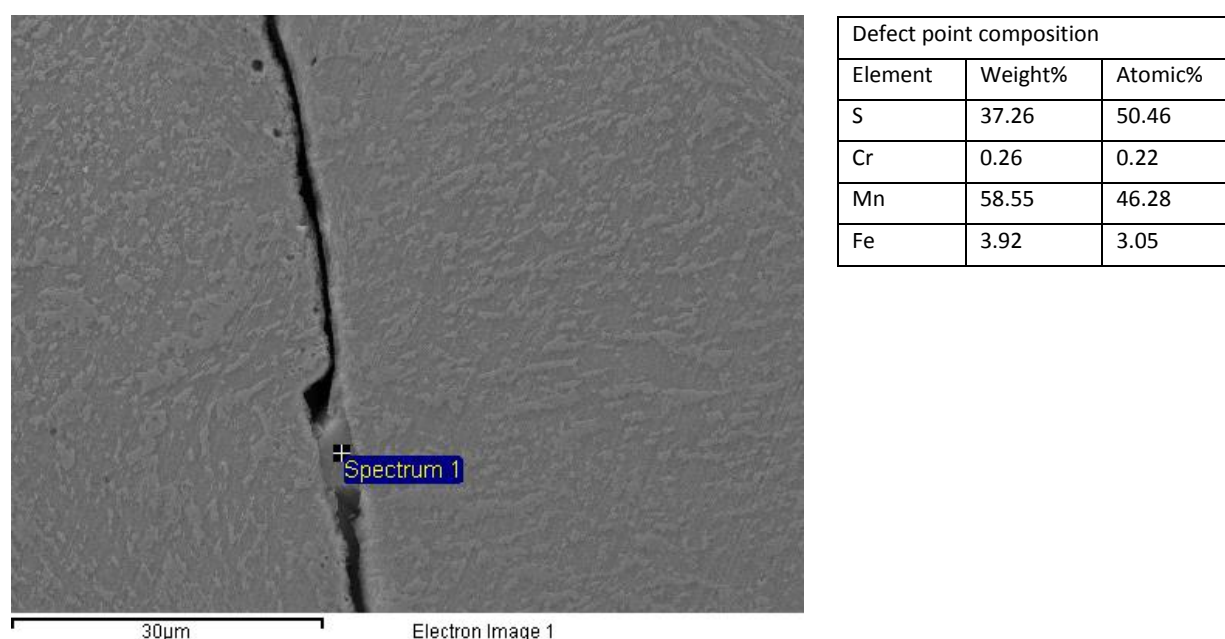
Figure 36: EDX analysis of the defect point and its compositions for steel specimen with charge number v6337

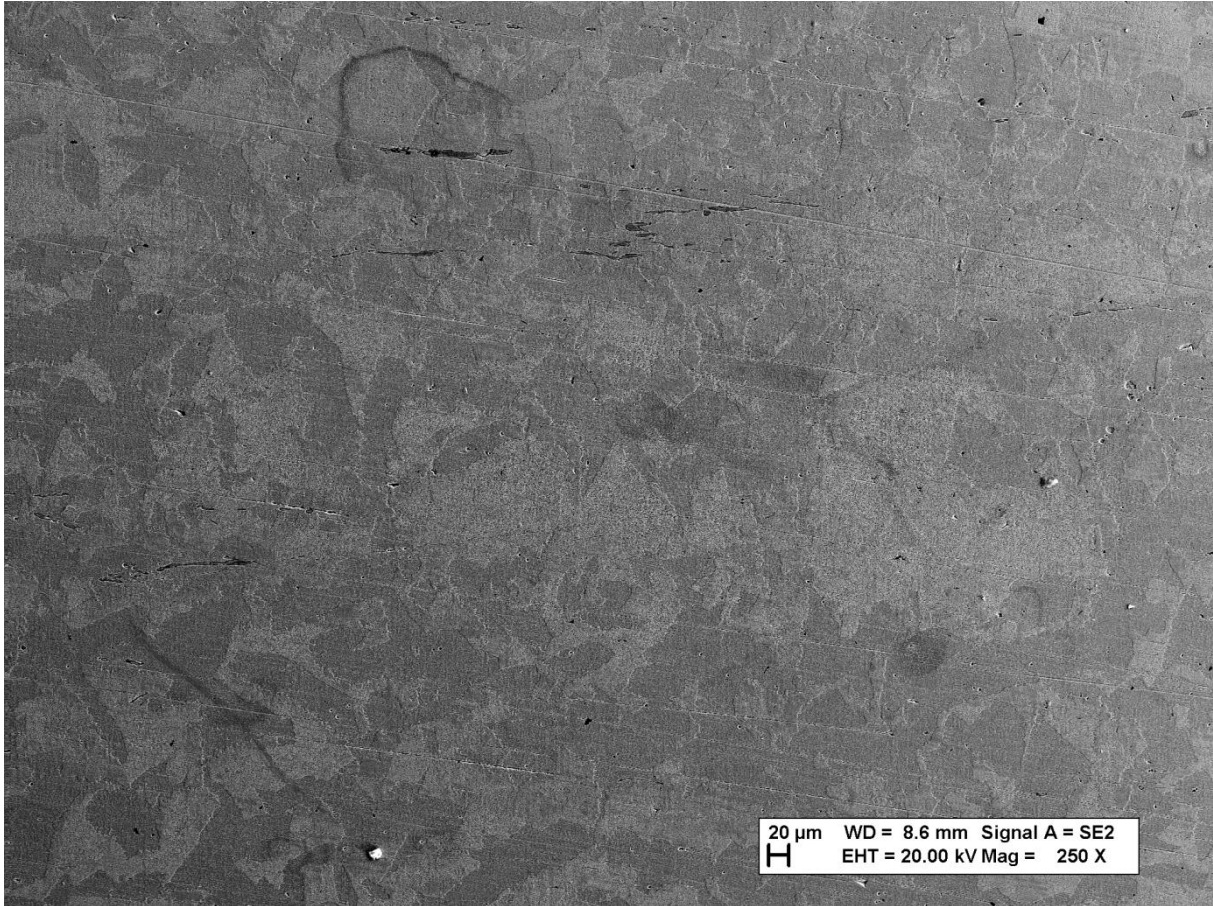
In this specimen a lot of defects were scattered about on the surface. A SEM picture is shown in Figure 37. EDX analysis of the bulk material as well as on two representative defects was made. The results of the analysis of the bulk material and a few representative analyses of the defects are shown in Figure 38 and Table 16.

Figure 37: SEM picture of steel specimen with charge number D1051. Picture width is 1180 μm.

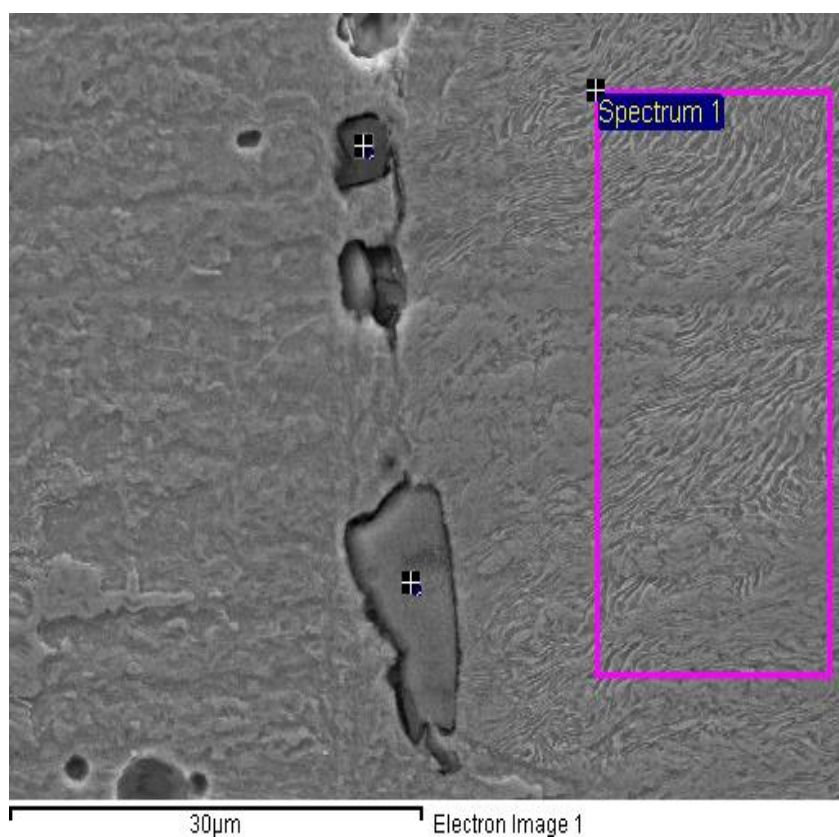
Figure 38: Bulk Material and defect EDX analysis and compositions for steel specimen with charge number D1051

Composition of the bulk material (pink area)		
Element	Weight%	Atomic%
Si	0.42	0.82
Cr	0.35	0.37
Mn	1.60	1.62
Fe	97.64	97.19
Defect point composition (bottommost point)		
Element	Weight%	Atomic%
Mg	0.72	1.27
Al	0.44	0.70
S	37.65	50.25
Ca	0.62	0.67
Mn	56.88	44.30
Fe	3.68	2.82
Defect point composition (topmost point)		
Element	Weight%	Atomic%
O	47.31	60.87
Mg	8.62	7.30
Al	39.55	30.17
Fe	4.51	1.66
