Formation of protective lubricious oxide layers on the surface of nitrogen alloyed steels in self-mated sliding

Amin Aeyadi

Degree project for master of science in engineering, mechanical engineering

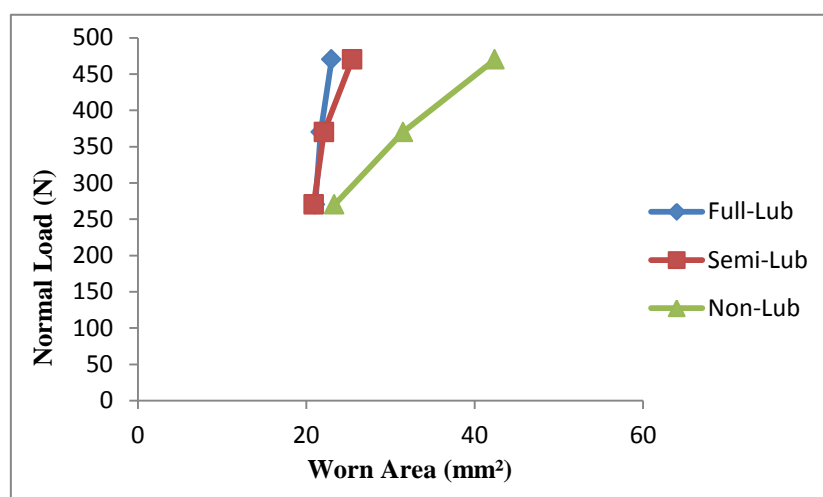
As can be seen on the diagrams the blue dots represent the Full-Lubricated condition, the red dots represent the Poor-Lubricated condition and finally the green dots represent the Dry or Dry condition.

Fig.19: S1 wear rates

However the Dry sample with 31.49 mm² worn area, indicates a considerable difference with the Low-Load wear rate, this material in High-Load condition gives 23 mm² worn area for Full-Lubricated, 25.45 mm² for Poor-Lubricated and 42.39 mm² for Dry samples.

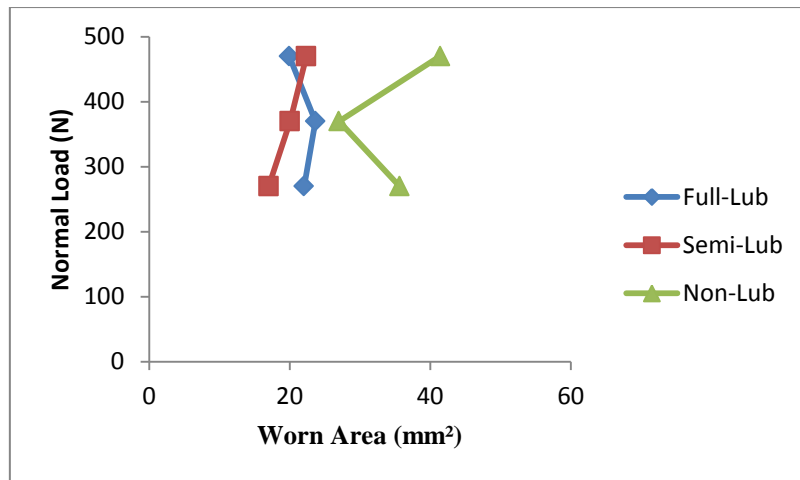
Fig.21: S3 wear rates
