Detector response from a defective wheel

Matthias Asplund^{a,b,*}, Pär Söderström^c

ABSTRACT

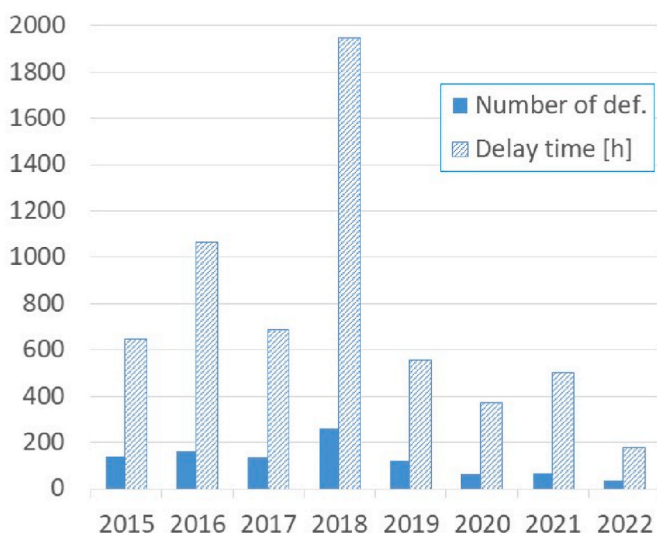
The number of defective wheels reported by the WILD, and those that are reported to traffic control by other sources, at the public railway network in Sweden, is generally between 38 and 263 events each year. The absolute majority of these events come from the WILD. These impact the capacity on track via inspections of the track to ensure that no safety issues are found after an event. This is called delay time caused by defective wheels. The amount of delay time caused by defective wheels varies between 177 and 1925 h each year. Fig. 2 shows the number of defective wheels and the amount of delay time coming from defective wheels due to track inspections; the x-axis is the year and the y-axis is the number of events or the hours of delay. In 2018, defective wheels caused lots of delay time due to the extraordinarily harsh winters with many days of cold degrees across the entire country that caused lots of disturbance for the traffic in terms of train delay. However, with the exception of 2018, there is a trend of fewer defective wheels in each successive year.

Fig. 2. Number of defective wheels from the Swedish railway network and its delay time for 2015 to 2022.

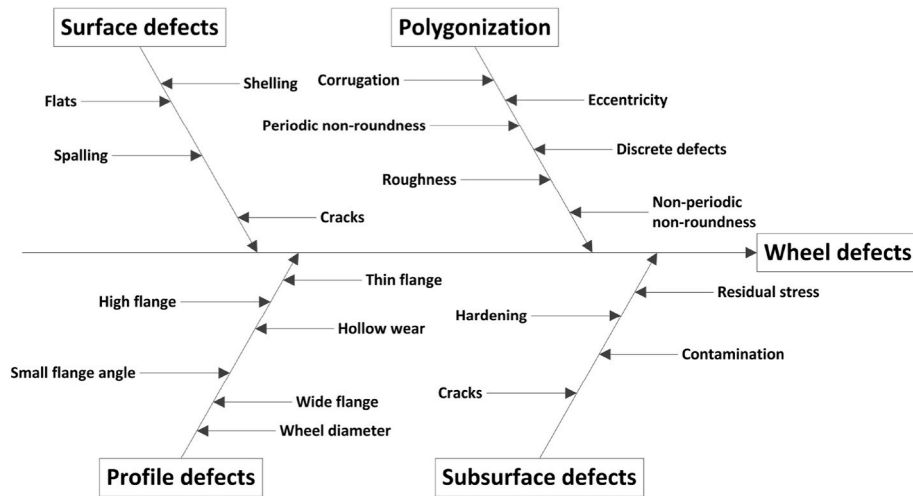
A simple way to organise the wheel defects is to divide them into four different categories: surface defects, subsurface defects, profile defects, and polygonization; see Fig. 3. These can be further categorised into different subheadings, as shown below, see Fig. 3 [19]. The wheels in this investigation have surface defects, such as spalling and shelling. These defects are also referred to as rolling contact fatigue (RCF).

Fig. 3. Wheel defect divided into four different groups [19].

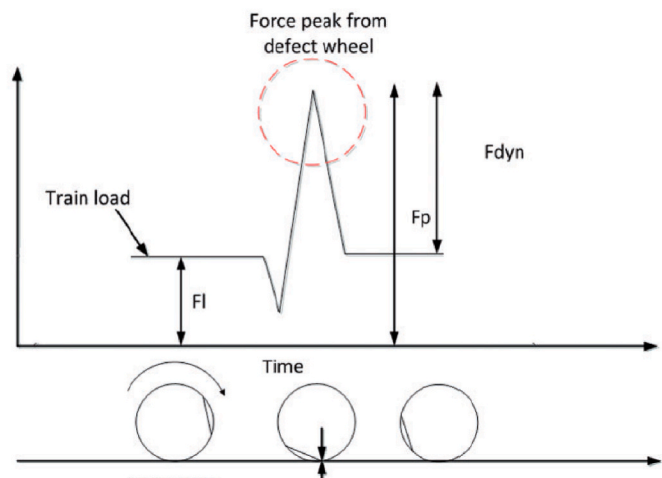
For this infrastructure, the alarm limit for the peak forces is 350 kN. There are also other alarm limits, including the ratio and the warning limits (280 kN) that the rolling stock owner can use to indicate that the wheel needs to be maintained or changed. Fig. 5 shows a simplified principle of the wheel force response on a WILD. The y-axis is the force level, and the x-axis is the time. The wheel has the quasistatic load presented as a train load (Fl); the highest force response is identified as force peak (Fp), and the difference between these is the dynamic force (Fdyn). This work is only concerned with the force peak (Fp). The shape of this force response from a damaged wheel is shown in simulations [21].

Fig. 5. The simplified principle of the WILD, y-axis force being response to the rail, x-axis being the time. F_l = the static train load, F_{dyn} = the dynamic response and F_p = total force response to the rail from a wheel.

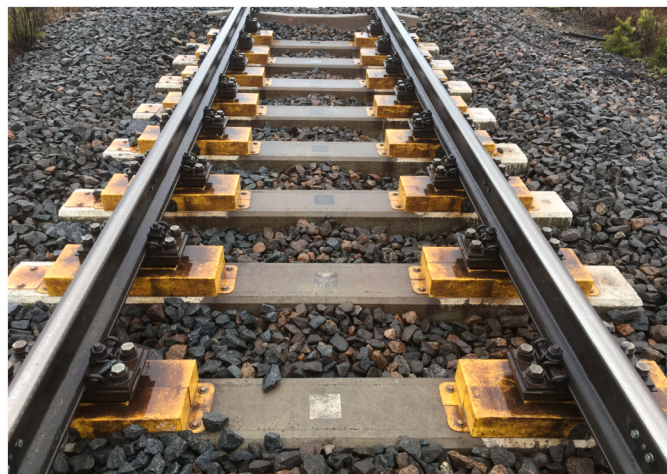
The WILD that is the subject of this investigation is located at Sunderbyn. The detector is located in a straight section of the track and more than 3 km from the closest curve. This detector is built upon load cells and has a length of eight sleepers, with a total length of 4.8 m, as shown in Fig. 6. This WILD is a Wheelscan produced by Schenck Process GmbH.

The latest calibration was performed in April 2017. This detector was also inspected in May 2018 by measurements of the rail profile and the track gauge. The track gauge was on average 1440.5 mm over the eight sleepers, which compares with measurements taken before and after the detector with an average 2.3 mm wider track gauge. This measurement was taken with MiniProf rail measurement equipment. Regarding the rail profiles and track in general, everything was normal and unremarkable compared to the track outside the detector.

Fig. 6. Wheel defect detector at Sunderbyn.
