Mosul Dam Full Story: Safety Evaluations of Mosul Dam

Nasrat Adamo¹ and Nadhir Al-Ansari²

Abstract

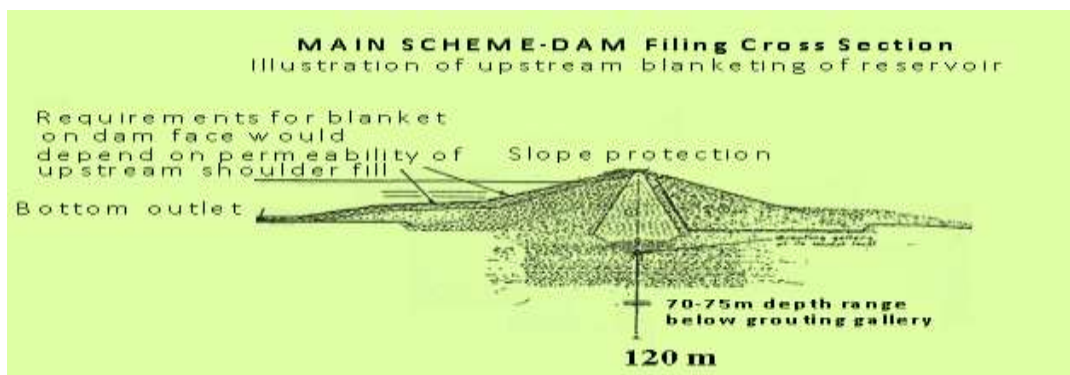
Blanketing the bed can be done without drawing down the reservoir by dropping the lining materials through pipes lowered to the bottom of the pond. Bentonite pellets are dropped in place first, and as bentonite absorbs water a highly impervious layer is formed. Sand is placed on top to hold the clay in place against any disturbances. But, as far as it is known this method has been used for small ponds and not for a reservoir of Mosul Dam reservoir size.

Figure 1: Illustration of upstream blanketing arrangement

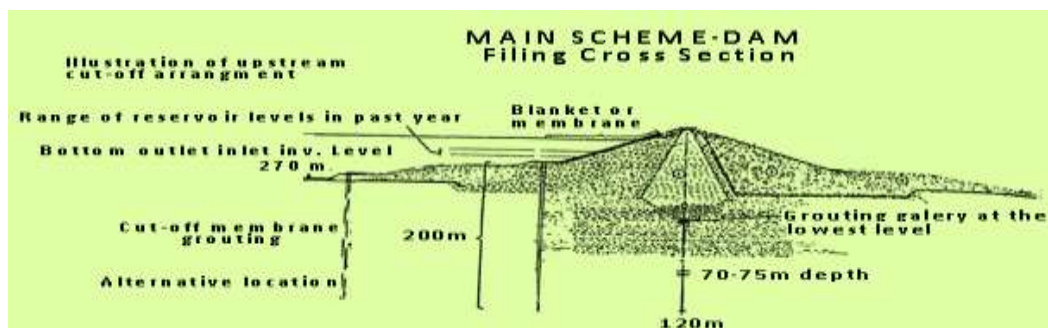
ii) Positive-Cutoff. This arrangement is shown in Figure (2).The difficulties in using this method are due to the combination of depth and the hardness of pervious strata, presence of cavities and voids in the foundation, in addition to maintaining the verticality of the diaphragm panels at these unprecedented depths. These would make trenching operations very problematic and tricky. The depth of the required trench has a great effect on the cost in the form of the very high cost of such large hydromill machines and their running costs. A location near the upstream toe of the dam or from the berm would give the least depth but it requires the drawing down of the reservoir. A trench from the crest through the core is a tricky operation and it extends for a considerable depth into the foundation, which may be technologically questionable and very costly.

Figure 2: Illustration of upstream cut-off arrangement from the berm or a new grout curtain in the upstream toe as described in (iii) below.

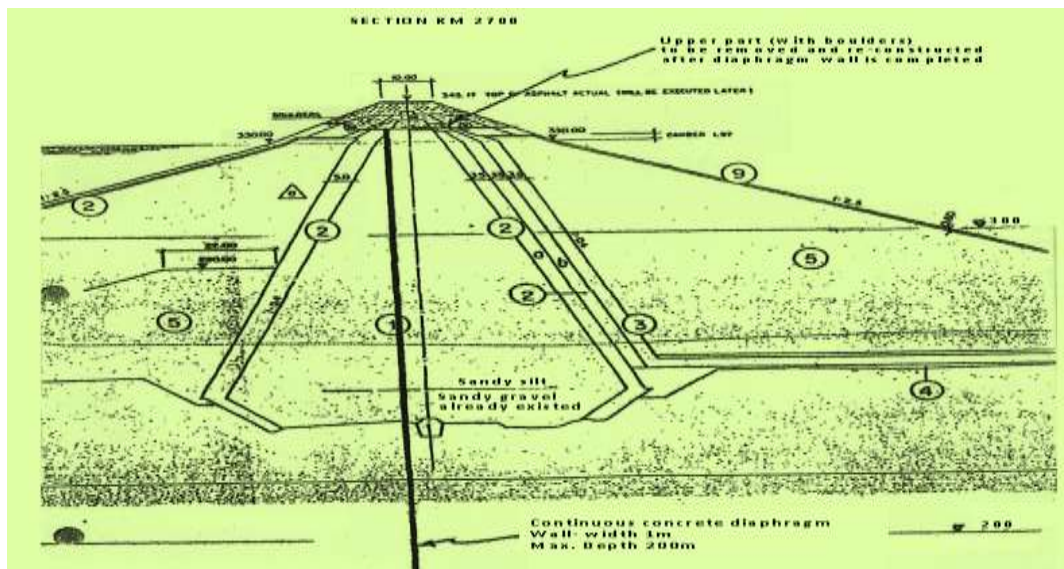
Figure3: Proposed Diaphragm driven from the dam crest.

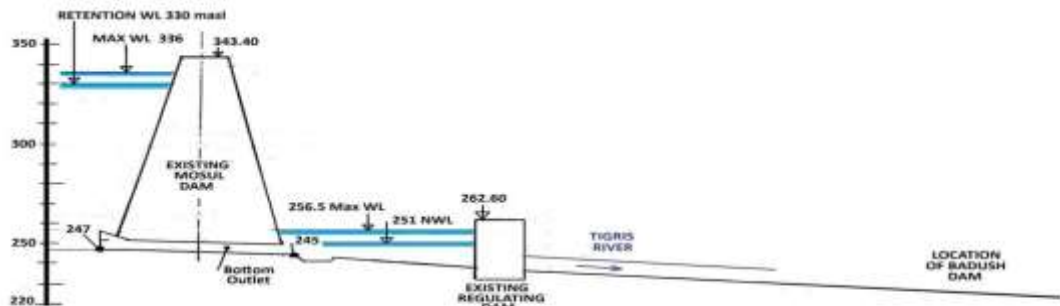
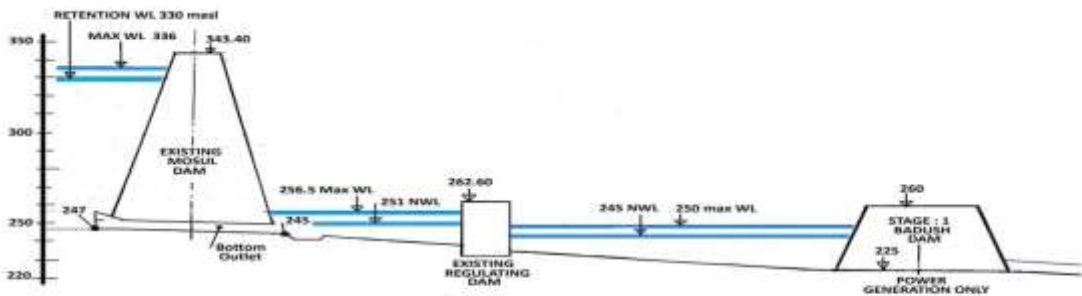
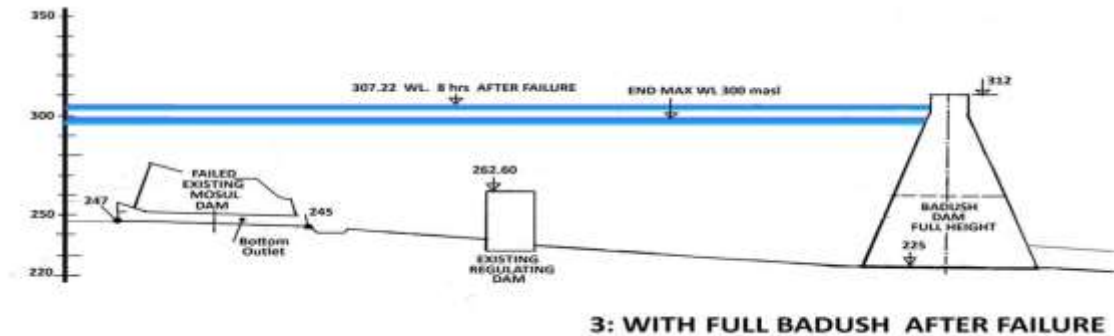
1 : EXISTING MOSUL DAM

2 : WITH BADUSH STAGE 1

Fig 6: Badush Dam Schematization with three different Conditions
