The impact of modernization of a 16th century timber-framed farmhouse, Suffolk, UK

Abstract – Well intentioned modifications to traditional buildings can potentially be detrimental if the full implications of the work are not fully understood. This paper presents the case of a 16th century Suffolk farmhouse. Extended in the 1700s, the timber-framed building was clad in cement render in the early 20th century. At a later date the timber sole plates were encased in concrete and painted with an impervious resin. Finally in 2005 the panel infills were replaced with rigid polyisocyanurate (PIR) thermal insulation. In-situ environmental monitoring and digital simulation are used to assess the impact of these measures on the performance of the building. The outcomes of this research are now being used to enhance the informed conservation of this building.

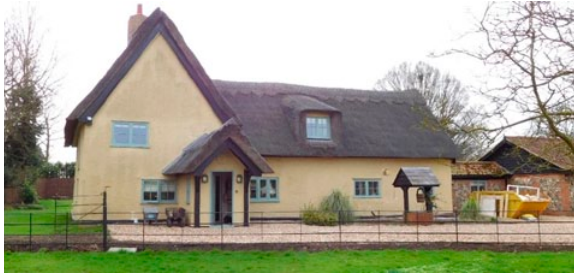
Figure 1. North entrance elevation of case study. Source: Author's own, 2017.

The oldest section of the house, the lower wing (right in Figure 1), contains a small section of 16th Century plain crown post roof structure [7]. A second, taller wing is thought to have been constructed at right angles to the first in around the 17th Century, with an axial red brick chimney with sawtooth shaft (ibid). Subsequent additions were added in the 1980s with a porch to the north (Figure 1), an en-suite bathroom at the junction of the two wings (Figure 2) and a service block to the west.

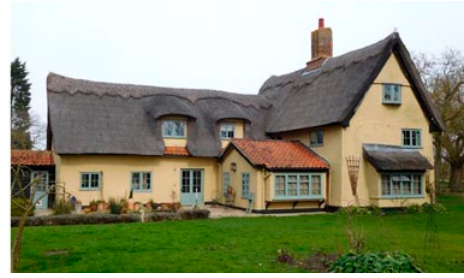
Figure 2. South, elevation. Source: Author's own, 2017.
