### Electric Vehicle Fire Safety in Enclosed Spaces

RISE Report 2023:42

# Abstract

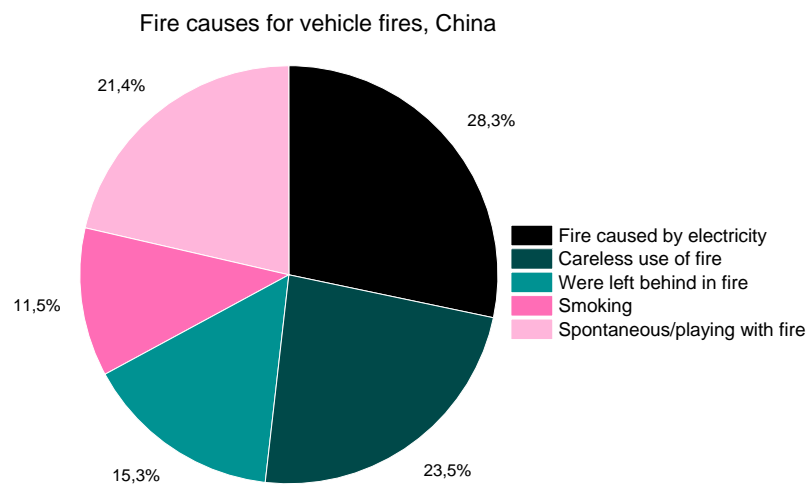
Figure 4. Vehicle fire causes reported for the first quarter of 2022, China. [11]

Limited statistics from China were retrieved in this project. Vehicle fires reported for the first quarter of 2022 are presented in Figure 4. The data does not distinguish EVs, but they state that out of the total 19 000 vehicle fires, 0.33% were reported for alternative fuel vehicles, [11] these also include gas vehicles. The data analysed does not reveal where the fire incident occurred, neither did it report fires related to collisions or the origin of fire. The most common fire origin was electric faults, but the connection to EVs for these fires is unknown.

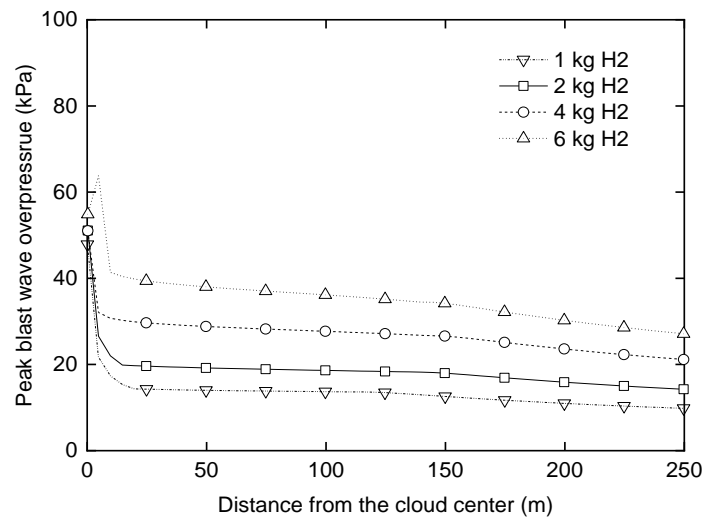
Figure 6. The blast pressure as a function of distance for various quantities of hydrogen gas stoichiometrically mixed with air in a tunnel.

In work by Li, [21] a numerical model was developed to obtain blast wave pressures, resulting from the explosion of a hydrogen gas cloud, in a 50 m<sup>2</sup> tunnel. The peak blast wave overpressure as a function of the distance from the cloud centre, for various quantities of hydrogen mixed with air in the tunnel, is presented in Figure 6. The pressure drops rapidly around 20 m from the cloud centre and attenuates slowly along the tunnel. The simulation using 1 kg of hydrogen was performed for this study, whilst the other simulations were retrieved from work by Li. [21]

The total amount of vent gas formed, can be estimated to  $\sim 0.5 \text{ L Wh}^{-1}$ . [24] This indicates that a 100 kWh LIB could potentially release  $\sim 50 \text{ kg}$  of gas. The total concentration of hydrogen could therefore be  $\sim 1.4 \text{ kg}$  (1 – 2 kg). For 1.4 kg of hydrogen, the peak blast pressure would end up between 14 – 20 kPa, at a distance of 20 – 50 m (see Figure 6). Notice that the contribution of other vent gases is not considered and may affect the outcome of the numerical model.

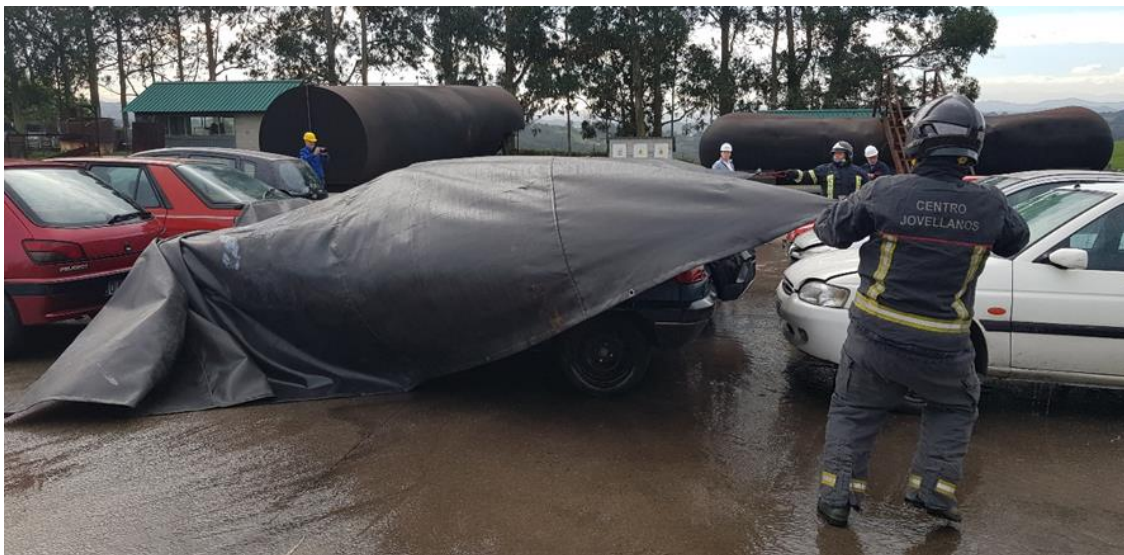
Figure 7. Firefighters applying a vehicle fire blanket during the fire drills in the LASH FIRE project. Photo by Anna Olofsson, RISE.

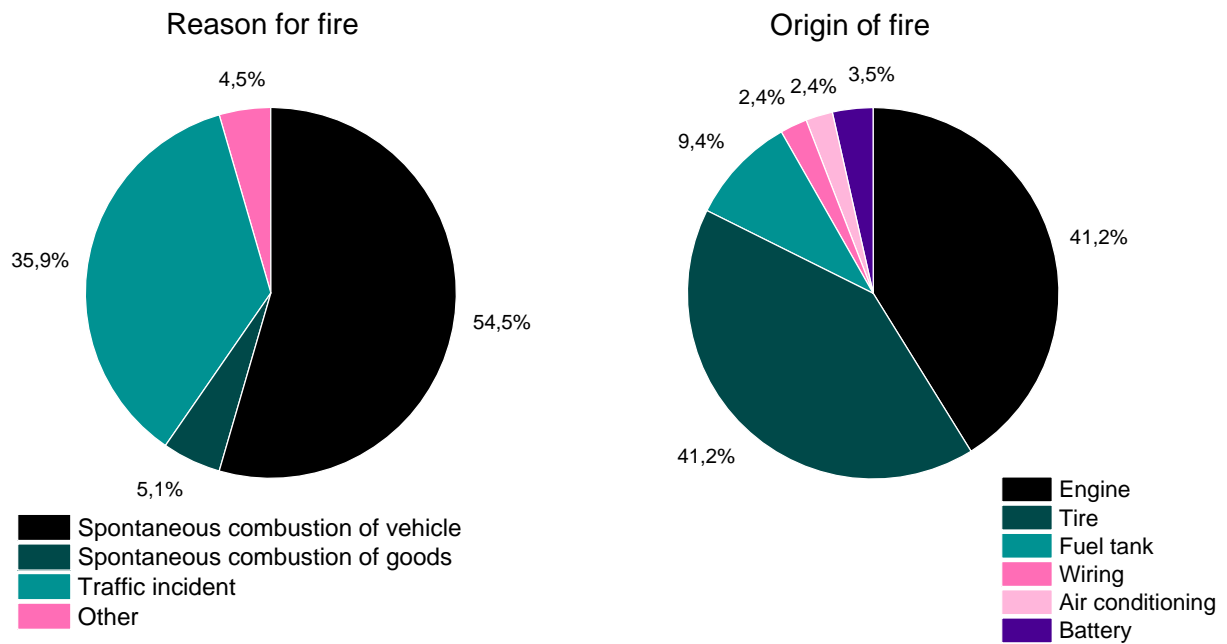
Figure 11. Reason for fire and origin of fire from 156 tunnel fire incidents, data taken from reference [33]

Bai et al. [33] analysed 156 tunnel fire incidents, mostly incidents in China, which resulted in the statistics on fire origin and cause in Figure 11. They concluded that a majority of tunnel fires in China occur in summer; tunnel fire accidents are more frequent in economically developed areas in China as well as in the mountainous areas in western China; long tunnels and very long tunnels experience more fire accidents, which occur mostly at tunnel entrance/exit (within 200 m from portals); most tunnel fires are caused by spontaneous combustion of vehicles (vehicle defects) and traffic accidents; consequences of tunnel fires include casualties, vehicle damage, damages to tunnel structure and facilities, and traffic interruption. Around 36% of the fire incidents were caused by a traffic accident (or collision). For vehicle fires caused by vehicle defects, the locations of ignition sources mostly involve the engine and tires.
