Microplastics and rubber in sediment collected over three years in road run-off treatment systems along highway E4 in Stockholm with particular focus on thermoplastic road markings

**Agnieszka Renman**

KTH Royal Institute of Technology

Commissioned by the Swedish Environmental Protection Agency

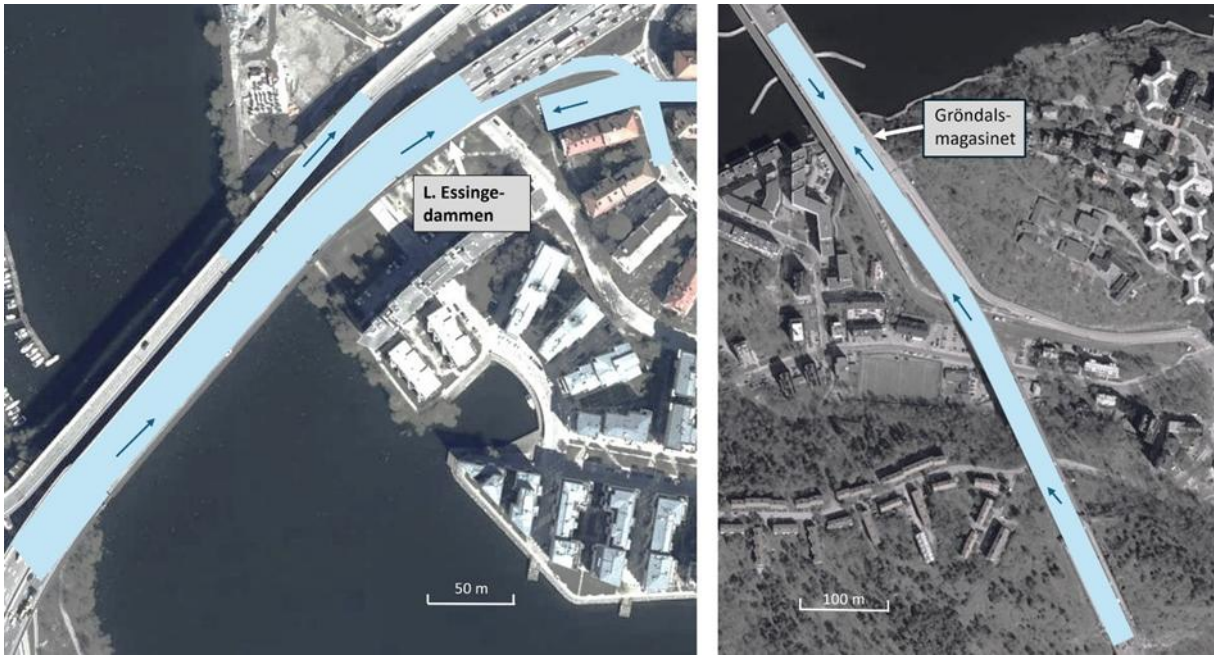
**Figure 1:** Catchment areas for Lilla Essingen RWTP (left) and Gröndal RWTP (right). Arrows showing the direction of runoff water to the runoff treatment plants. Maps based on <https://kartor.eniro.se/m/1PJ1A>.

The Lilla Essingen runoff water treatment plant catchment area is made up of the E4 road (Essingeleden), also including 12 % of a housing area on the island of Lilla Essingen (Fig. 1). The catchment area can be separated into three main sections. The highway Essingeleden, Gamla Essinge Broväg and the housing area cover a total asphalt road run-off area of 17,945 m<sup>2</sup> (Table 1). The annual average daily traffic (AADT) in Essingeleden is 165,000 vehicles. The Lilla Essingen runoff water treatment plant, with its sedimentation pond, is located under the bridge (Fig. 1). The run-off is collected in gutters hanging under the bridge and discharged by gravity flow to the sedimentation pond (Fig. 2). The stormwater from the housing areas (12% of the entire catchment area) is discharged by pipes to the sedimentation pond. The sedimentation is sequential and controlled by the level in the sedimentation pond, thus the water levels will vary between minimum water level (1.0 m) and maximum water level (1.4) during operation. At high flows, bypass/overflow is done before the sedimentation pond. The catchment area for the Gröndal runoff water treatment plant covers an area of 25,800 m<sup>2</sup> (Fig. 1; Table 1). It consists solely of road surface with asphalt and has an AADT of 165,000 vehicles. Two gutters

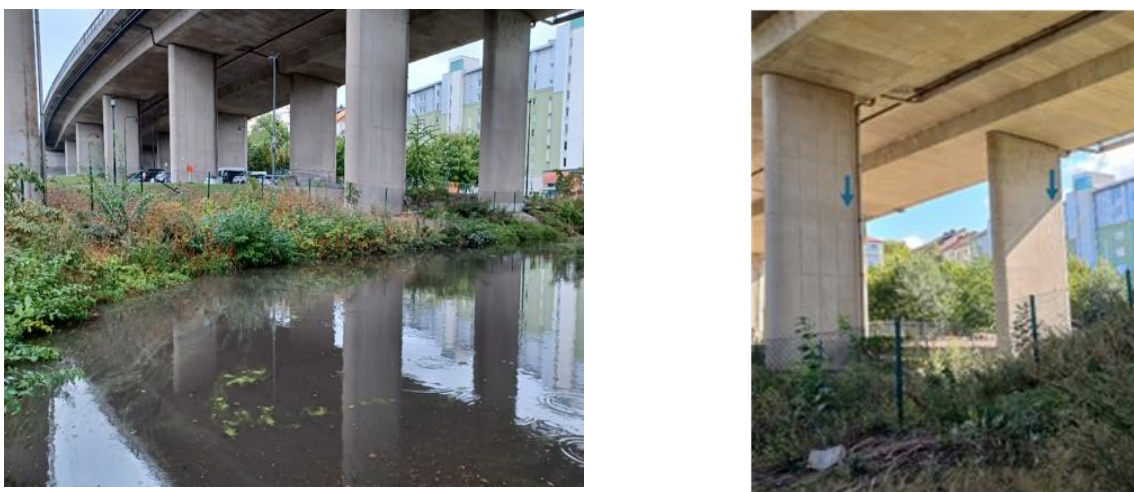
**Figure 2:** The Lilla Essingen treatment pond, situated below the Essinge-leden bridge of the E4 highway, filled to its maximum storage volume. (Cf. Fig. 4). The arrows show the downflow pipes from gutters hanging under the bridge.

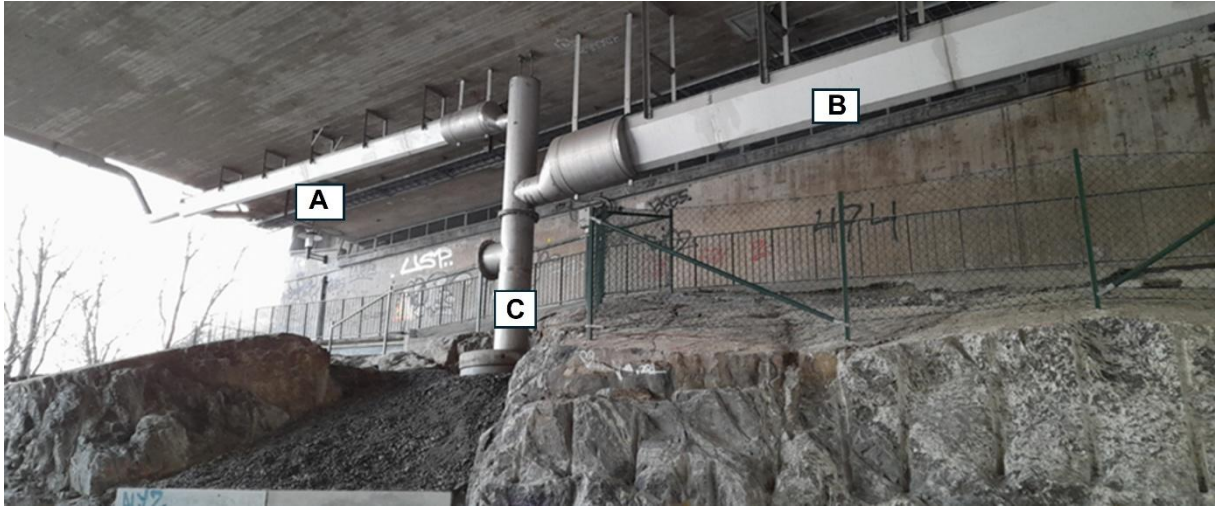
**Figure 3:** Gutters to the Gröndal runoff treatment plant. A. Gutter collecting run-off from the bridge between Gröndal and Stora Essingen; B. Gutter transporting runoff from the southeast E4 road; C. Incoming pipe to the Gröndal RWTP.

collect the road run-off (Fig. 3), transporting it to the Gröndal runoff water treatment plant (RWTP). The Gröndal runoff water treatment plant comprises a sand trap and a sedimentation basin. At the beginning of the basin, an aluminium-based chemical flocculant is added to accelerate the separation of finer particles. The sedimentation is sequential and controlled by the turbidity and level in the basin; thus, the water levels will vary between the minimum water level (0.9 m) and the maximum water level (2.0 m) during operation. At high flows, an overflow pipe diverts the water.

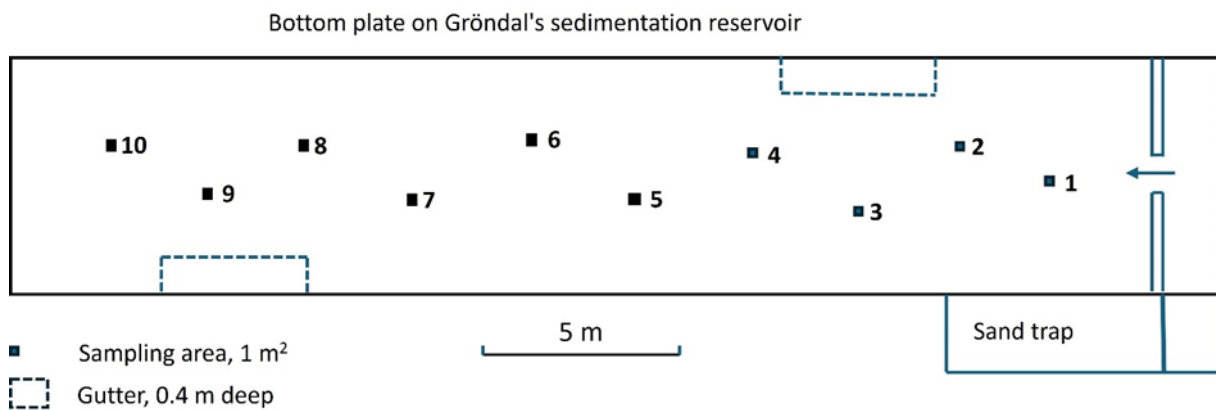
**Figure 5:** Distribution of sampling points in the Gröndal sedimentation basin from inlet (1) to outlet (10).

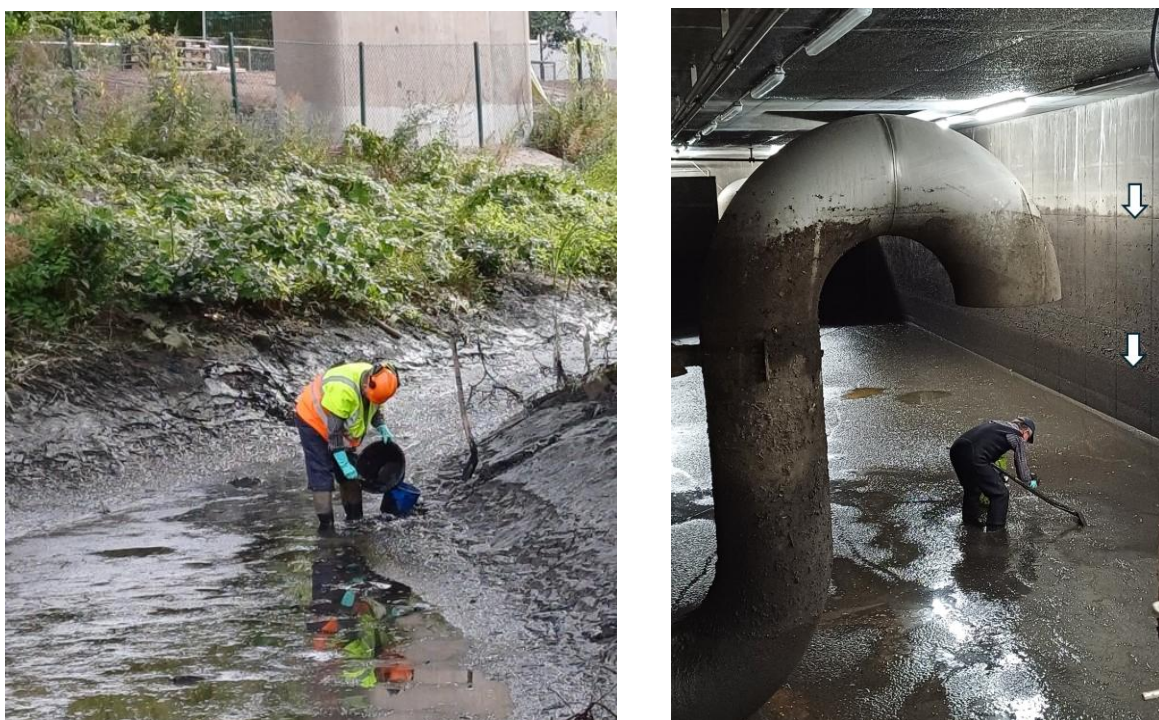
**Figure 6:** Left fig., Sediment sampling in the Lilla Essingen sedimentation pond. Right fig., sampling in the Gröndal underground treatment system. White arrows show high and low water levels in the sedimentation basin.

To facilitate sampling of the sediments in the two runoff treatment plants the supernatant water was carefully removed by pumping over two days. It was possible to fully expose the sediment in the sedimentation pond at Lilla Essingen. However, the sediment in the sedimentation tank in the Gröndal runoff treatment plant had more unconsolidated sediment, posing a risk for unintended removal during emptying. Thus, the pumping was stopped when reaching a water depth of approximately 30 cm from the bottom of the sedimentation basin. Ten sediment samples, evenly distributed over the sedimentation pond and sedimentation basin, were collected. In addition, one field blank was also gathered at both plants and one sample from the sand trap at the Gröndal runoff treatment plant (Figs.4 and 5). A 1x1 m boundary was applied in situ around each sampling point, using a steel shovel. The square meter area and associated volume were thoroughly mixed before a 10 L stainless steel bowl was filled and the sediment remixed with a long-handled metal spoon. Samples were taken into glass jars received from the accredited laboratory Eurofins. The shovel was washed between sampling points with the water available in the RWTP. To avoid plastic contamination from the inside of the metal lid, pieces of aluminium foil were placed as protection. The samples were stored in a refrigerator at 4 °C until analysis. The analysis included field blanks. For more information, see Figure 6.

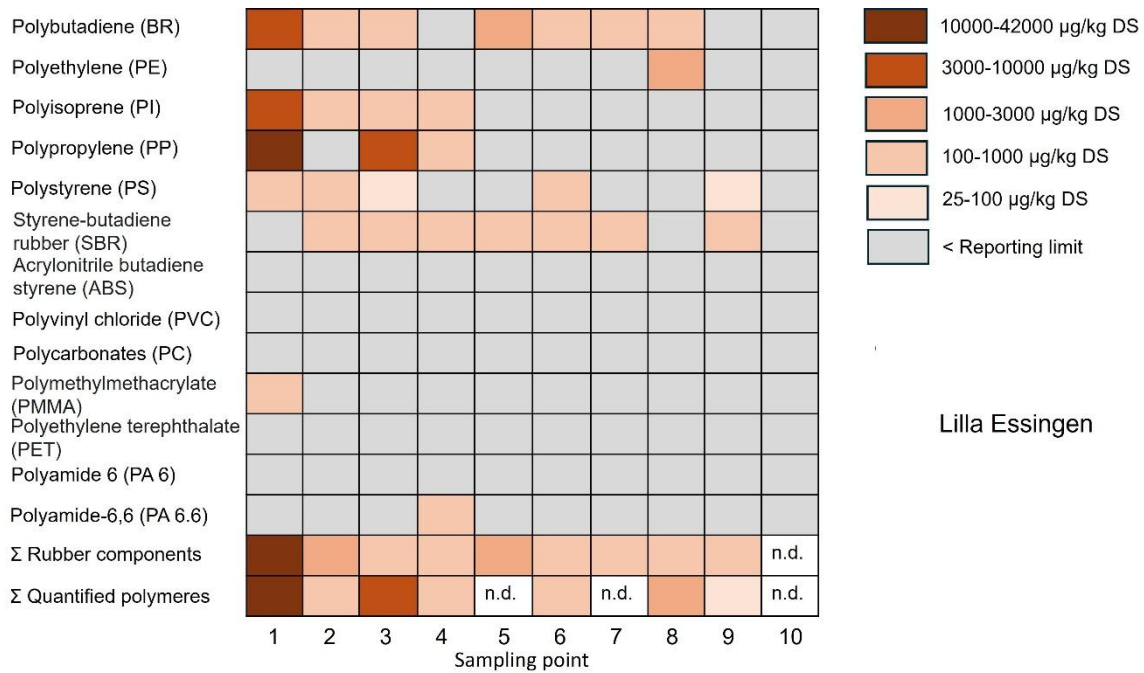
**Figure 8:** Concentrations of rubber components and microplastic polymers (PS, PMMA, PA 6) in road runoff sediment accumulated for three years and eight months in the Lilla Essingen sedimentation pond. Reporting limit = below the limit of quantification. No data = n.d.

The results of the MP and rubber analysis performed on the sediment samples from the two studied sites are shown in Figures 8 and 9. The longitudinal distribution from the inlet (sample point 1) to the outlet (sample point 10) shows a pattern of more deposition closer to the inlet zone. This is clear for the Gröndal system where the sediment layer thickness slowed down towards the outlet. The highest concentrations of rubber components are found in the inlet zones but spread over the entire sedimentation areas. The quantified polymers are also deposited to a higher degree in the inlet zone. The sum of polymers is unfortunately not given by the Eurofins laboratory for points 1 and 2 in the Gröndal case. The MP analysis included 13 microplastics and rubber components but only eight of them were detected in Lilla Essingen sediment and five in the Gröndal.

The road marking areas shown in Table 1 were used to calculate the wear of microplastics per hectare and year. In Table 6 the wear regarding the marking's area is given based on the highest average interval concentration presented in Figures 8 and 9 for polystyrene (PS), polymethylmethacrylate (PMMA) and polyamide 6 (PA 6). In the case of Essinge-leden, one hectare of road marking area (RMA) would release polymers with road runoff of 3.83 kg/year corresponding to 23.2 mg/year/vehicle.

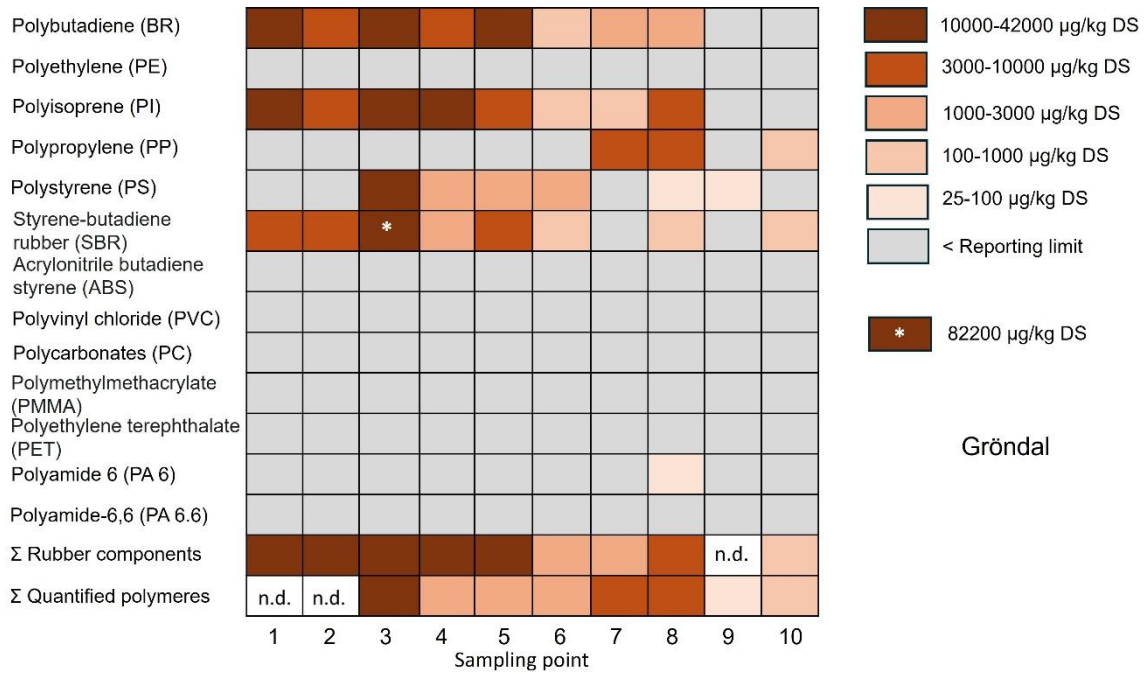
**Figure 9:** Concentrations of rubber components and microplastic polymers (PS, PMMA, PA 6) in road runoff sediment accumulated for three years and eight months in the Gröndal sedimentation facility. Reporting limit = below the limit of quantification.

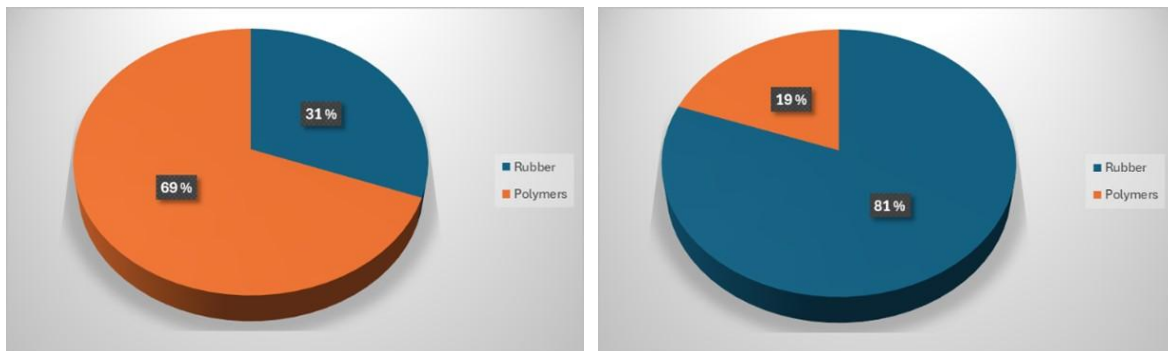
**Figure 10:** The distribution of rubber and polymers in Lilla Essingen (left fig.) and Gröndal (right fig.) sediments.

The two road runoff catchment sediments studied differ in the composition of microplastics and rubber components, as evident in Figure 10. The reason for this pattern can probably be found in the nature of the catchment areas and the traffic. The Gröndal area is characterized by only traffic areas while the Lilla Essingen area is more multifaceted. In the latter area, people can walk and cycle in some parts and there are smaller green spaces and parking lots. This area has two road exits and one entry point while Gröndal has only one exit and entry point. The open Lilla Essingen pond can collect air and water pollutants from everywhere in its surroundings, however the dominating source of pollution must be the road runoff.

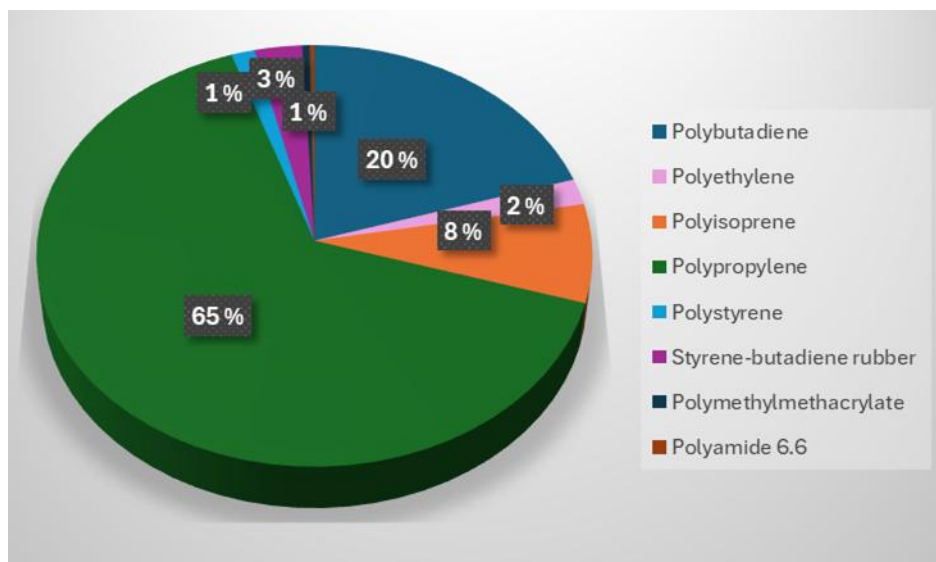
**Figure 11:** Distribution of polymers and rubber components in sediment from the Lilla Essingen pond.

Looking more into the detailed distribution of polymers and rubber found in the two sediments, it is evident that differences exist (Fig. 11 and 12). The proportion of polymers related to paint in road markings is very small in both cases. Polymers and rubber with a most likely origin from tire wear largely dominate, making the relative contribution of microplastics less from road paint.

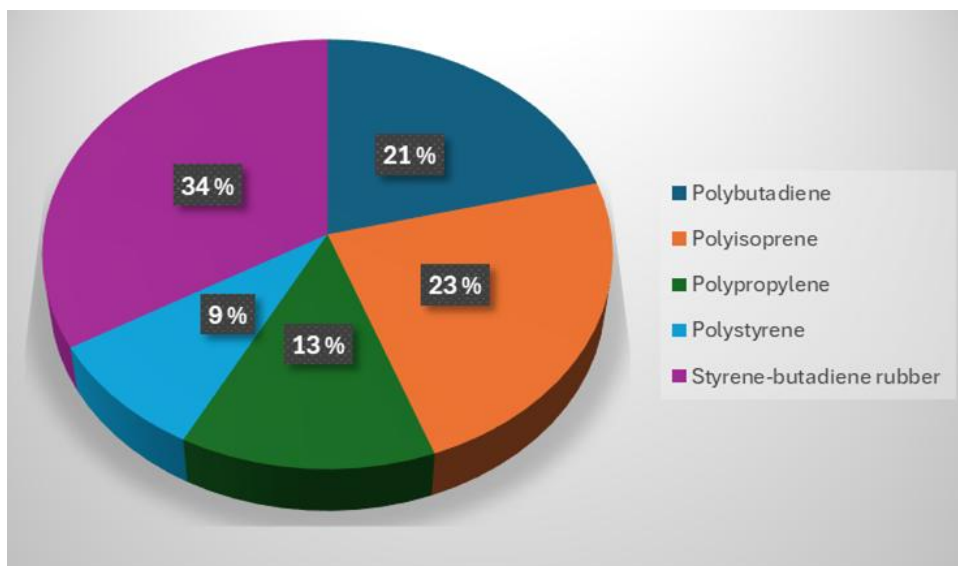
**Figure 12:** Distribution of polymers and rubber components in sediment from the Gröndal sedimentation system.

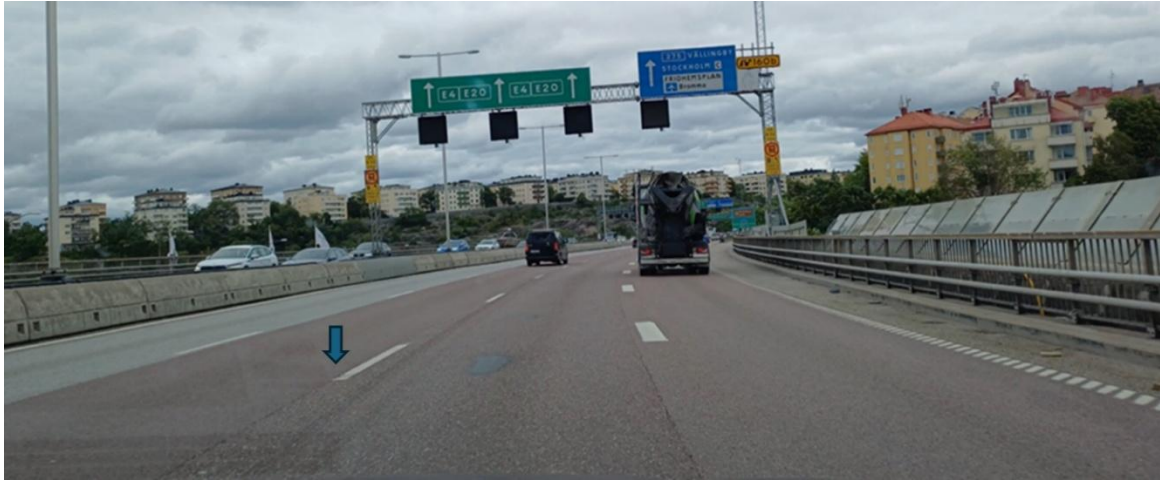
**Figure 13:** Road area at the beginning of the exit to Lilla Essingen island. The pond is situated below this part of the bridge. The blue arrow indicates the wear of the lane line. On the right-hand side, the so-called stair-flex line is visible.

The field investigation performed during autumn 2024 shows that less than 5% of the road markings have visible wear. This mainly occurs at exits and entries of the highway and as there are few, paint-borne microplastics will likely not be found to a large extent in the studied sediments. The vehicles seem to keep their position well between the lane lines as the lines are not much affected by wear. The stair-flex lines and the solid road lines on the edges of the road surfaces are almost unaffected by vehicles but road management with snow ploughing and sand sweeping can probably cause a release of paint and microplastics. Figures 13 and 14 show examples of road marking areas affected by road wear.

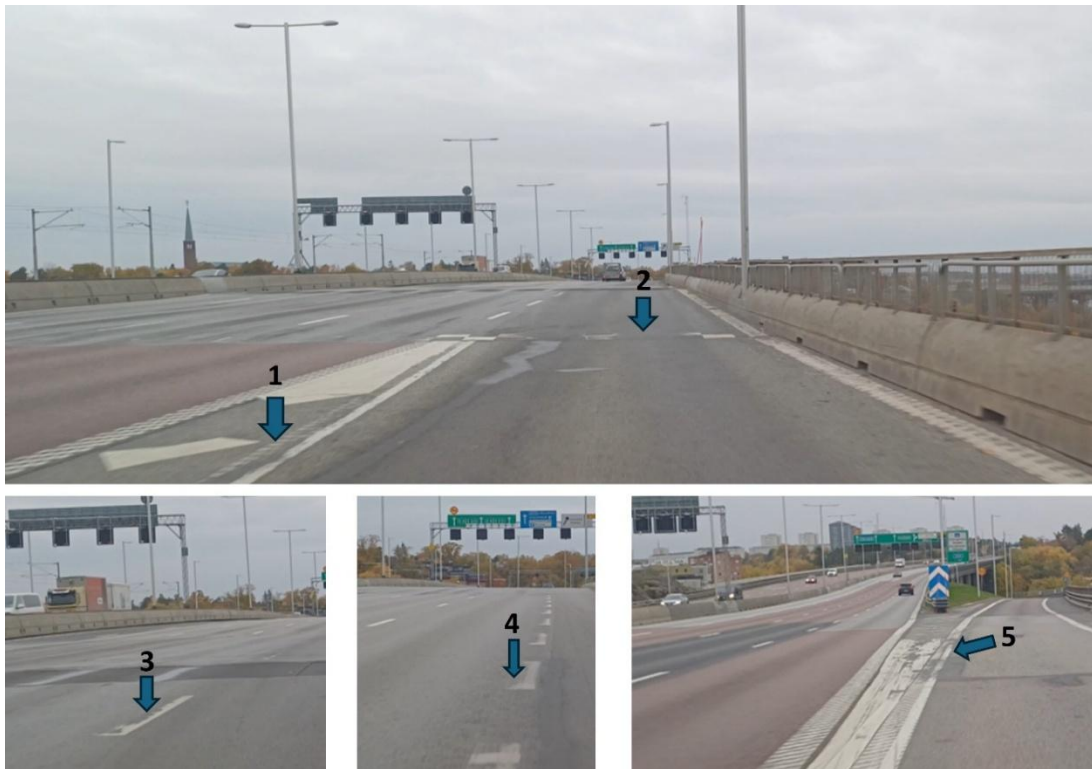
**Figure 14:** Road marking wear at the entry (1, 2) on the Gröndal bridge (3, 4) and the exit (5) to the district Gröndal. These markings are on vehicles crossing areas with obvious wear and possible release of paint-borne microplastics.

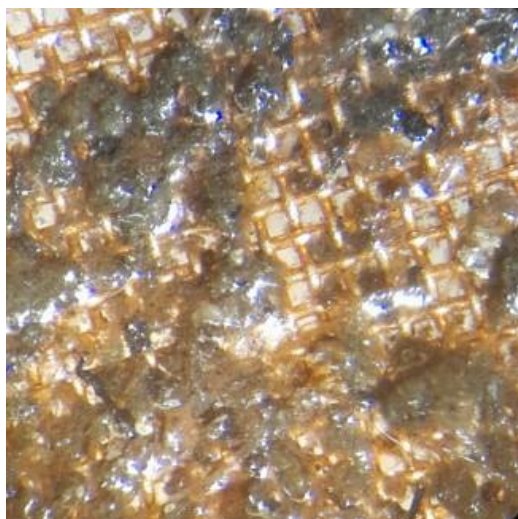
**Figure 15:** Sediment filtered through stainless steel (mesh size 500  $\mu\text{m}$ ). The blue colour is reflected light in glass beads present in the sediment and originating from road marking paint.

This study should be followed up by more investigations of the collected sediment samples. For instance, the glass microbeads observed in the microscope (Fig. 15) should be studied and estimated in detail in Gröndal and Lilla Essingen sediments. Such analysis could cast light on the microbeads as proxies for road marking paints (Turner et al., 2024). The Gröndal reservoir and the Lilla Essingen pond are managed differently as flow-through systems. The precipitation agent dosing in Gröndal proved more efficient for MP removal than the traditional sedimentation in Lilla Essingen. The outflow of MPs from these systems was not extensively studied in a previous project, however, analysis of a few water samples indicated low levels of MPs in incoming runoff and almost removed after filter media filtration (Agnieszka Renman, unpublished data). A complementary study should include sampling of influent and effluent water and clarify if sediments are valuable archives for studies of waterborne MPs. Similar systems with different and lower traffic loads to the two studied should be included and flow-monitored from the state of emptied sediment basins to filled-up after 2-3 years. The results should gain knowledge of how to engineer and manage current and forthcoming stormwater treatment systems to reduce microplastic and rubber pollution from roads and urban areas. Sediments and sludge collected over time constitute historical archives that can reflect real conditions, but more development work needs to be done regarding sampling and, above all, analyses of microplastics.

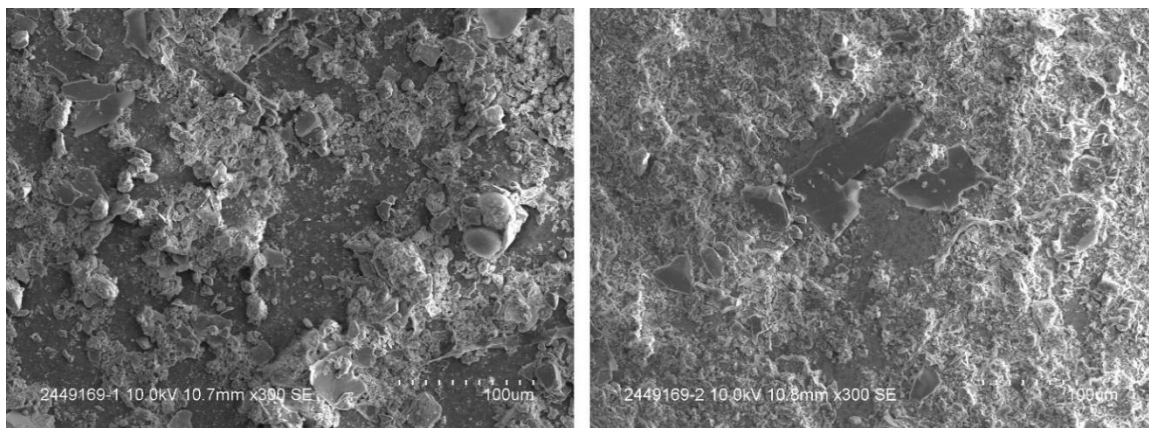
**Figure 16:** SEM images of sample from Lilla Essingen sediment (left) and Gröndal (right). Small pieces of glass beads are seen and mineral grains of silicon. The Gröndal sediment contains precipitation products after using PAX, which gives the sediment mass another character than the Lilla Essingen sediment.
